NEW JERSEY  
**BOONTON DAM**

**PARSIPPANY DIKE**

**PHASE I INSPECTION REPORT**

**NATIONAL DAM SAFETY PROGRAM**

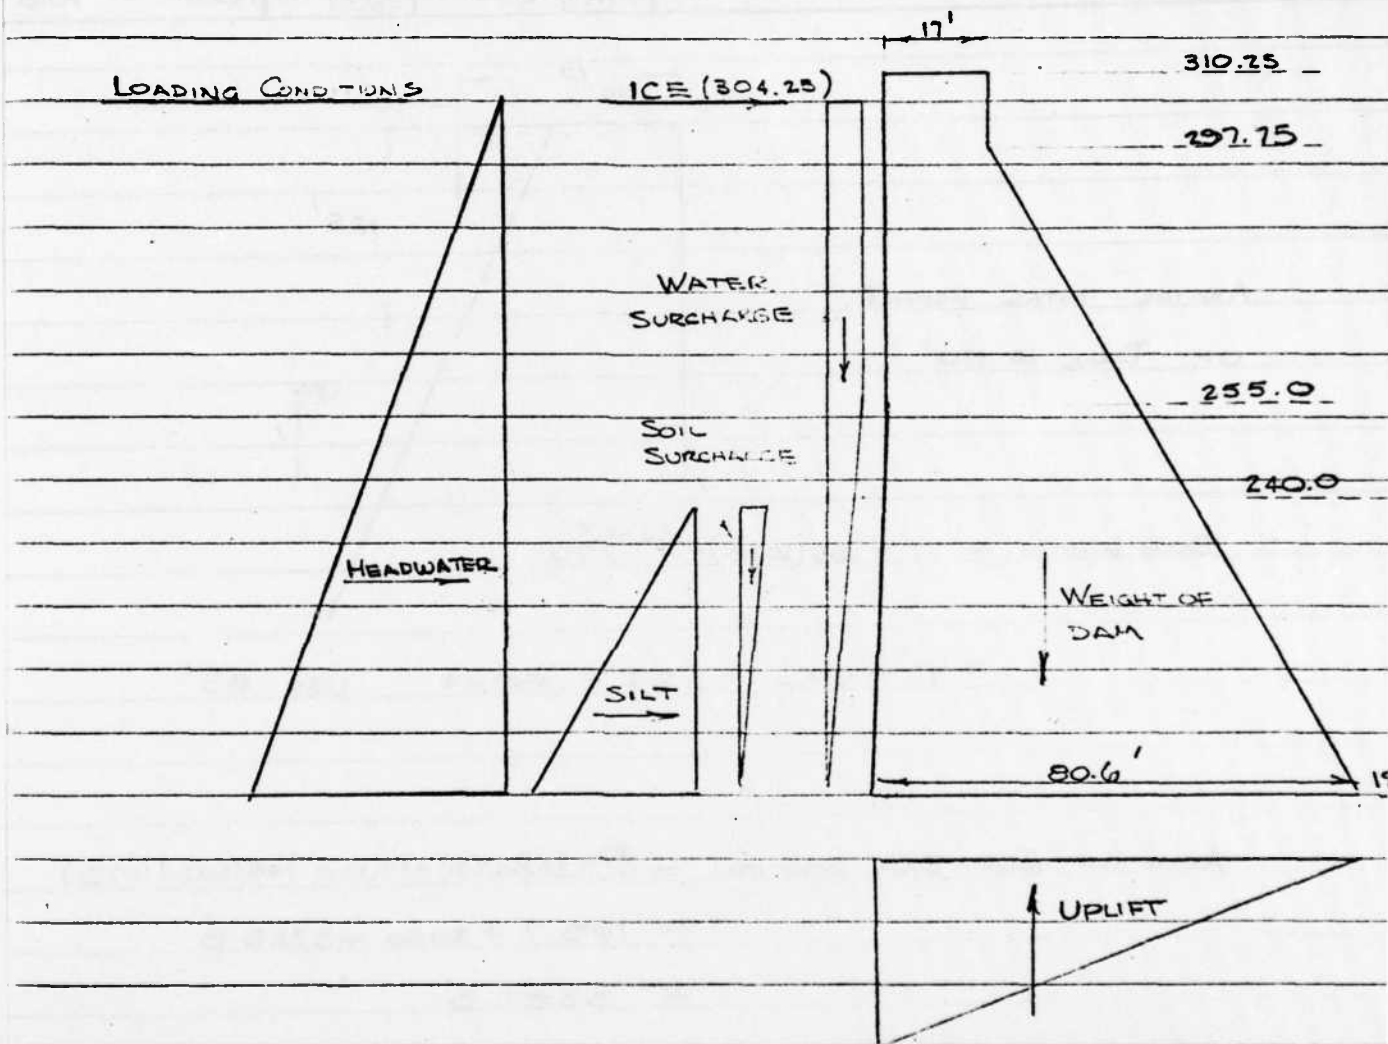
| BARTON RESERVOIR DAM | 1A | REH | 5/3/78 | 1ew m. 19! |

- SEISMIC LOADINGS APPLIED: HORIZONTAL INERTIAL FORCES DEVELOPED BY THE WEIGHT OF THE DAM AND THE HYDROSTATIC LOADING. INCLUSION OF THE SEISMIC SILT LOADING HAS A NEGLIBLE EFFECT ON THE RESULTS AND HAS BEEN OMITTED FROM THE ANALYSES.
- SLIDING PLANE: FOR SIMPLIFICATION OF THE ANALYSES, THE DAM SECTION HAS BEEN EXTENDED DOWN TO THE APPROXIMATE BASE ELEVATION OF THE SHEAR KEY.
