DEGRADATION OF COATING ALLOYS  
IN SIMULATED MARINE ENVIRONMENTS

R.H. Barkalow and F.S. Pettit  
Pratt & Whitney Aircraft Division  
United Technologies Corporation  
400 Main Street  
East Hartford, Connecticut 06108

15 June 1978

Final Report: 1 March 1976 to 1 March 1978

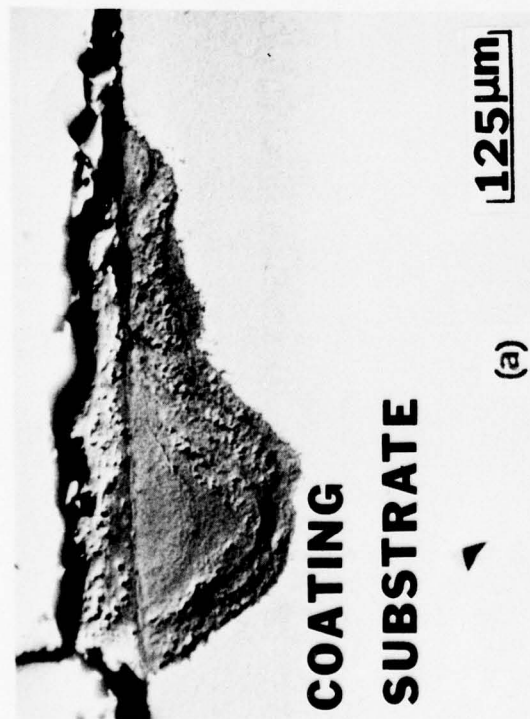
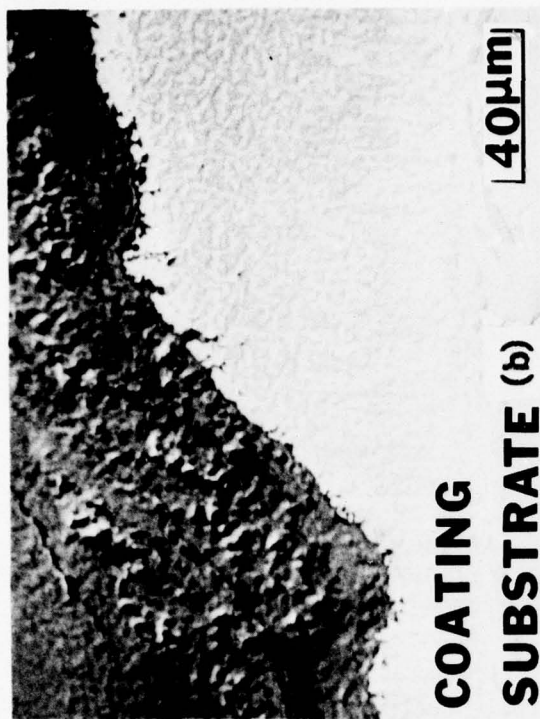
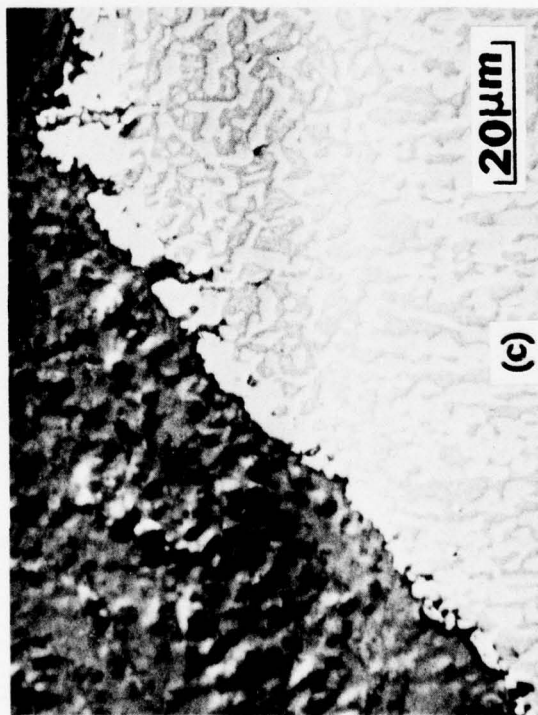
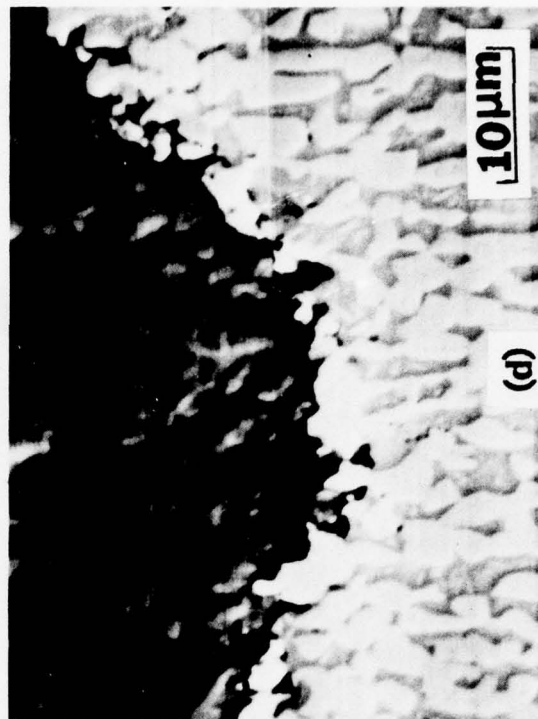
Figure 1. Typical coating protrusion in CoCrAlY-coated (IM 6250; 18-24%Cr, 11-13%Al, 0.1-0.5%Y) IN 792 first stage turbine blade operated 4801 hours in Asiafreighter engine.

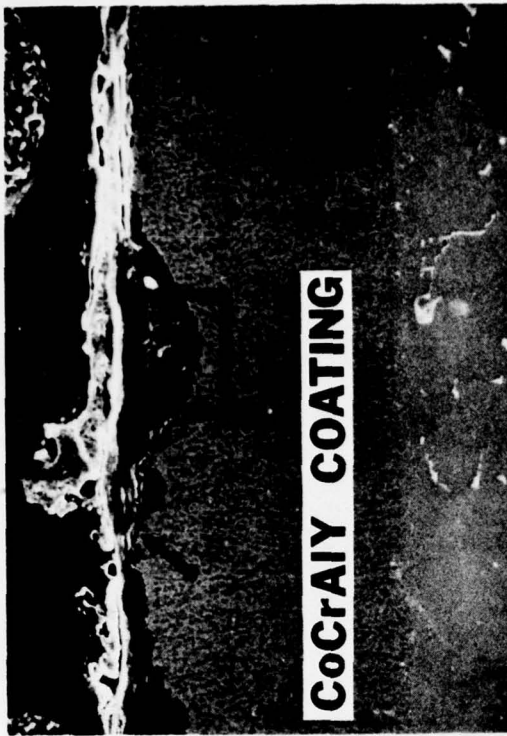
7b. Typical nodular attack and surface corrosion products near leading edge

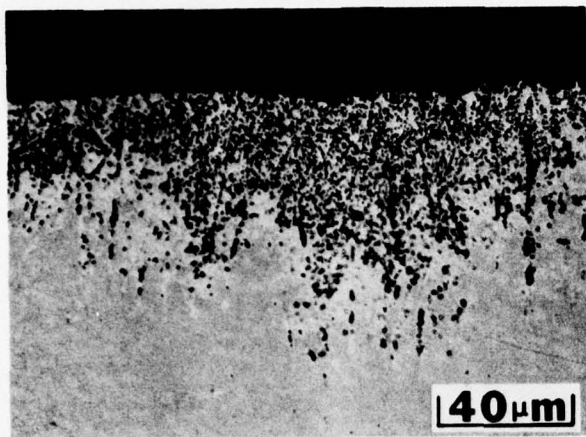
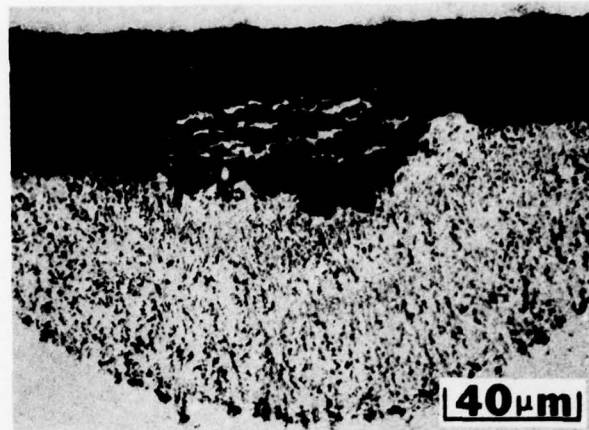
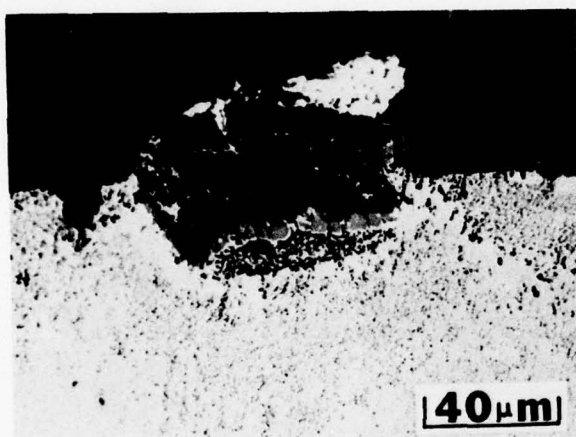
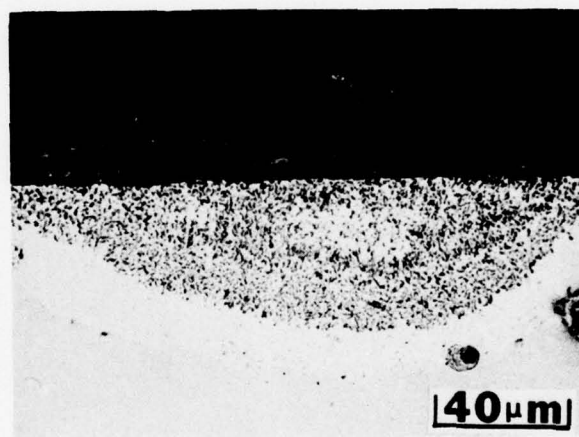
Figure 11. Degradation of state-of-the-art CoCrAlY (PWA 68), NiCrAlY (PWA 267), and NiCoCrAlY (PWA 270) coatings (a, b, and c respectively) and an experimental high-chromium CoCrAlY alloy after cyclic hot corrosion testing for 500 hours at 649°C (1200°F) with  $\text{Na}_2\text{SO}_4$  - 10% NaCl.

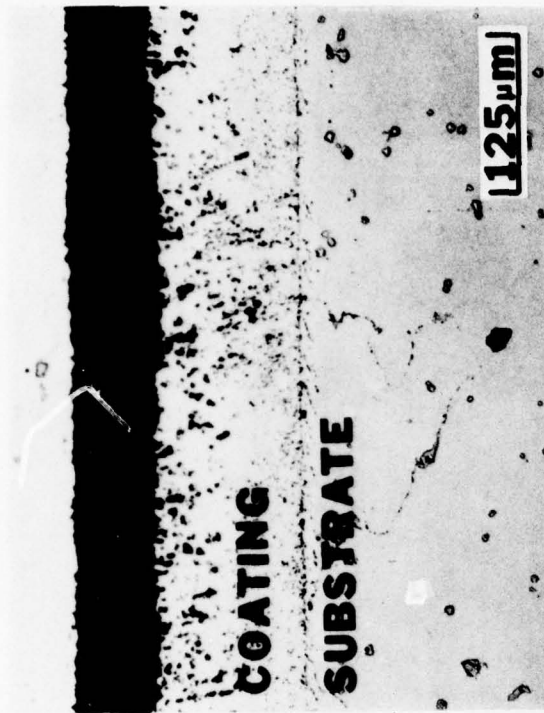
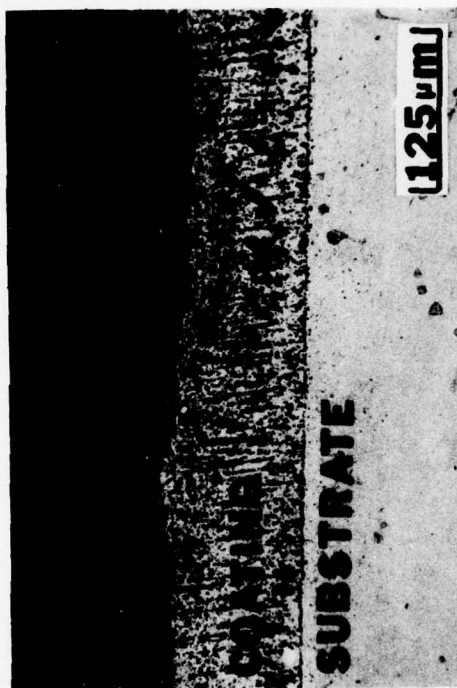
The chloride effect is also dramatically illustrated in the photomicrographs of CoCrAlY-coated IN738 in Figure 14. Exposure for 500 hours at 899°C produced negligible attack under a deposit of 100% Na<sub>2</sub>SO<sub>4</sub> but almost complete  $\beta$ -dissolution and internal oxidation of the coating under a deposit of Na<sub>2</sub>SO<sub>4</sub> - 5% NaCl (Fig. 14b). A higher concentration of chloride in the deposit (90%)<sup>4</sup> caused coating failure in only 40 hours (Fig. 14c).

Figure 14. Effect of chloride-containing deposits on degradation of CoCrAlY-coated IN 738 in 899°C cyclic hot corrosion test: (a) 500 hours with  $\text{Na}_2\text{SO}_4$ , (b) 500 hours with  $\text{Na}_2\text{SO}_4$  - 5% NaCl, (c) 40 hours with  $\text{Na}_2\text{SO}_4$  - 90% NaCl.

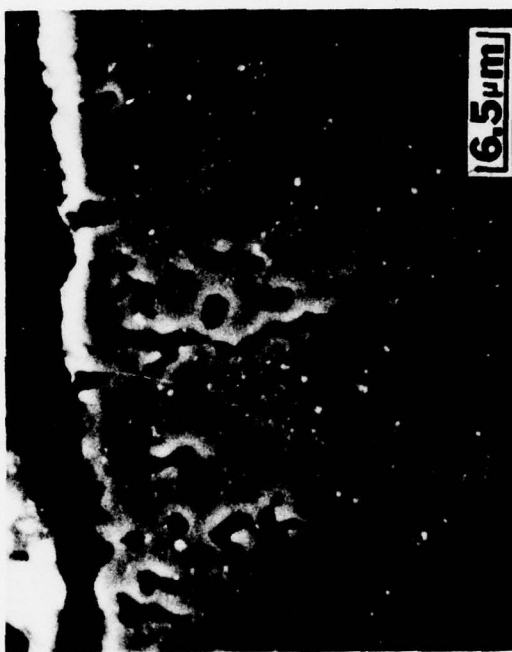
\*Features such as that in Fig. 21b were difficult to locate on polished specimens. However, the fractured sample illustrated in Fig. 19 would suggest that continuous channels to the surface are common in the three-dimensional geometry of pores and  $\beta$  particles in the  $\alpha$  matrix.

Figure 21. Scanning electron micrographs of polished section through specimen of Fig. 20. Note that large pores are similar but not identical in shape and distribution to those of the  $\beta$ -CoAl phase in the unaffected microstructure.

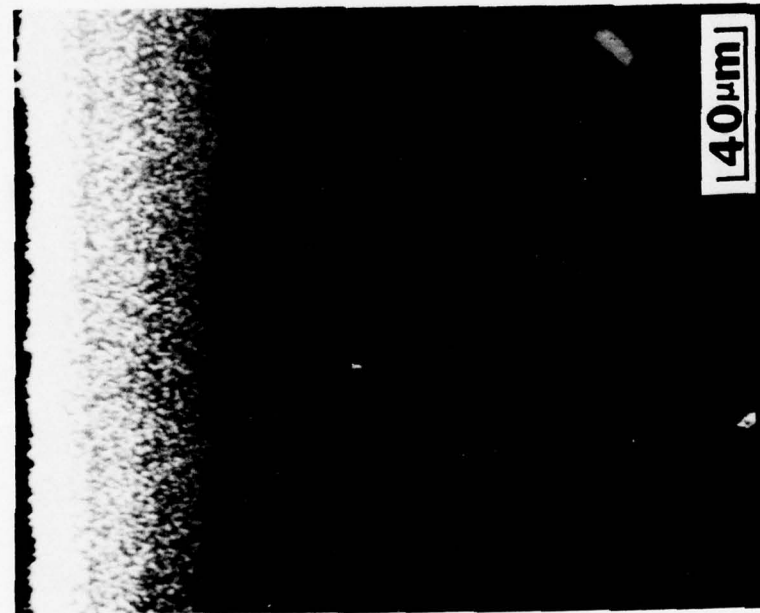
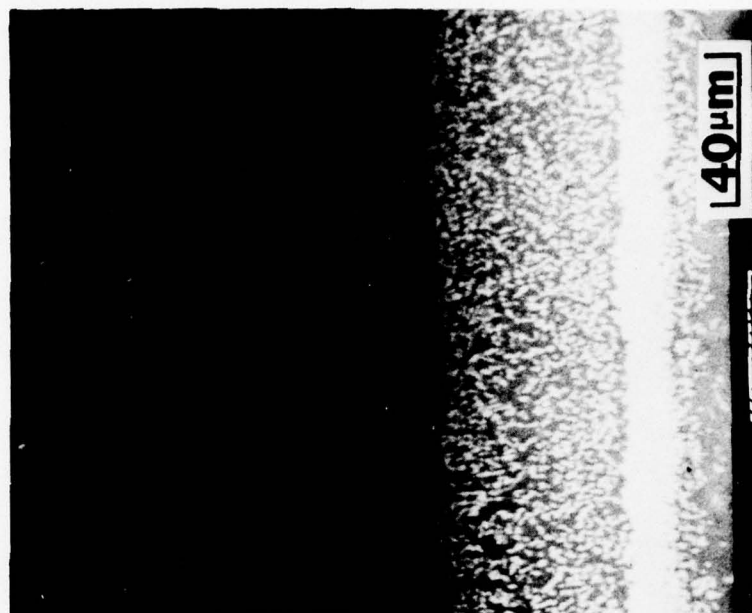
Figure 27. Back scattered electron images of platinum-modified CoCrAlY coatings shown in Figs. 26b and 26c. Overlayer and underlayer and extent of platinum-containing diffusion zones are defined by atomic number contrast which renders Pt-rich phases very bright due to high back scattering power of heavy elements.

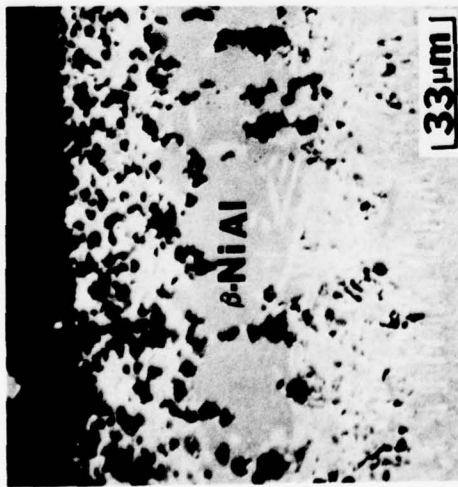
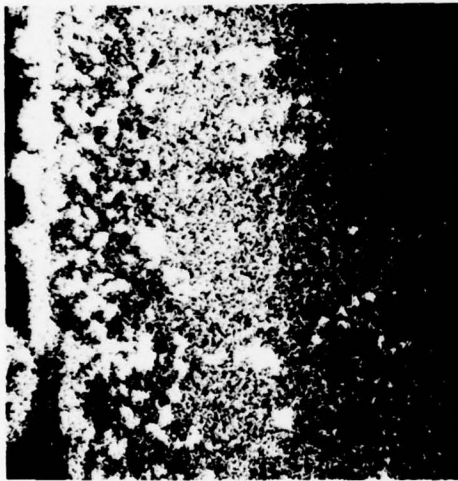
Figure 29 includes x-ray area scans of the degraded coating for Al, Ti, Cr, O, and S. It is evident that the external scale is  $\text{Al}_2\text{O}_3$ ; this scale is much thicker than that which would have formed in absence of the salt deposit and is spalling off in numerous areas. Oxides found within the coating are rich in Al and Ti, and chromium sulfides are also readily apparent (Figures 29b-29f). Such development of internal oxides in a coating still rich in aluminum (i.e. still containing  $\beta$ -NiAl) indicates the liquid salt must be de-alloying localized regions of aluminum.

Figure 29. Typical microstructure of PWA 273 coating after 500 hours cyclic hot corrosion testing at 899°C. Note retention of substantial amounts of β-NiAl phase, as shown in BSE and Al X-ray images.

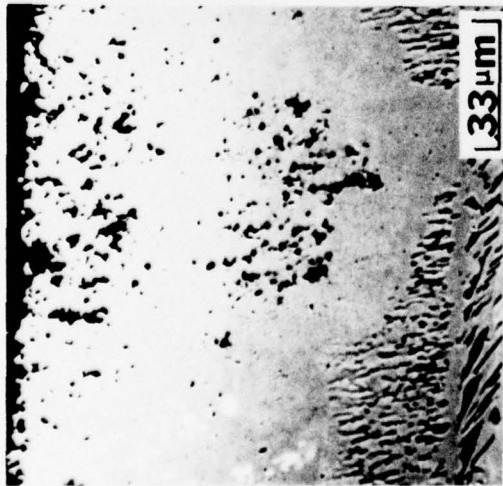
Performance of the CoCrAlY coating was significantly improved by the platinum overlayer; both samples were exposed for 500 hours, although edge distress was evident in some locations after 300 hours. In spite of oxide mounds on the surface, metallographic examination showed no penetration of the coating except at edges of the coupons. Development of coating protrusions appeared to involve the same mechanism of aluminum dealloying and internal oxidation as in FWA 68 but the coating lifetime was extended by the necessity of first penetrating the platinum overlayer (Figure 34). Pene-

Figure 34. Scanning electron micrographs of coating protrusion in PWA 68 + Pt overlay coating. Structure and element distribution appear similar to those of PWA 68 (Fig. 32) except for the Pt-containing phases.

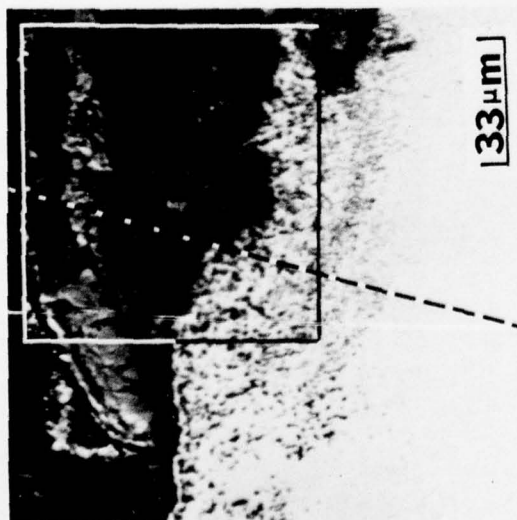
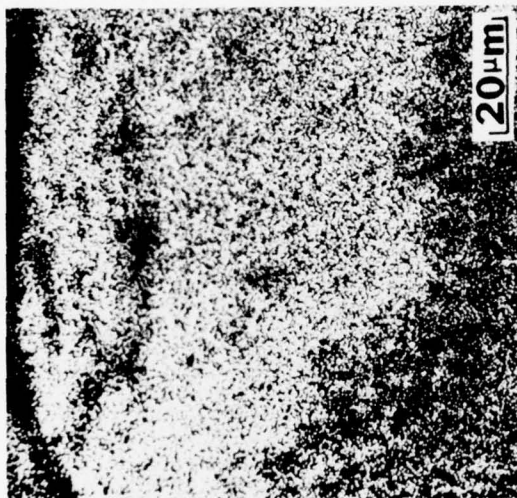
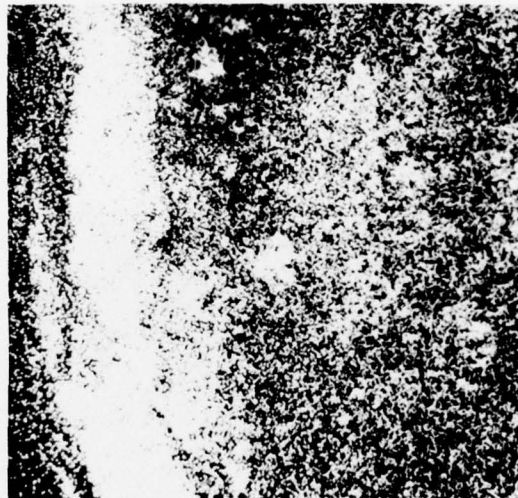
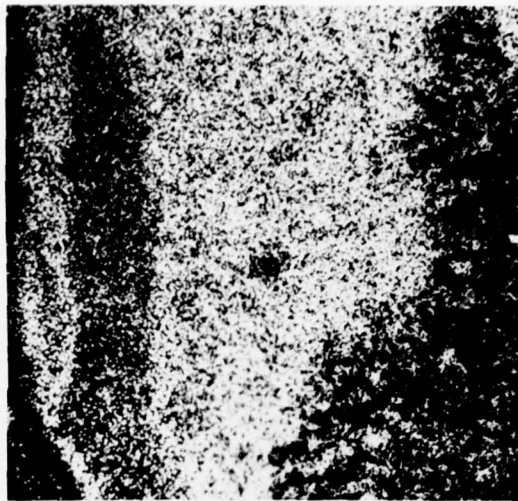
Figure 41 includes a back scattered electron image and X-ray area scans for oxygen, sulfur, and the major coating constituents. These photos, a line scan along the path shown in Figure 41a, and KEVEX spectra of selected points indicate the affected area consists of a front of  $\text{Al}_2\text{O}_3$  particles, a zone of  $\text{Al}_2\text{O}_3$  and  $\text{CrS}$  particles, and a mixture of Cr- and Al-rich oxides forming the volume of the protrusion. There is relatively little  $\text{CoO}$  (Figure 41d) except for the outer layer of the oxide mound. The line scan showed that the matrix solid solution in the zones of  $\text{CrS}$  and  $\text{Al}_2\text{O}_3$  precipitation was almost completely dealloyed of aluminum and a gradient of Cr content existed through this zone. This shows that the chloride-containing melt is capable of dealloying the coating of chromium, as well as aluminum, although the aluminum is apparently attacked first and its concentration must be reduced to a low level before chromium is preferentially removed from the alloy.

Figure 41. Coating protrusion in PWA 68 after cyclic hot corrosion testing for 780 hours at 649°C with  $\text{Na}_2\text{SO}_4$  - 50%NaCl. Box in 41a is area of X-ray images; dotted line is path of line scan discussed in text.

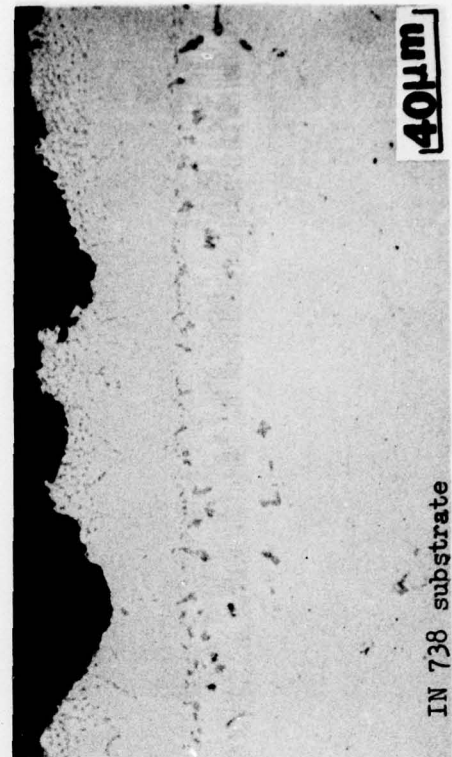
No significant difference in performance of four specimens of diffusion aluminide coatings (PWA 273, PWA 70 + PWA 273, PWA 73, and Ti + PWA 273) on IN738 was discernable, except possibly for a thicker oxide and greater scale spallation on the Ti-modified coating. Post-test metallography showed a similar nature and extent of attack on all of the samples (Figure 70).

Figure 70. Degradation of Ni-base diffusion aluminide coatings in 649°C hot corrosion test with  $\text{Na}_2\text{SO}_4$  salt and  $\text{SO}_3$  gas. Exposure time = 100 hours (5 cycles with fresh salt applied every 20 hours).

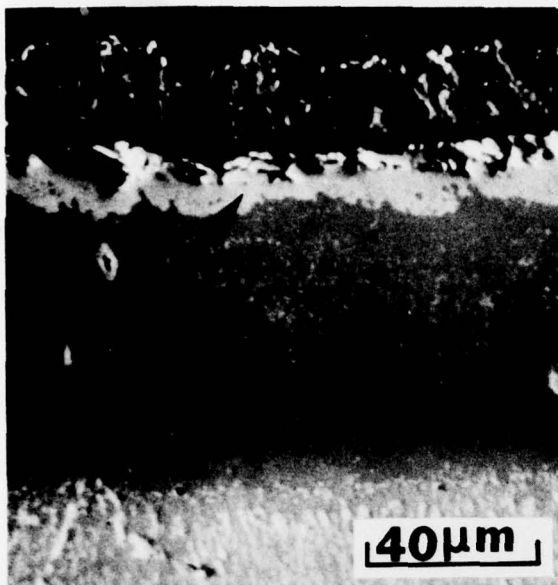
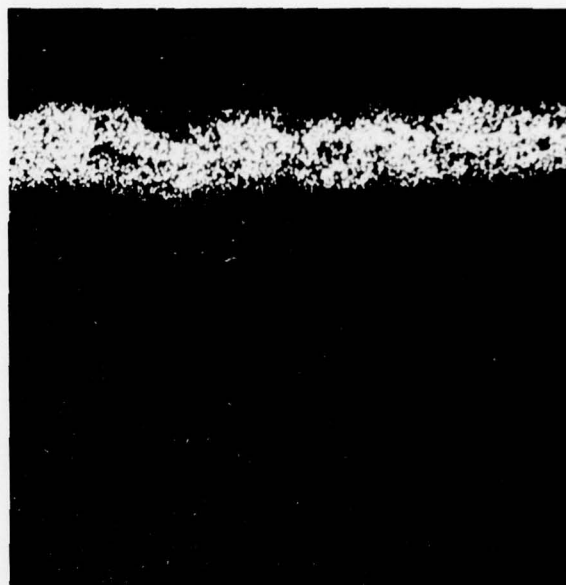
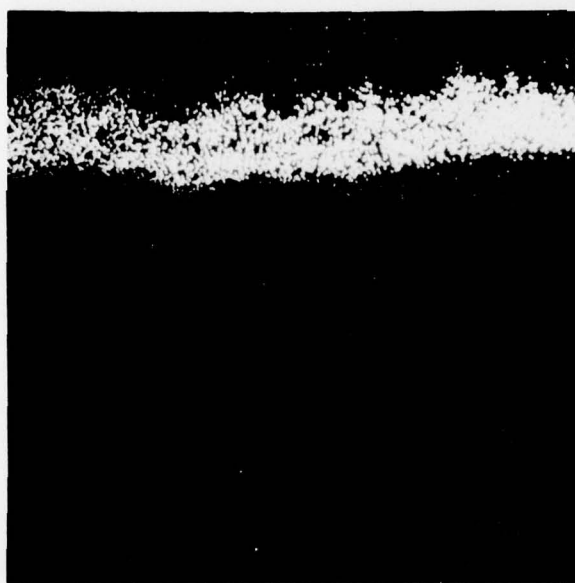
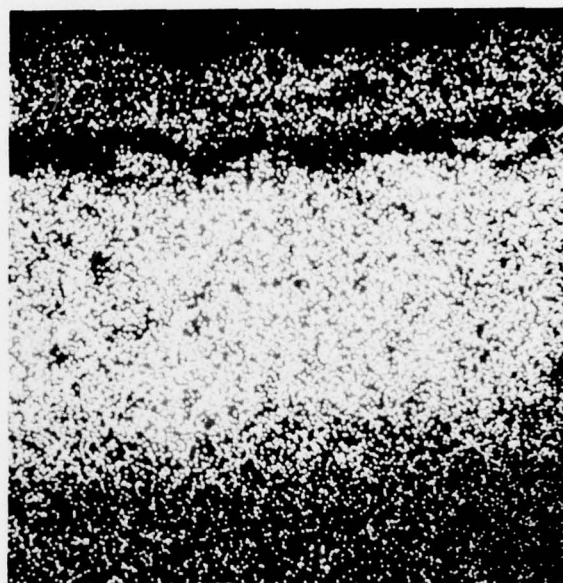
Somewhat surprisingly in view of the ineffectiveness of the Pt overlayer on CoCrAlY, the Pt-modified PWA 273 appeared distinctly better than the other aluminides. The initial visual inspection at 20 hours suggested relatively little degradation, although there was some evidence of selective attack after 100 hours. Metallographic examination showed a Pt-rich surface layer generally unaffected except for a thin scale (Figure 71).

Figure 71. SEM photomicrographs of sputtered platinum + PWA 273 diffusion aluminide coating tested concurrently with the specimens of Fig. 70. Residual salt and surface scale are evident on the dry-polished sample, but a Pt-rich surface layer (arrow) is still intact and there is minimal dealloying of the  $\beta$ -NiAl.

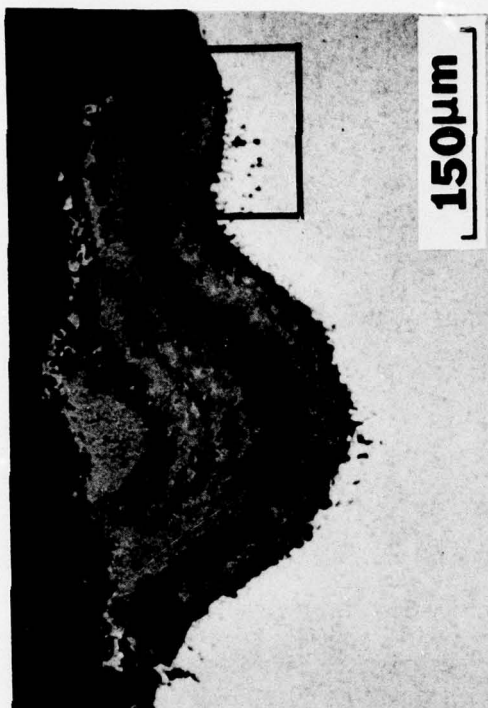
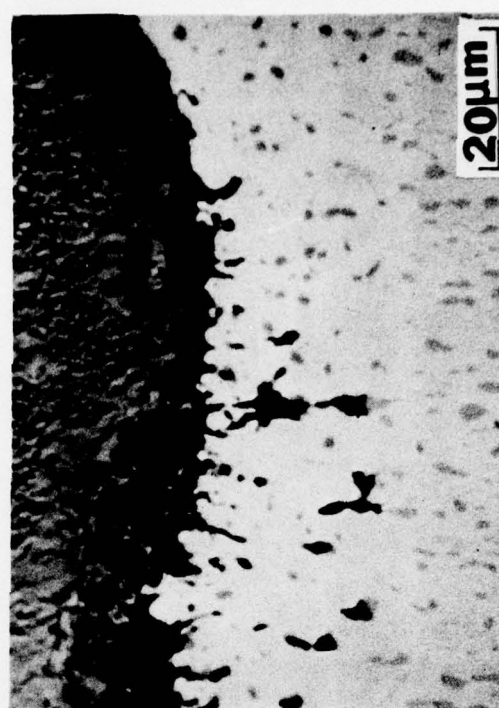
72b. PVD Co-25Cr-6Al

The Co-25Cr-6Al showed several areas of very deep, localized attack as in Figure 72b. Again there was a substantial  $\beta$ -depleted zone with precipitates of Cr-rich sulfides (black arrows); a layer of corrosion product immediately adjacent to the scale/metal interface was highly enriched in aluminum and sulfur (area scans not presented).

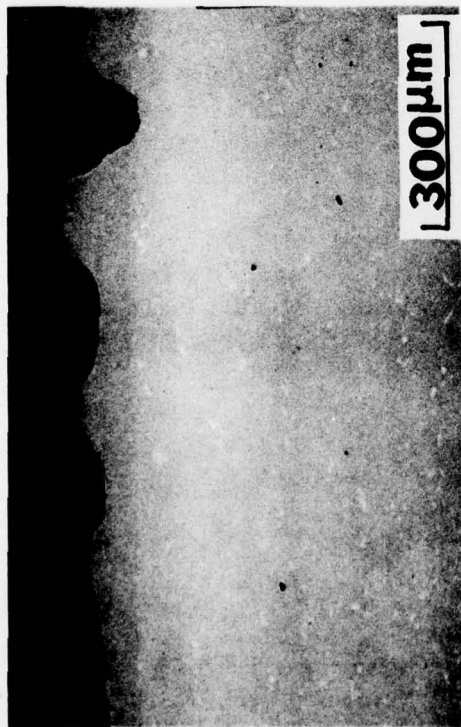
a. Typical protrusions and structure of scale/  
metal interface

Figure 73. CoCrAlY-coated IN 738 exposed 40 hours at 760°C (1400°F) with  $\text{Na}_2\text{SO}_4$  salt and  $\text{SO}_3$  in the gaseous environment. Coating was penetrated in numerous areas and completely consumed on one edge of the coupon.
