MIDVALE DAM

**PHASE I INSPECTION REPORT
NATIONAL DAM SAFETY PROGRAM**

NJ 00205

JUNE 1978

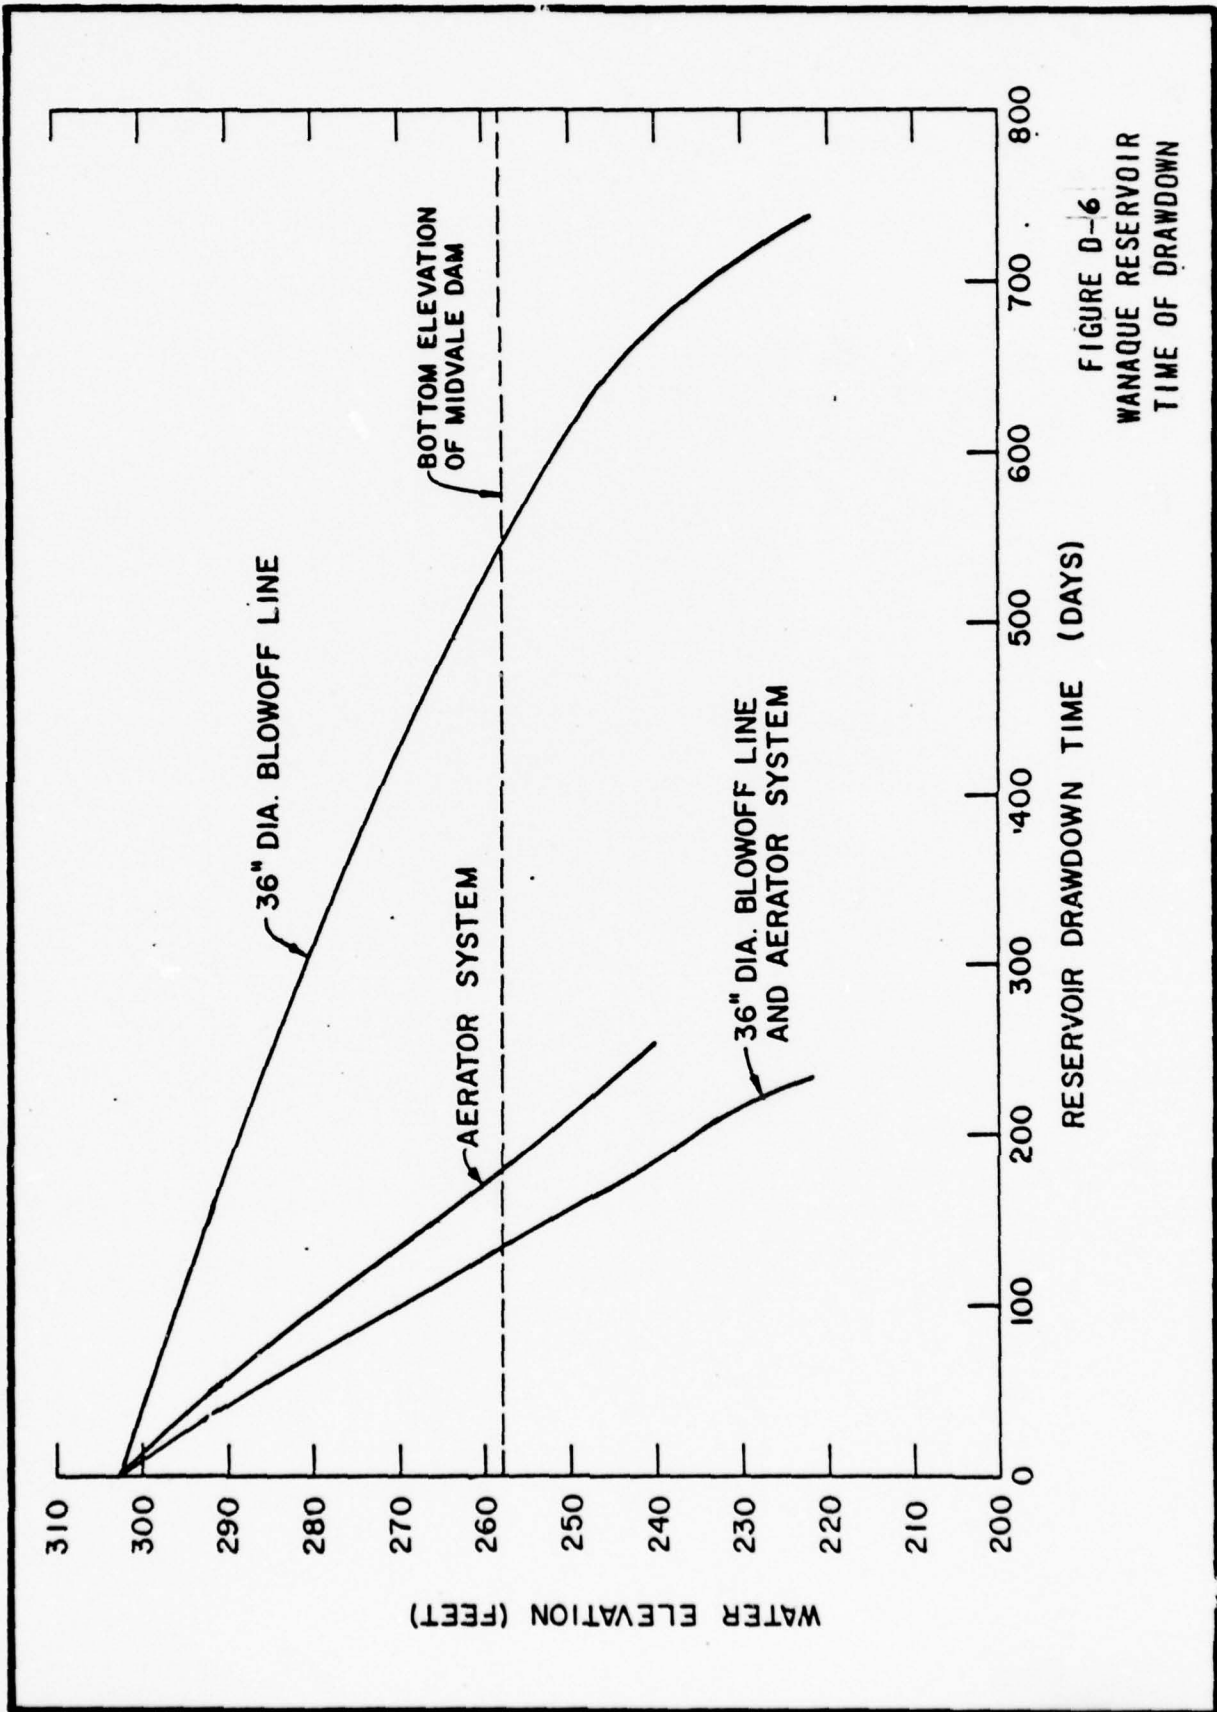
FIGURE D-6
 WANAUKE RESERVOIR
 TIME OF DRAWDOWN

The existing emergency drawdown facilities installed in the several dams of the Wanaque Reservoir are not adequate to lower the water level of the reservoir in a short period of time. It is recommended that the owner designs and constructs water release structures that will allow lowering the water level within an acceptable period of time. A preliminary evaluation of the performance of the
