# CRYSTAL LAKE DAM

PHASE I INSPECTION REPORT

NATIONAL DAM SAFETY PROGRAM

NJ 00217

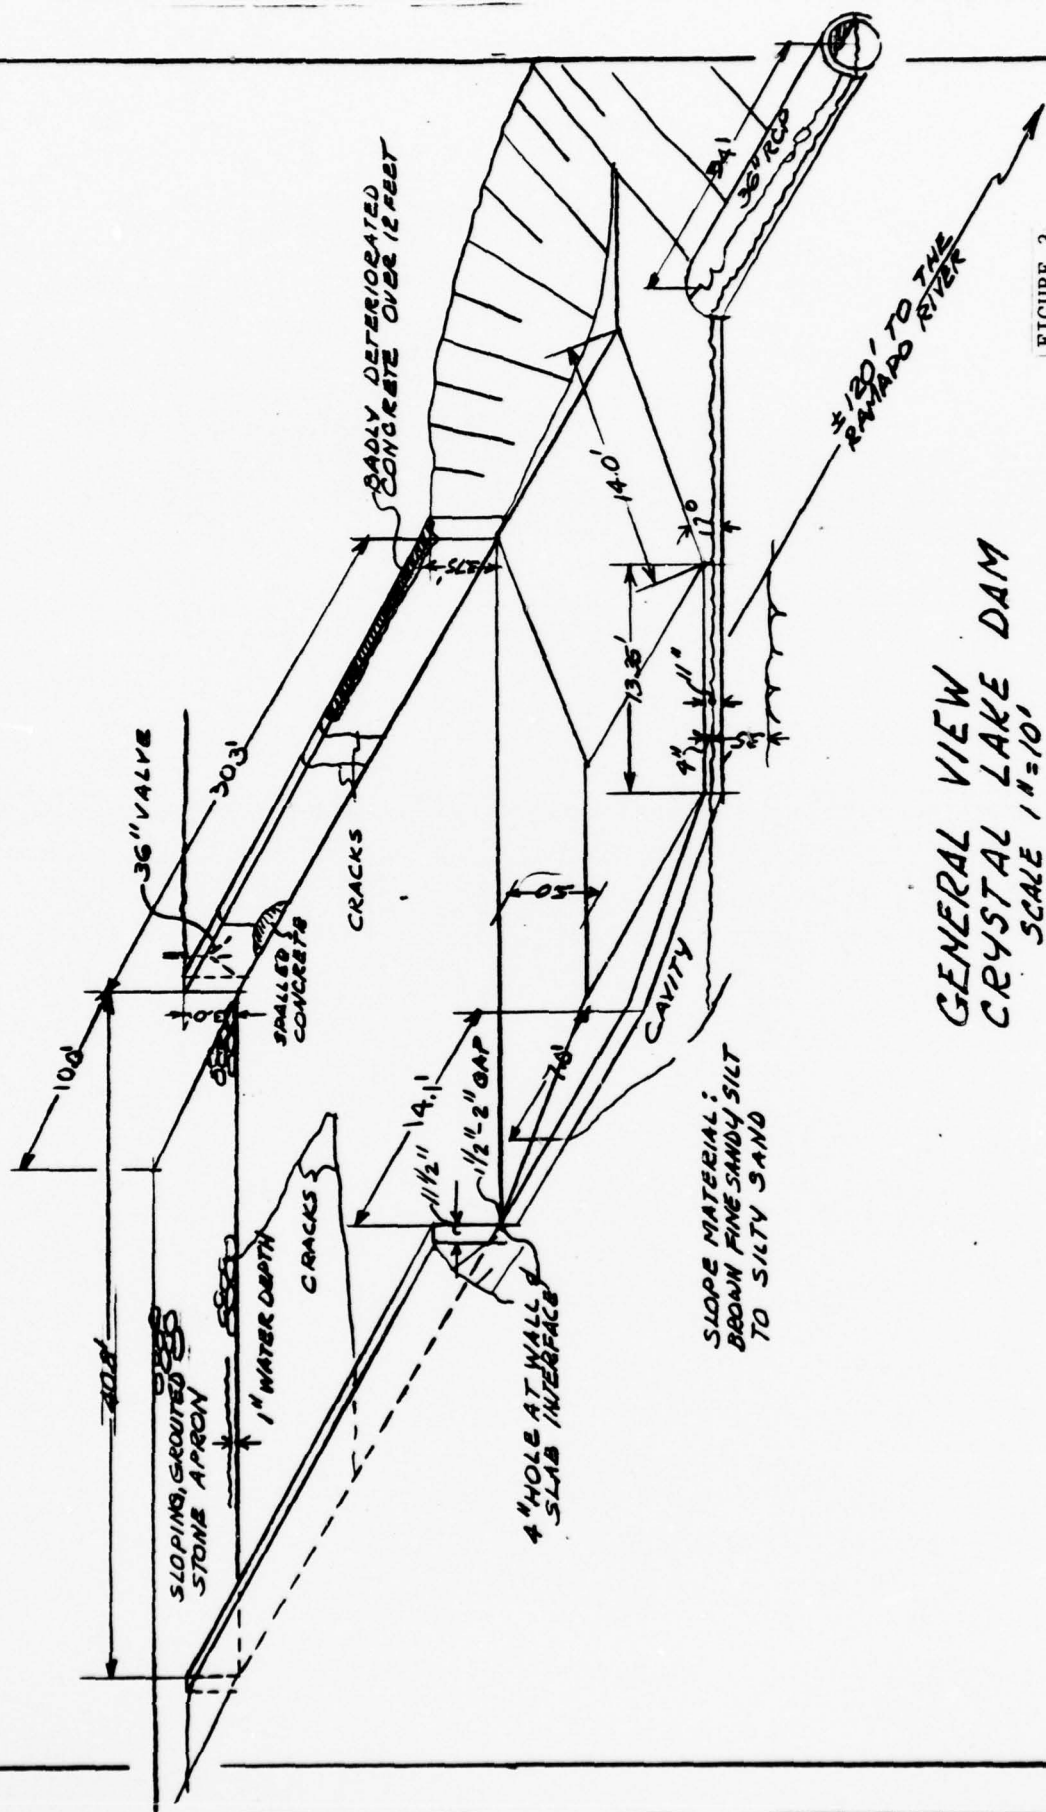
FIGURE 3

c. Validity: Cannot be judged considering unavailability of record drawings. A sketch of the concrete structure based on field measurements is shown in Figure 3. Appendix C shows photographic details of several portions of the structure described and evaluated within this report.
