**CANOE BROOK RESERVOIR  
NO. 3 DAM**

**CANOE BROOK RESERVOIR  
NO. 3 DIKE**

**3 PHASE I INSPECTION REPORT  
NATIONAL DAM SAFETY PROGRAM.**

NJ 00527  
NJ 00550

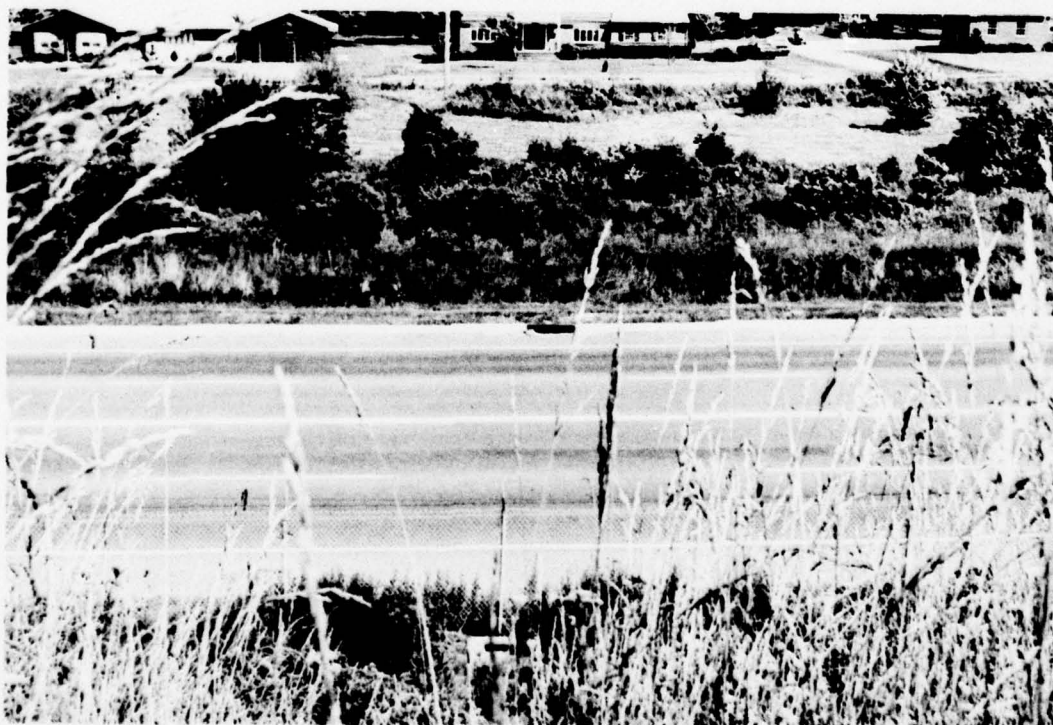
**PHOTO 5**

Photo 5 - View Northwest Across Eisenhower Parkway at Maximum Height Dike Section; Curb Inlet Between Two Cars Marks Inlet of 36 Inch Storm Drain Extending Beneath Reservoir to Outlet Shown in Overall View of Dam; Crest of Dam is in Center of Photo, Above Dike Crest and Below Tree Line - 14 June 1978.
