PASSAIC RIVER BASIN

# POINT VIEW DAM

PHASE I INSPECTION REPORT

NATIONAL DAM SAFETY PROGRAM

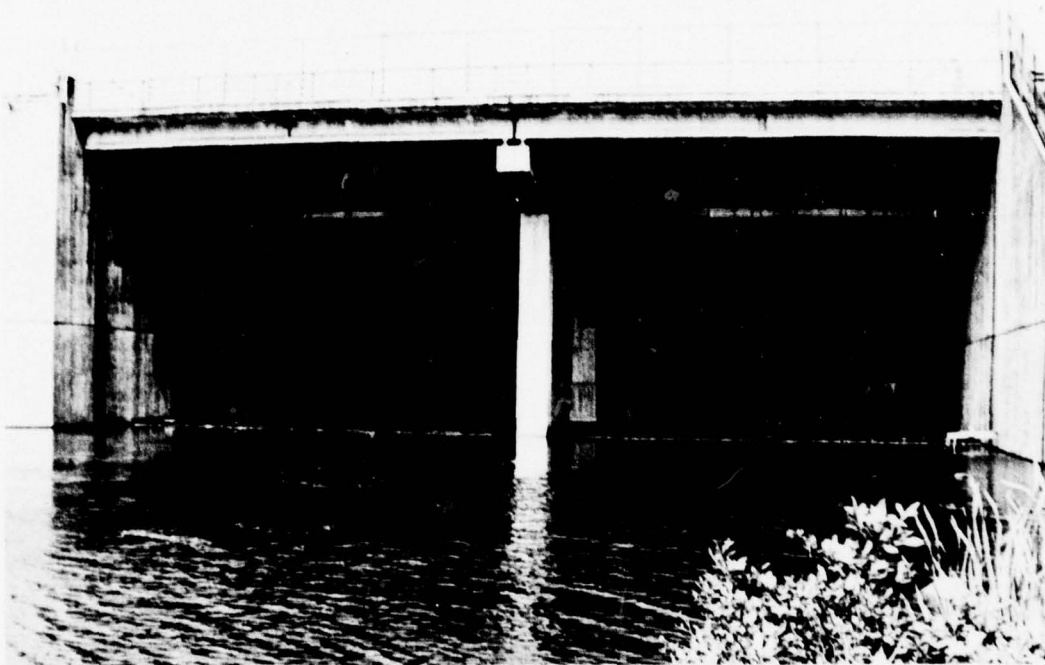
PHOTO 1

- Photo 1 - View Upstream (East at Spillway Outlet From  
Southwest Bank of Lionheads Lake - 9 June 1978
- Photo 2 - View North Along Cyanamid Drive From Left (South  
Abutment of Dam; Spillway and Gate Control Chamber  
in Center (Right of Station Wagon); Intake Tower  
at Right Edge of Photo - 9 June 1978

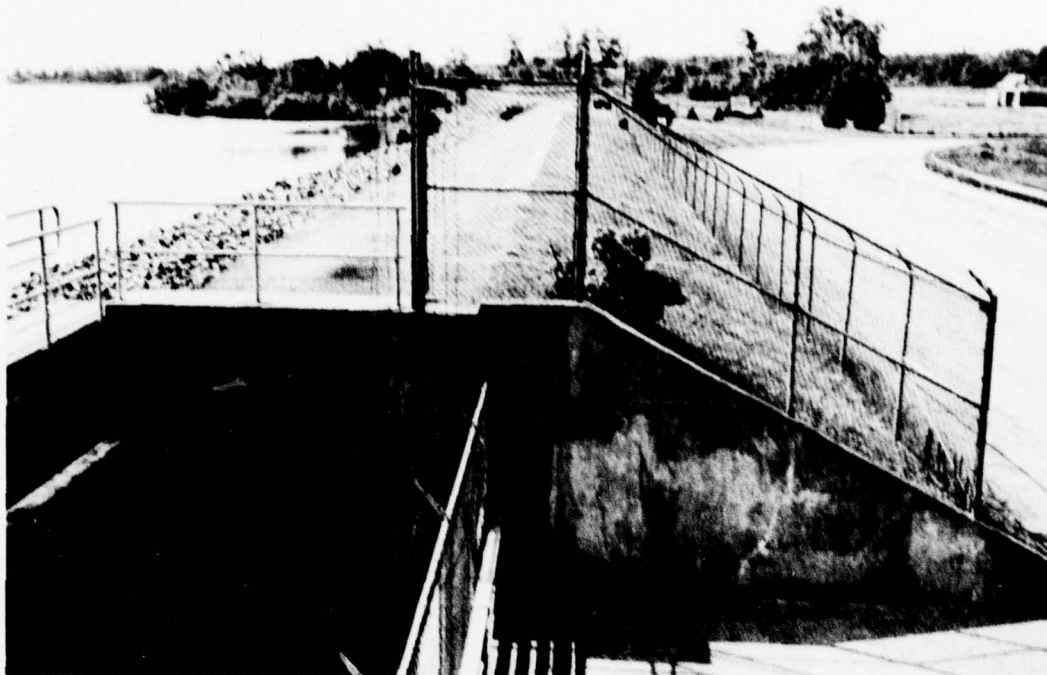
PHOTO 3

- Photo 3 - View South Along Dam Crest From Gate Control  
Chamber; Ungated Spillway Section at Left -  
9 June 1978
- Photo 4 - View Northeast at Right Side of Spillway (Gated  
and Ungated Section) From Gate Control Chamber -  
9 June 1978

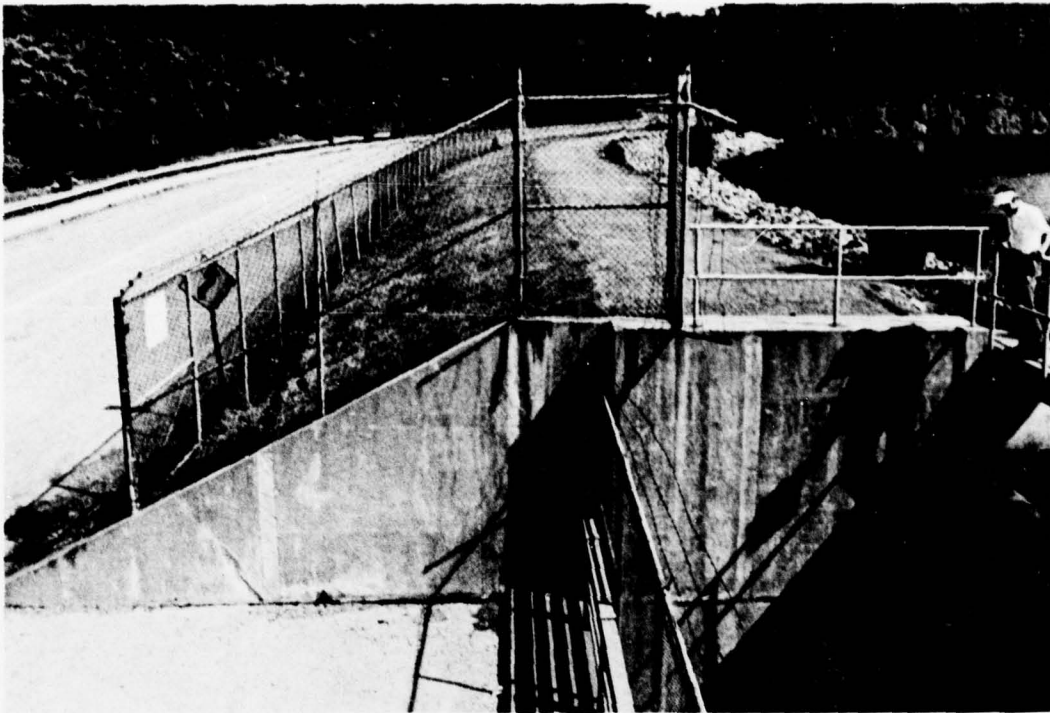
PHOTO 5

- Photo 5 - View North Along Dam Crest From Gate Control  
Chamber; Ungated Spillway Section at Right -  
9 June 1978
- Photo 6 - View Downstream (West) at Right (North) Side of  
Spillway and Upstream Slope of Dam From Intake  
Tower; Gate Control Chamber and Walkway to Intake  
Tower at Left Edge of Photo - 9 June 1978
