USARTL-TR-78-13

REVIEW OF ENGINE/AIRFRAME/DRIVE TRAIN DYNAMIC  
INTERFACE DEVELOPMENT PROBLEMS

W. J. Twomey, E. H. Ham  
Sikorsky Aircraft  
Division of United Technologies Corporation  
Stratford, Conn. 06602

Final Report for Period August 1977 - March 1978

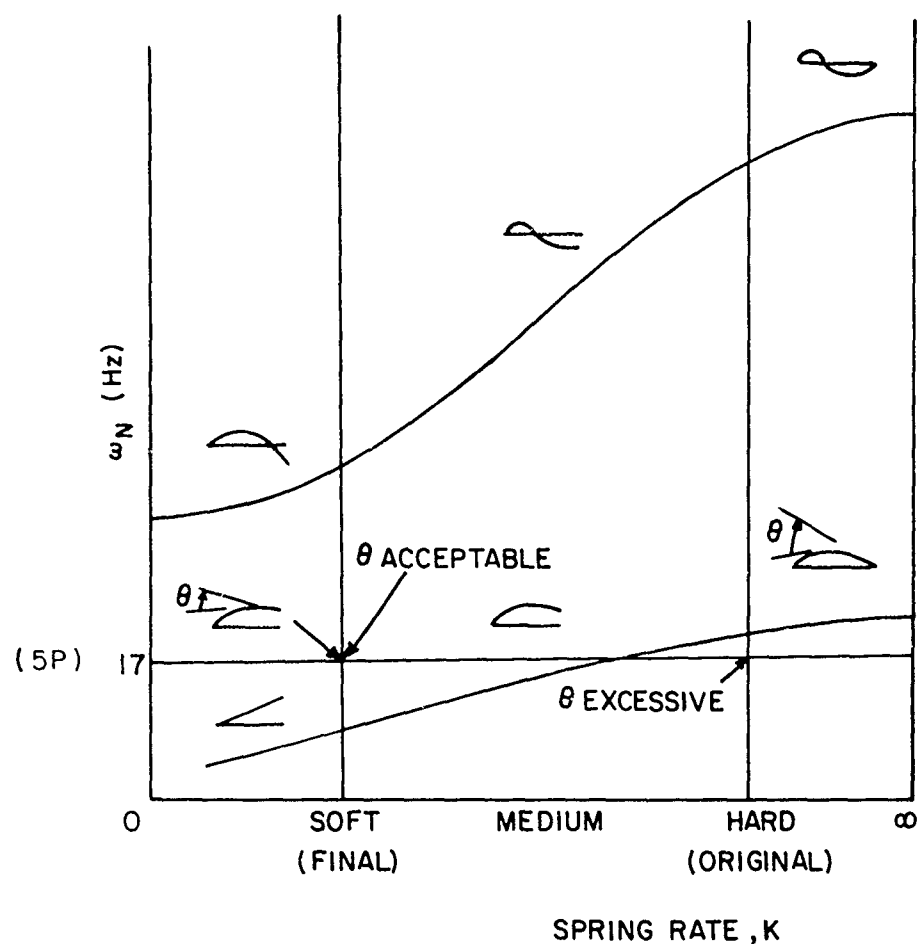
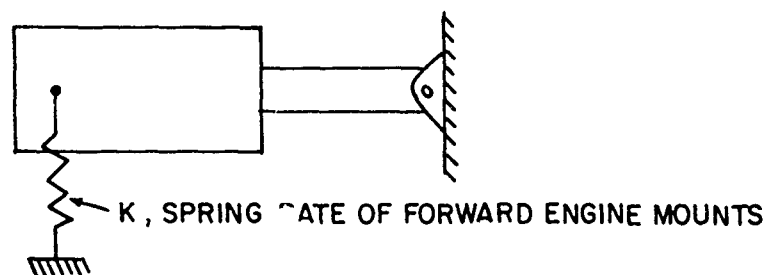
Figure 13. Engine Mode Frequencies vs Spring Rate of Forward Mounts.

The solution was to increase the interface flexibility between the front frame of the engine and the airframe. Figure 12 shows the S-61L engine installation. The "hard" front engine support struts were switched to "soft" elastomeric isolation mounts. This lowered the resonant frequency of the critical first bending mode from 23 Hz to 10 Hz (Figure 13).

The solution also lowered the 2nd engine bending mode frequency so that now it became the primary contributor to the engine response (Figure 13). The result was an engine response still exceeding the original specifications (which were made in terms of local translational accelerations), but which now caused no excess engine bending (i.e., stress) levels, as the original excessive response had done. As a result of this finding, the engine vibratory response specifications were also changed. The maximum allowable translations were raised, but specifications were added limiting the engine flexural bending angle response to typical values known to have been reached on the problem-free SH-3A. Engine bending, not engine translation, was directly related to the critical stress levels in the power turbine bearing housing structure.

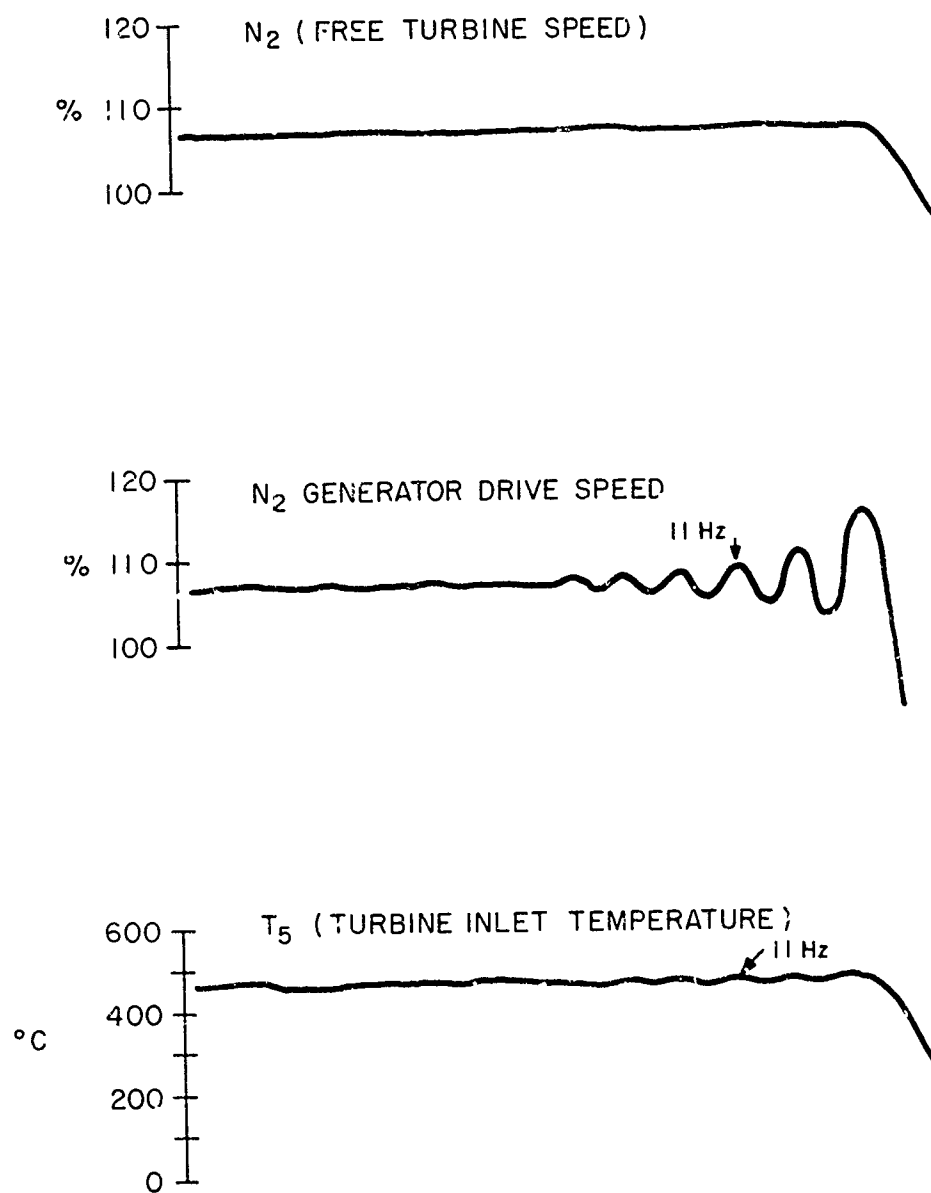
Figure 43. Measurement of  $N_2$  Governor Drive Speed on PSTB.

Special instrumentation was installed to measure speed at the N<sub>2</sub> governor drive. Tests conducted with this special instrumentation installed verified that speed oscillations were occurring at the governor drive input. The frequency of these oscillations was 11 Hz and it was demonstrated repeatedly that each time a speed oscillation peak occurred at or above 115%, the overspeed was actuated and flameout occurred (see Figure 43).

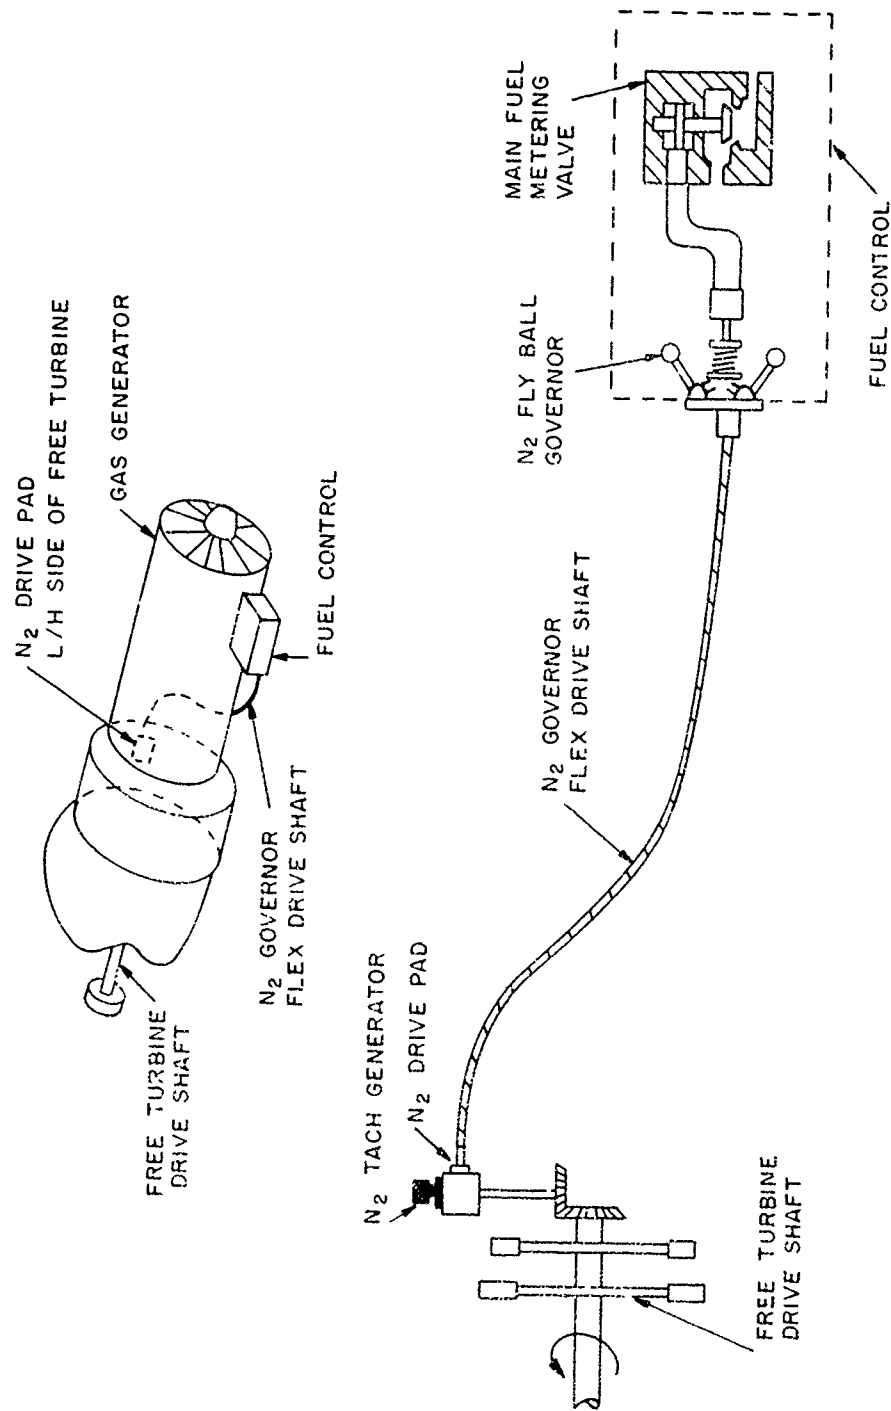
Figure 44. Schematic of N<sub>2</sub> Governor Drive System.

Additional tests were conducted to determine the torsional natural frequency of the N<sub>2</sub> governor flex drive cable (see Figure 44). These tests confirmed a torsional natural frequency of 11 Hz.

1. The N<sub>2</sub> governor flex drive cable installation was redesigned to shorten its length and thereby raise its torsional natural frequency.
2. The N<sub>2</sub> governor servo valve was modified to a "T" slot configuration. This modified valve provided a much reduced gain for small error signal inputs but retained high gain for larger error signal inputs, as shown below:

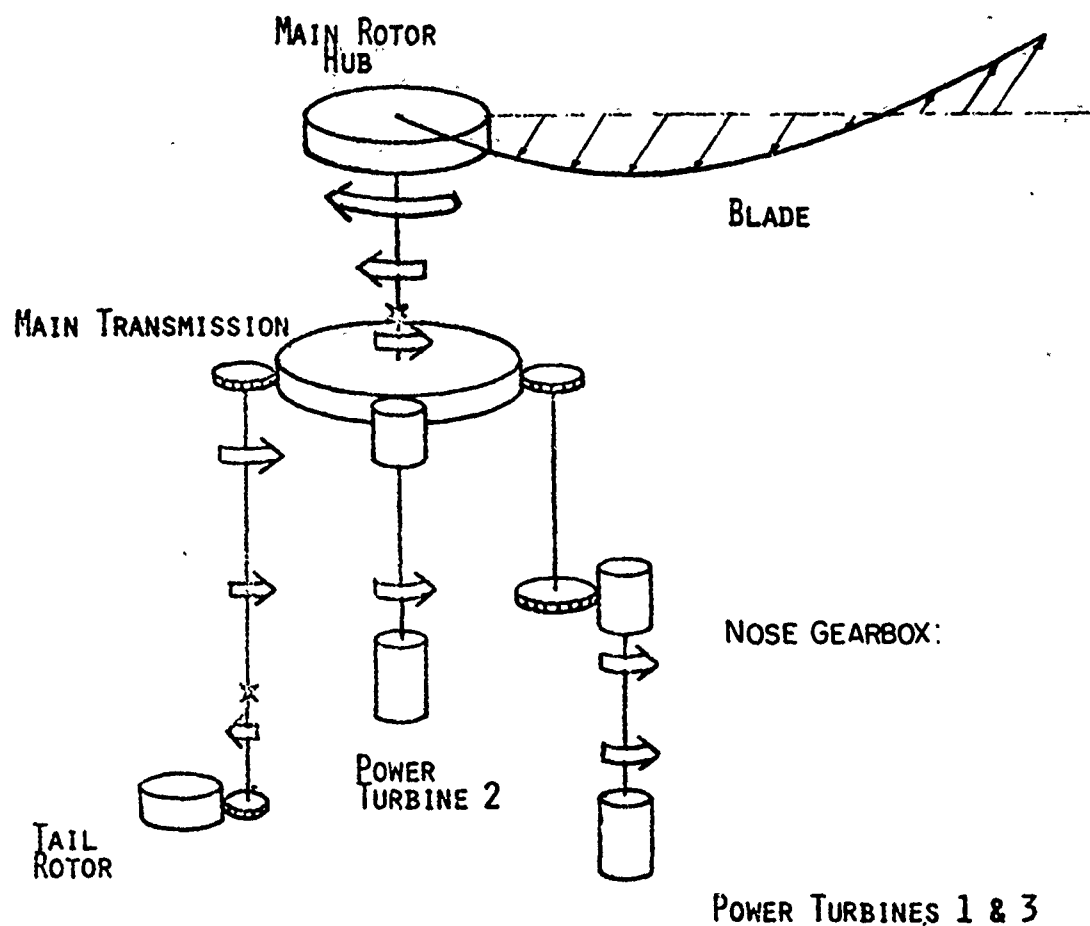
Figure 47. Self-Excited Mode: 3rd Torsional Mode of Rotor/Drive System.

Study of test and analytical data showed that the self-excited mode was a torsional mode comprised of blade edgewise bending, with all seven blades acting collectively, and drive system torsional motion. Node lines were on the blades (at 3/4 radius), in the main rotor shaft, and in the tail rotor shaft (Figure 47). The blade motion combined rigid body lag and first bending mode, summing to give little motion across the lag damper (solid line of Figure 48). A ground test was conducted in which the flight controls were oscillated at varying frequencies and the rotor response was measured. The test confirmed the existence of a mode at 3.6P. Still, sustained oscillations of the type experienced would not have been present if this mode were not being excited by coupling to a source of energy.

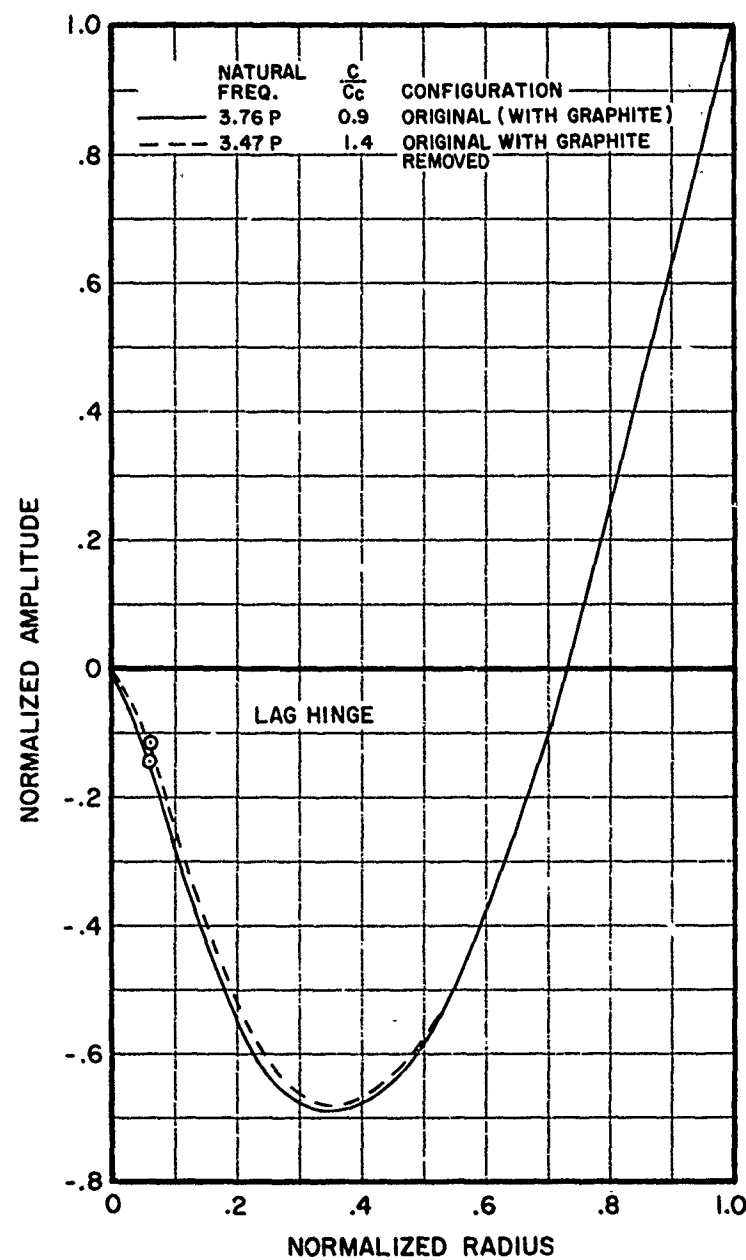
Figure 48. Self-Excited Mode: Detail of Blade Motion.

The 3.6P edgewise mode has very little angular motion across the lag hinge. Therefore, the lag damper is ineffective in providing damping for this mode. The calculated mode shape is shown by the solid line in Figure 48. The hub arm and the root end of the blade move together. The 3.6P mode also has substantial flatwise deflection as shown in Figure 54, which was obtained from the coupled mode analysis. The 2.6P mode, Figure 55, is primarily flatwise. The edgewise motion is relatively small. The curves show modes at a collective pitch of 11 degrees. The modes show less coupling between flatwise and edgewise motion as pitch is decreased.

The oscillation was eliminated by softening the edgewise stiffness of the blades. This decreased the natural frequency of the 3.6P mode and increased the motion across the lag damper in the mode. Figure 48 shows the calculated results. This resulted in a 50% increase in modal damping from the lag damper. The analytical natural frequency went from 3.76P to 3.47P. The test frequency drop, as found from ground tests, was from 3.6P to 3.45P.

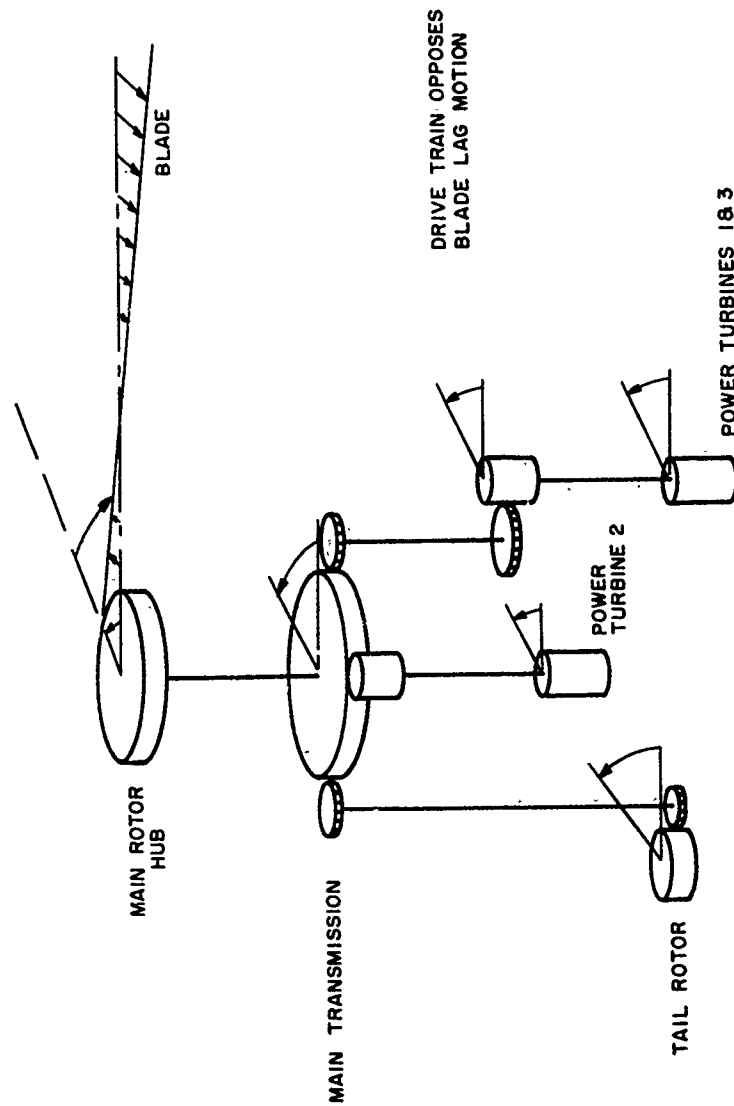
Figure 56. Self-Excited Mode: 1st Torsional Mode of Rotor/Drive System.

Subsequent analysis and testing showed that the oscillation was a closed loop feedback self-excited oscillation of the collective rotor/drive train/engine/fuel control torsional system. The oscillating mode was the first (nonzero) natural mode of the elasto-mechanical system. In this mode the main rotor blades lag together against the drive train and engines, the only node line occurring on the blades outboard of the lead-lag hinges (Figure 56).

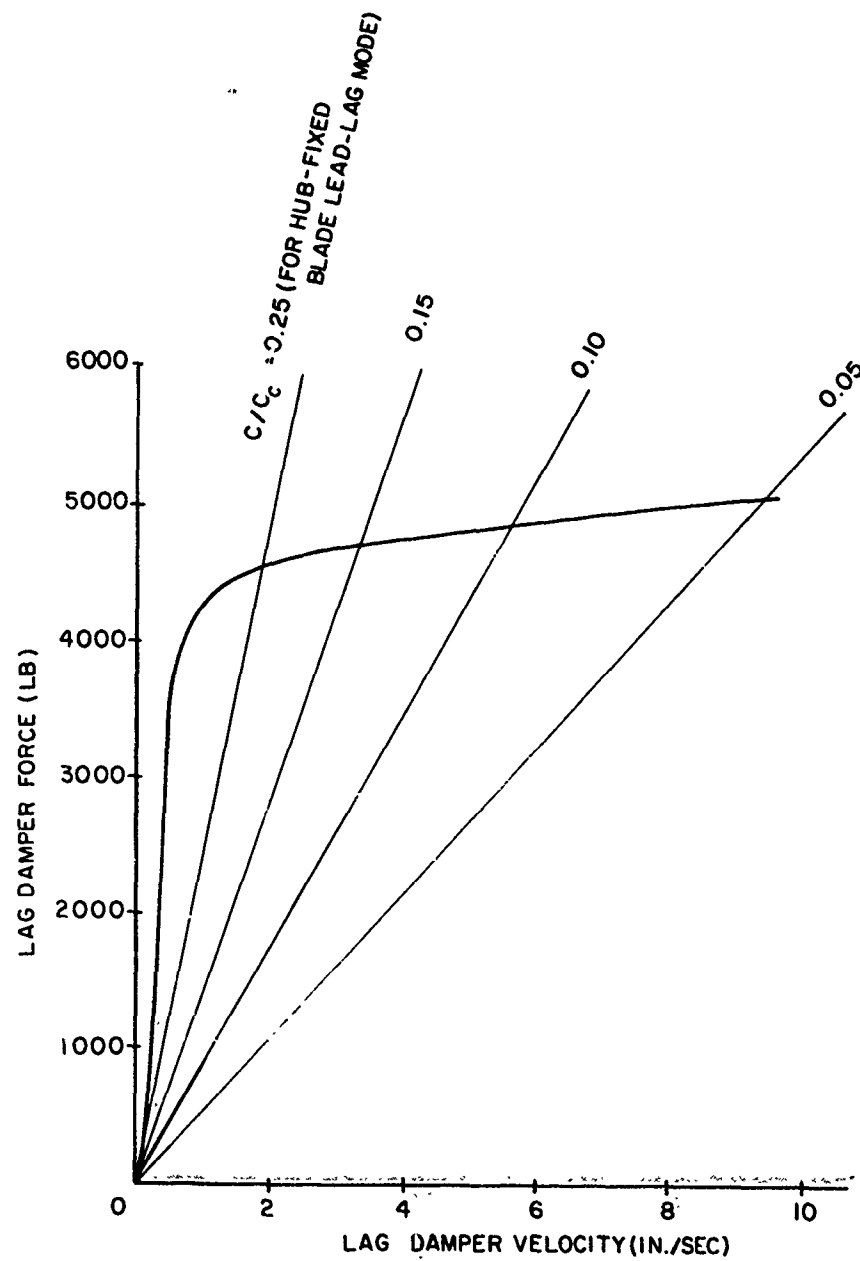
Figure 59. Lag Damper Instantaneous Force-Velocity Relationship.

The instantaneous force-velocity relationship for the damper is given in Figure 59. In this damper an orifice-type damping force, proportional to the velocity squared, is present up to the "breakout point", at which a preloaded relief valve opens (at a velocity of 0.8 in/sec) and the damping derivative suddenly becomes very much smaller. The effectiveness of such a damper is diminished by the presence of steady-state harmonic (n/rev) lag motions, as seen from bench test data plotted in Figure 60. These motions, which become larger with increasing airspeed (Figure 61), cause the damper relief valve to remain open for increasing portions of the cycle. The resulting loss in damping is shown in Figure 62. Eventually a speed is reached at which the damping available is insufficient to dissipate the energy input from the fuel control system and the overall gain margin goes to zero (Figure 63).

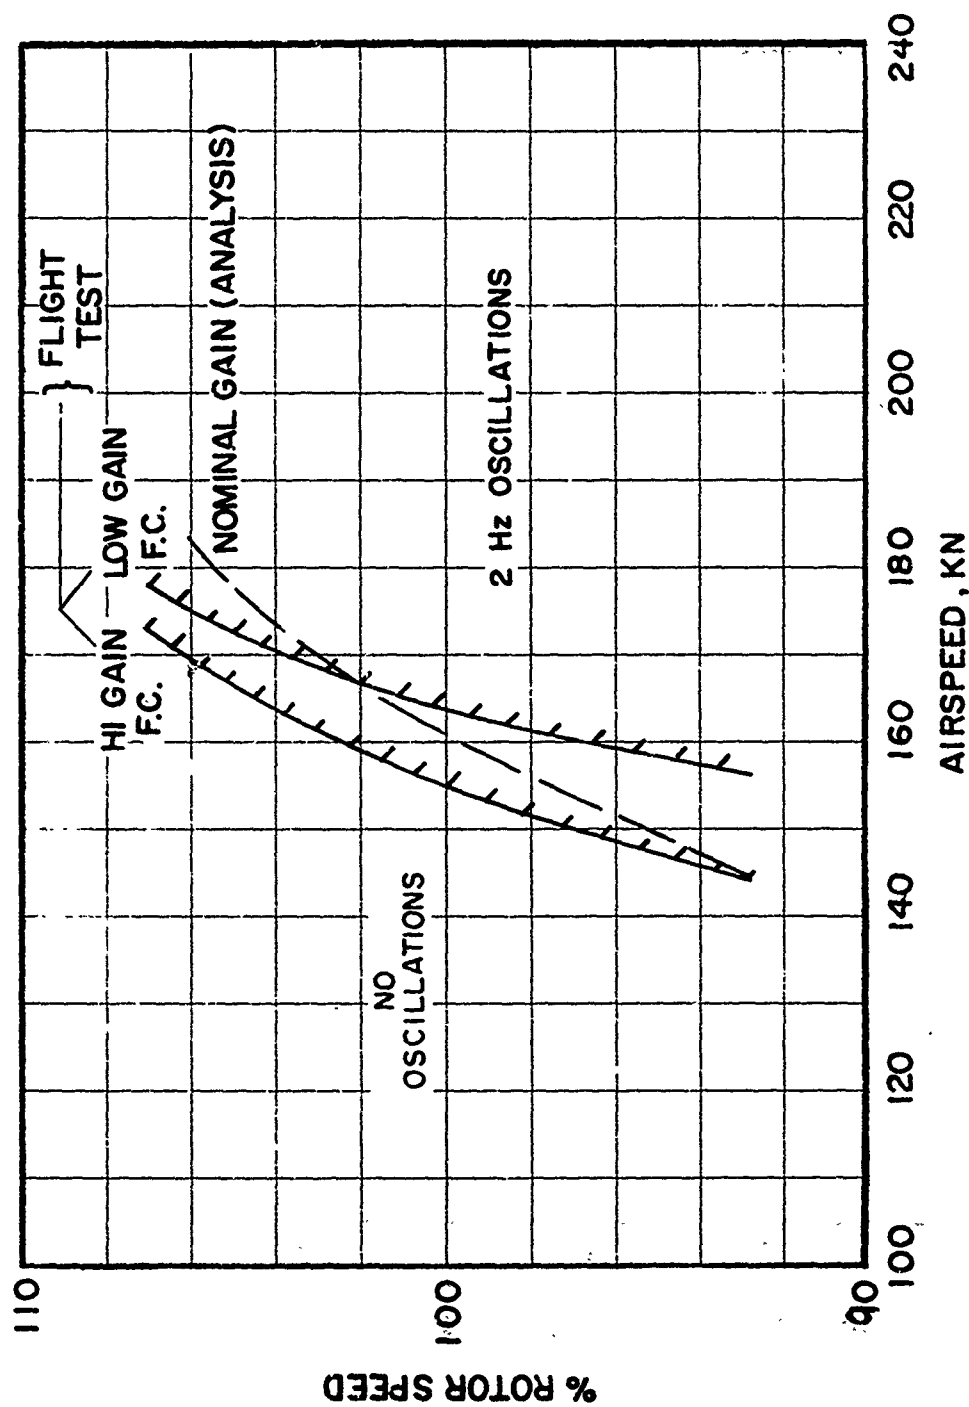
Figure 64. Oscillation Boundaries of Torsional Mode.

Decreasing the gain of the fuel control system was first shown to be effective in increasing stability when flight test results of aircraft having fuel control gains on the high and low sides of manufacturing tolerances were compared (Figure 64). Analysis showed that the fuel control gain was most sensitive to:
