ENGINEERING REPORT LCR-E-1004

(E) **DUD INVESTIGATION OF  
M69 ELECTRIC DETONATOR**

(10) BY: JOSEPH O. JULIANO

US ARMY ARMAMENT RESEARCH AND DEVELOPMENT COMMAND

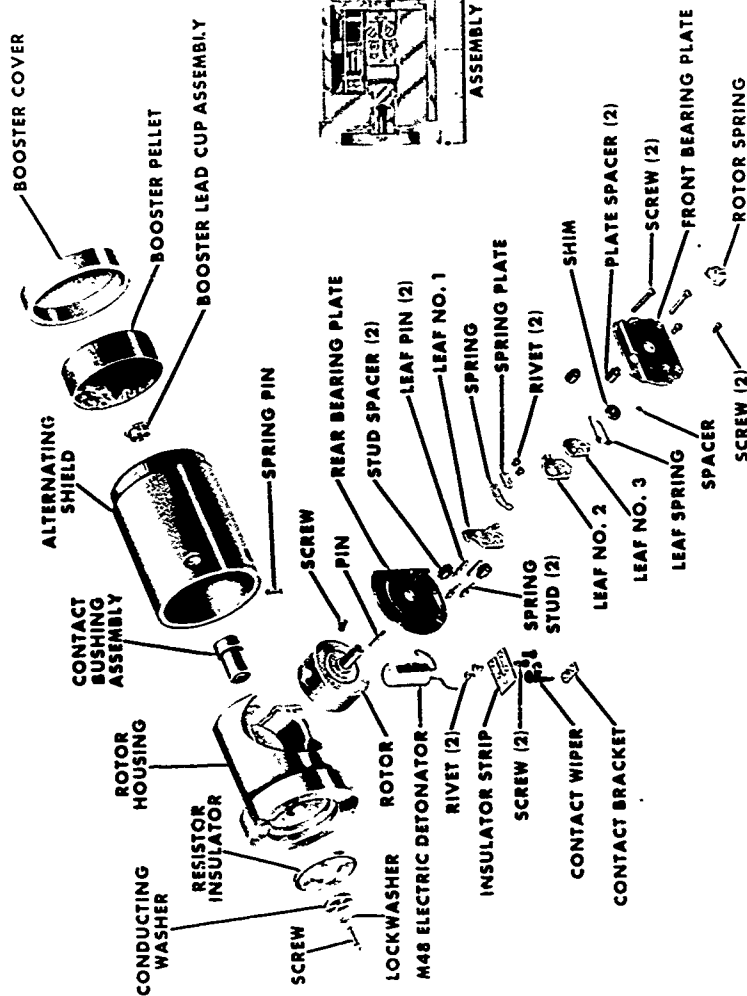
FIGURE 1

The M509A1 PIBD Fuze (Figure 1) is currently used in a number of HEAT Cartridges, specifically the 105MM M456A1; the 106MM M344A1 and the 90MM M431E2. Recently, the M456A1 and M344A1 Cartridges have been the subjects of in-bore premature malfunction investigations. As such, the M509A1 Fuze became an inherent part of those investigations with regard to its relationship as a potential contributor to the malfunctions. The culmination of the fuze investigation was the discovery of a number of M509A1 Fuze Technical Data Package inadequacies affecting both the safety and reliability of the fuzing system.

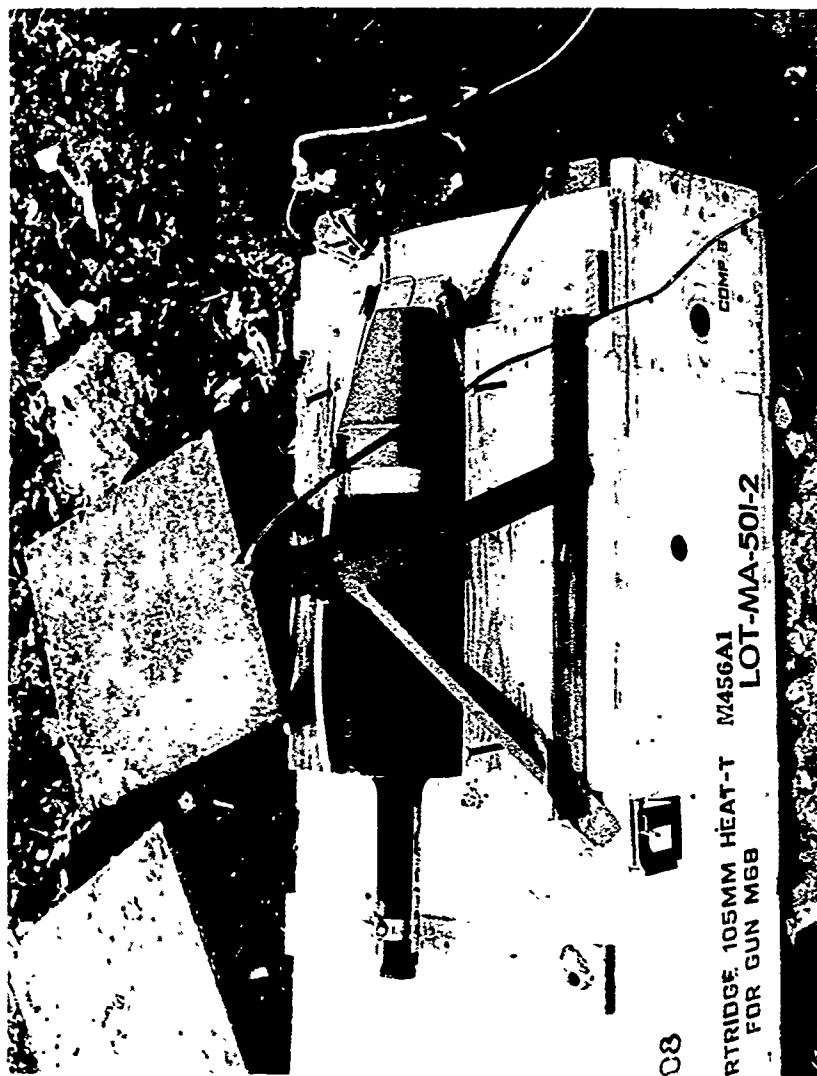
FIGURE 2a

The primary discovery relative to safety, was the absence of adequate out-of-line detonator safety in the M509A1 Fuze. Static detonator safety tests conducted during the investigation, resulted in initiation of the HE filler of an M456A1 Cartridge (Figures 2a and 2b). Additional detonator safety tests conducted on the fuze alone, showed that the M48 Detonator, when in the safe out-of-line position, was able to blast through the steel fuze housing shield with sufficient force to initiate the HE projectile filler directly. Research on the past history of the M509A1 Fuze, revealed that the fuze was considered only marginally detonator safe in the out-of-line position because of bulging and cracking of the fuze housing shield. It was also found that during the ensuing years of production, an
