Report No. CG-D-61-78

COLLISION ACCIDENT  
INVESTIGATIONS FOR 1977  
SEASON

FINAL REPORT

APRIL 1978

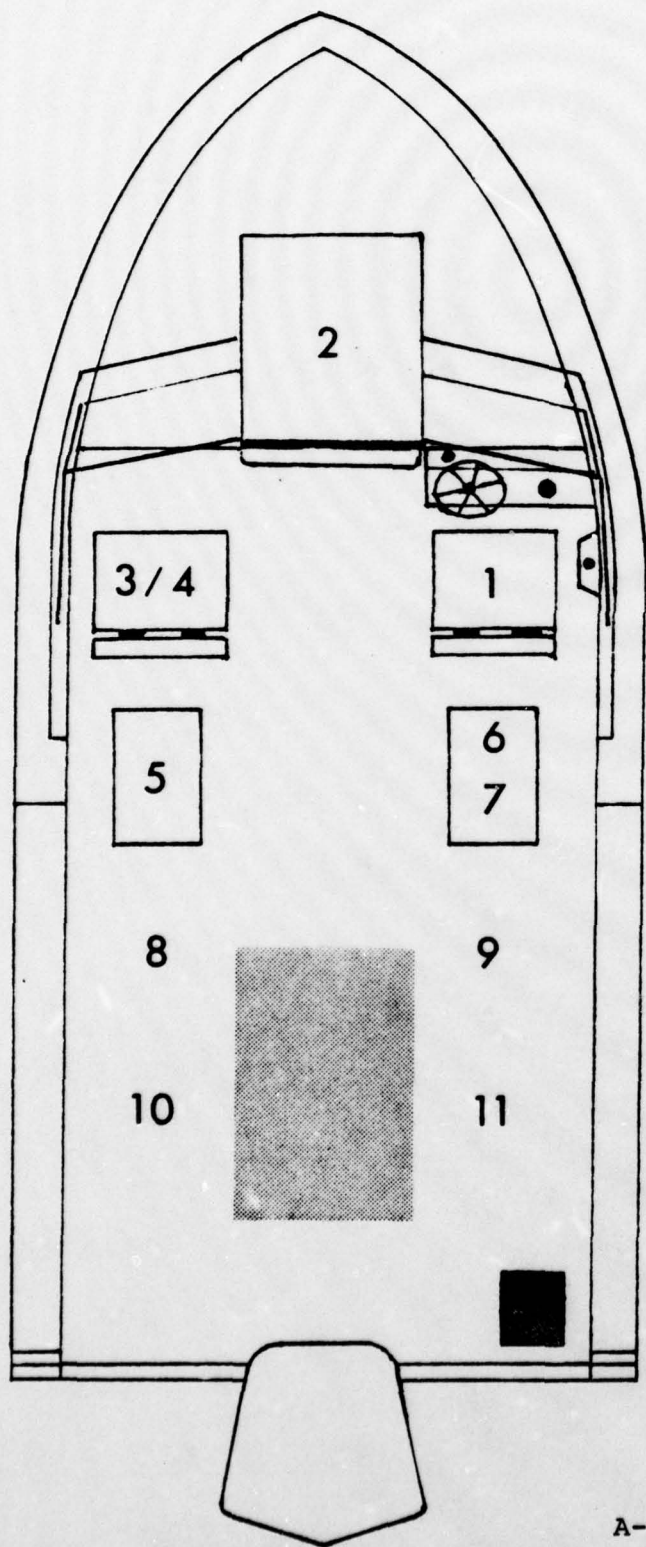
FIGURE 3  
 19' 6" AQUA SPORT - LOAD DIAGRAM (BOAT #1)

- BATTERY (45LBS) (20.3KG)
- ▨ FUEL TANK (120LBS) (54KG)

- 1 - OPERATOR (195 LB.) (87.8KG)
- 2 - ADULT MALE (150 LB.) (67.5KG)
- 3 - ADULT FEMALE (100 LB.) (45KG)
- 4 - CHILD (30 LB.) (23.5KG)
- 5 - ADULT FEMALE (115 LB.) (51.8KG)
- 6 - CHILD (45 LB.) (20.3KG)
- 7 - CHILD (45 LB.) (20.3KG)
- 8 - CHILD (70 LB.) (31.5KG)
- 9 - CHILD (35 LB.) (15.8KG)
- 10 - CHILD (80 LB.) (36KG)
- 11 - CHILD (50 LB.) (22.5KG)

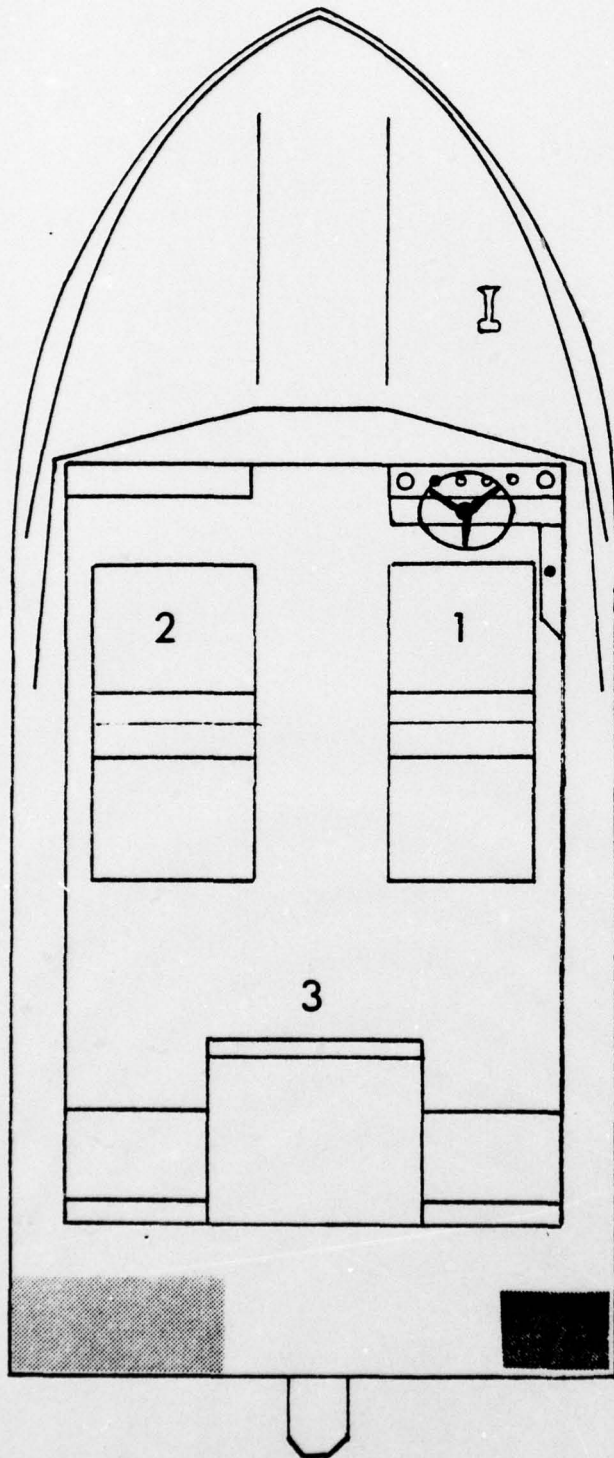
FIGURE 4

19 SEA RAY - LOAD DIAGRAM (BOAT #2)

- - BATTERY (45LBS) (20.3KG)
- ▨ - FUEL TANK (100LBS) (45KG)
- 1 - OPERATOR (145LBS) (65.3KG)
- 2 - ADULT MALE (120LBS) (54KG)
- 3 - ADULT FEMALE (155LBS) (69.8KG)

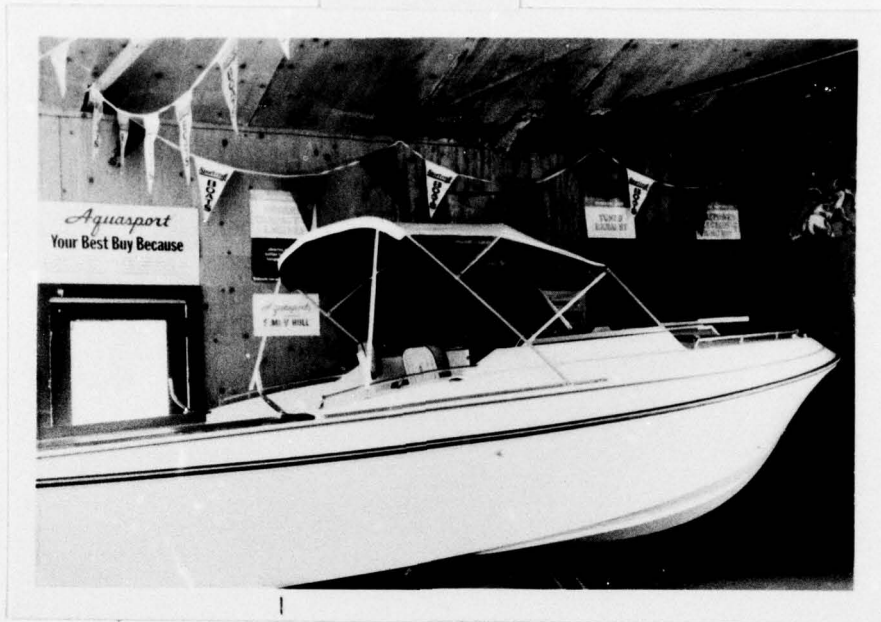
FIGURE 13

NAVY TOP ON 19' 6" AQUA SPORT

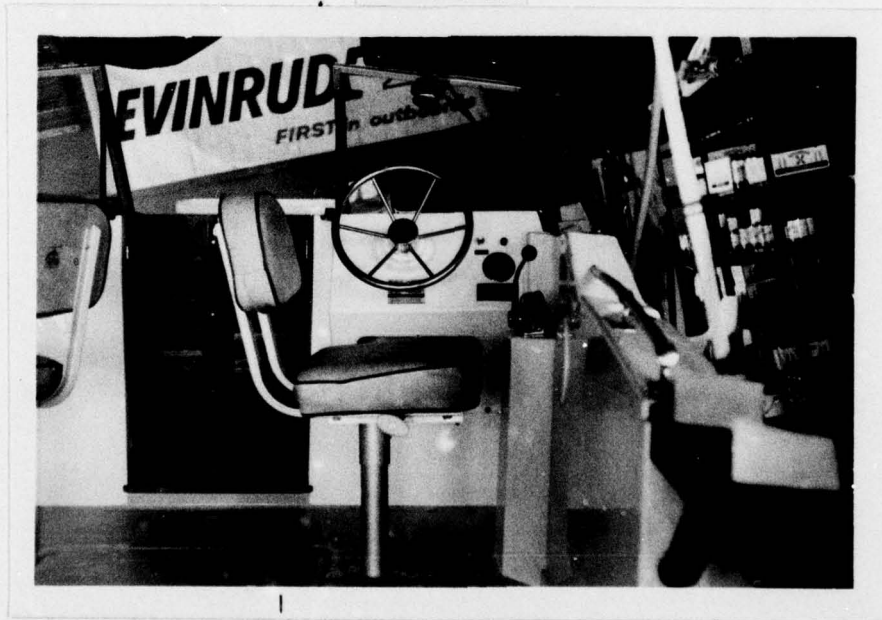
FIGURE 14

HELM, 19' 6" AQUA SPORT
