CEEDO-TR-78-40

Premature Failure of Deep Well Anodes

THOMAS F LEWICKI

JUNE 1978

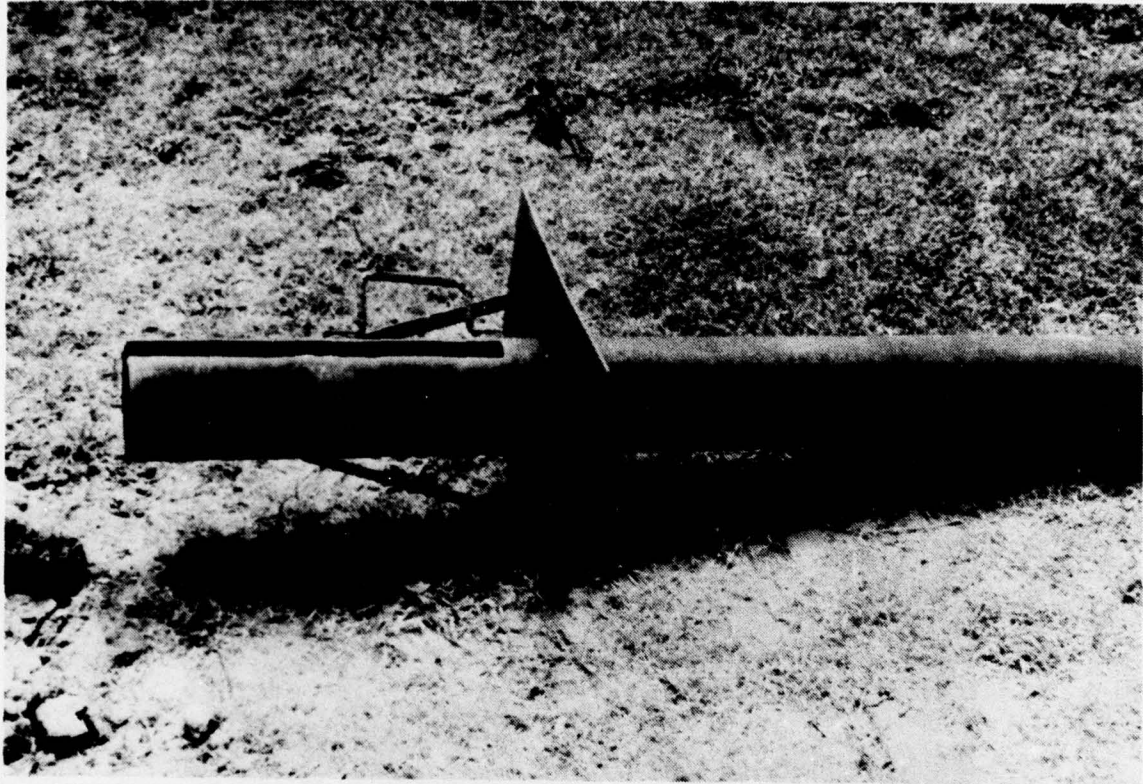
Figure 10. New Well Cap

At Barksdale, a new well was drilled to a depth of 250 feet and the anodes suspended by the Kymar[®] rope from a well cap shown in Figure 10. The ropes were tied to a steel rod welded across the top of the opening. Figure 11 shows the complete installation with the anode lead wires running from the well cap through the 2 inch plastic conduit. The figure also shows the excess Kymar[®] rope sticking out of the top of the well cap. The excess rope was later cut off and the slot in the well cap was sealed with pipeline tape.

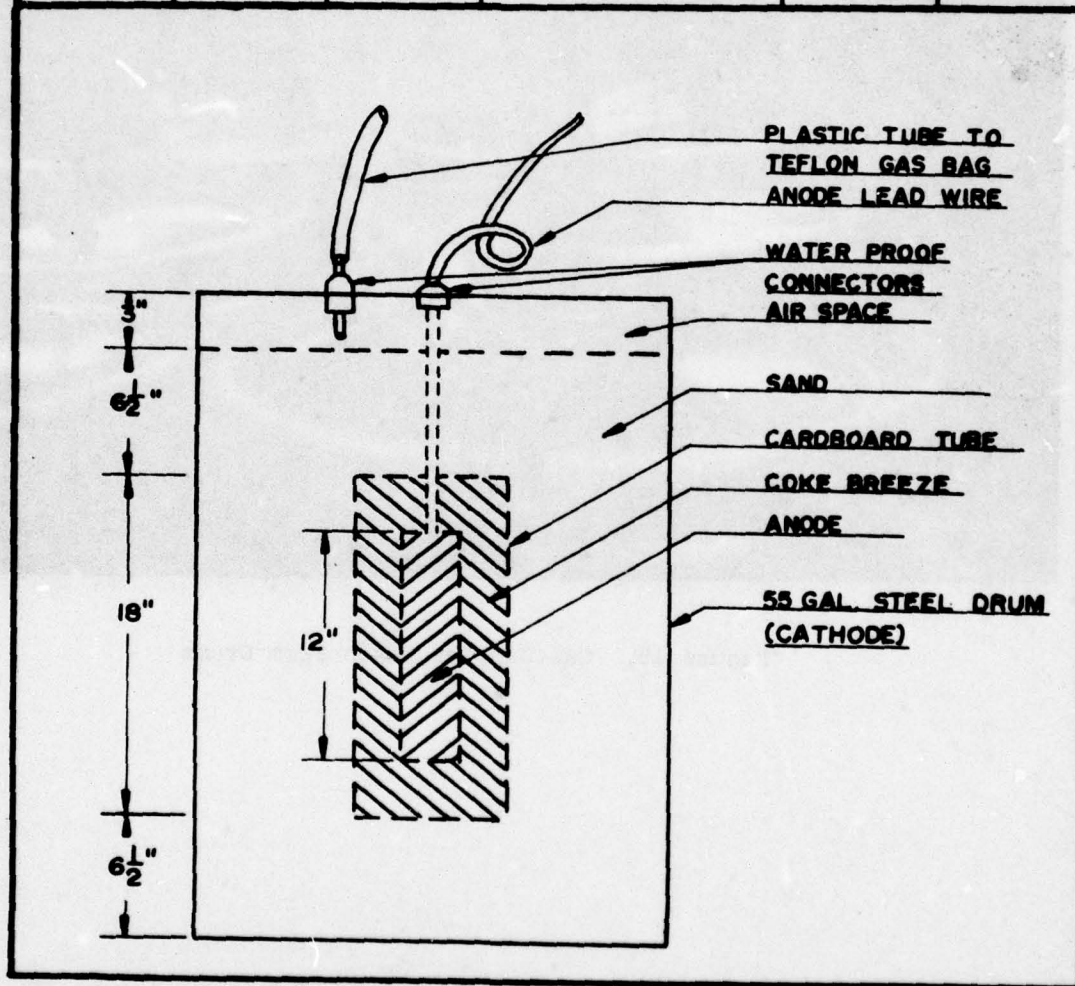
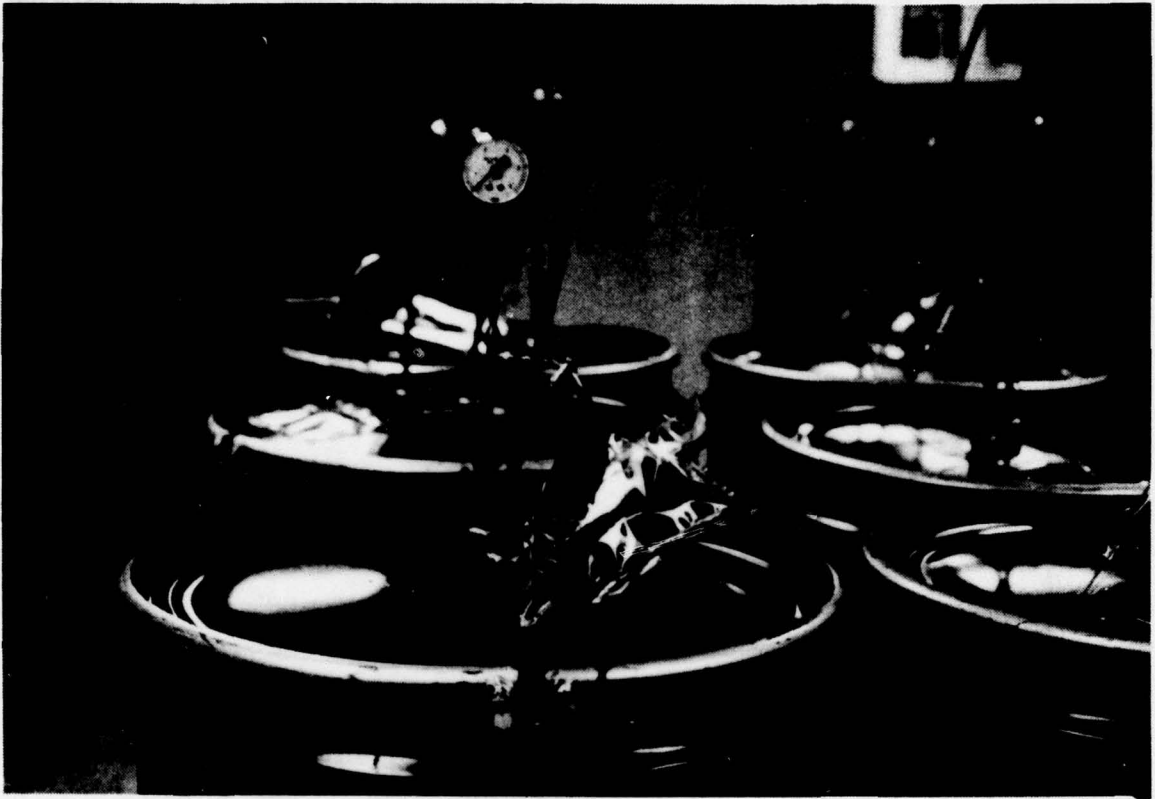
Figure 15. Gas Samples Taken From Drums

Samples of gas generated within the drums were captured in teflon gas bags (Figure 15) and were rushed to the Naval Coastal Systems Laboratory in Panama City, Florida for analysis. Gas samples from the various drums were analyzed in this way on 8 different occasions. A sample analysis is shown in Table 5. The significant findings from these gas analyses were:

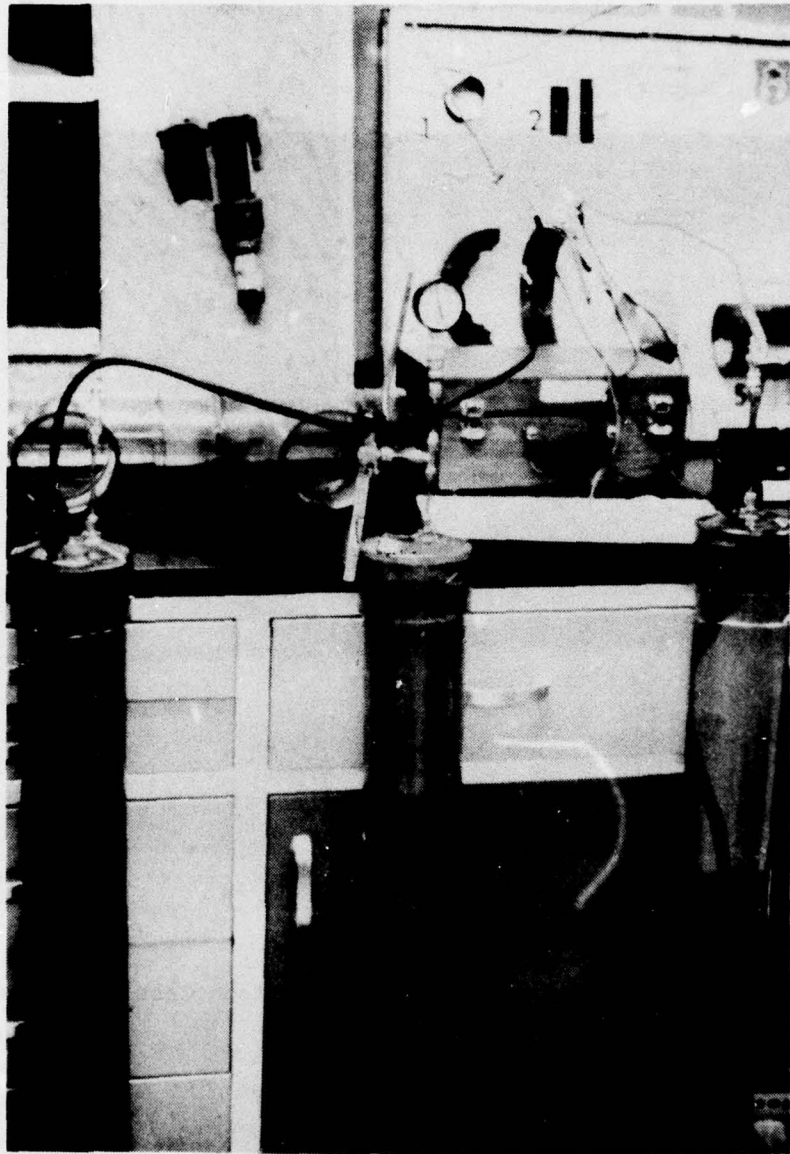
Figure 20. "W" Cell Test Apparatus

It was recognized that the tests using anodes within the drums had two major drawbacks. They could not be operated at deep well pressure (a 200 foot deep anode in a well full of water would be subjected to 86.7 PSI) and cathode gases were in contact with anode gases. To overcome these drawbacks, a "W" cell was constructed from 4 inch diameter polyvinyl chloride pipe. The "W" cell consisted of 3 vertical columns connected at the bottom by two 4" elbows and a tee (See Figure 20). The electrolyte was common to all columns but gases were separated in that they rose to the top and were trapped within their separate compartments. A graphite anode was hung in the left column, a HSCI anode in the right column, and a piece of steel in the center column for the cathode. All lead wires were insulated with high molecular weight polyethylene. In the first test, glass beads were used as backfill around the anodes to aid in the entrapment of gas around the anode and lead wire. The current to each anode was adjusted to one amp per square

foot of anode surface area. The electrolyte added to the cell was a high chloride solution similar to that added to drums 3 and 4. The gases created by the anodes created pressures as high as 90 PSI. Gas samples were captured in teflon bags and were analyzed at the Naval Coastal Systems Laboratory, Panama City FL. The analysis showed that large amounts of nascent oxygen were generated and that larger quantities of CO_2 and CH_4 were generated by the graphite anode indicating deterioration of the graphite (See Table 7). Another finding was that a solution in the bottom of the teflon gas bag that condensed from the gases contained large amounts of chlorides (3,813 PPM). These chlorides must have come from anodegenerated chlorine gas that could not be detected by the gas chromatograph, but was detected by smell.
