National Dam Safety Program. Dalton  
Run Dam (NDS-I.D.-232), Ohio River Basin,  
Dalton Run, Somerset County, Pennsylvania  
Phase I Inspection Report.

PHASE I REPORT  
NATIONAL DAM INSPECTION PROGRAM

NAME OF DAM: Dalton Run Dam  
STATE LOCATED: Pennsylvania  
COUNTY LOCATED: Somerset  
STREAM: Dalton Run, tertiary tributary of Conemaugh River  
DATE OF INSPECTION: April 24 and May 4, 1978

DALTON RUN DAM  
NDS I.D. NO. 232  
APRIL 24, 1978

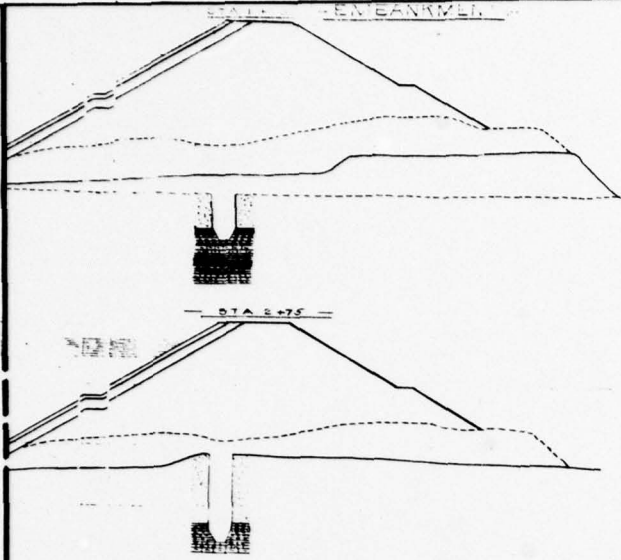
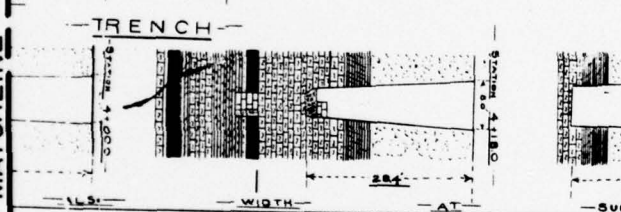
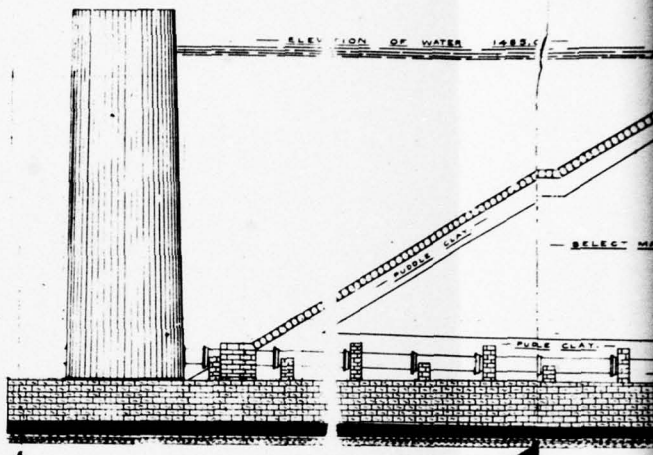
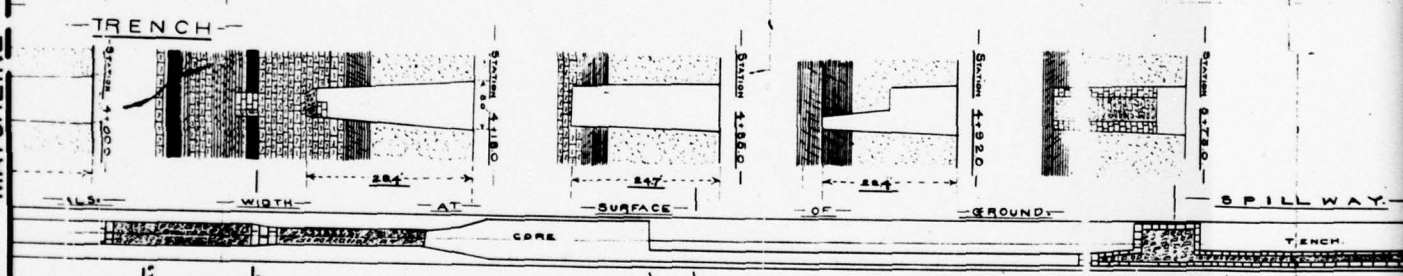
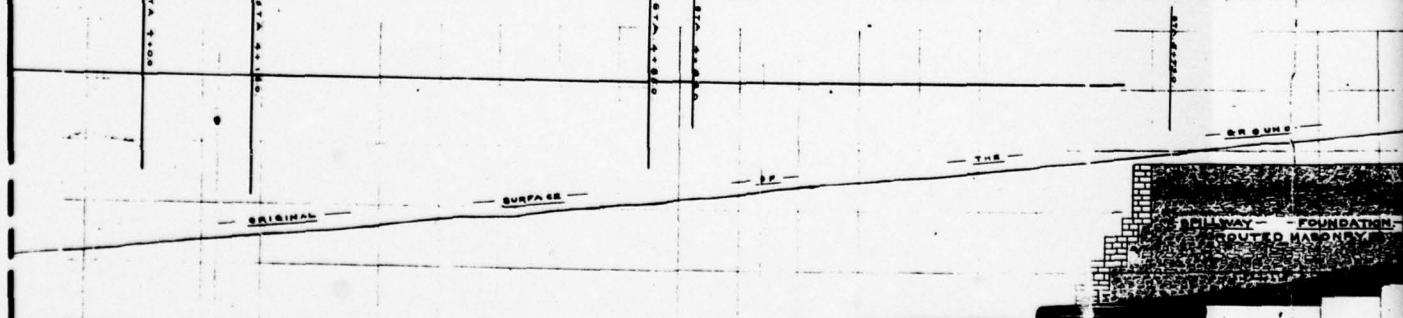
PLATE 3

- (a) As designed, the dam is a zoned embankment with a "puddle" clay core. In the design drawings, four different zones were identified (Plate 3): (1) "select material" in the upstream half of the embankment with three feet of "puddle" clay on the upstream slope and bottom, (2) a "puddle" clay core extending to "impervious" strata, (3) a "select material" zone immediately downstream of the core, and (4) "ordinary material" in the downstream half of the embankment. The design drawings also indicate that a "puddle" clay cutoff was constructed at the upstream toe.

- (c) Plates 3 and 4 illustrate the rock formations at the site. The right abutment is shown to consist of a sandstone layer extending from Elevation 1450 to Elevation

- (d) The 1914 state inspection report notes that the 2-foot coal seam separating the upper and lower sandstone layers was excavated 60 feet back from the outcrop and replaced by clay. On the left abutment as shown in Plate 3, the coal and fire clay were sealed by grouted masonry and a masonry wall.
- (e) As shown in Plate 3, the foundation of the primary spillway consists of grouted masonry contained in masonry walls extending down to a slate layer approximately at Elevation 1460.

Outlet works for the dam consist of two 30-inch-cast-iron pipes supported on masonry walls founded on rock (Plate 3). The inlet and outlet inverts of the blow-off pipe are approximately at Elevations 1432 and 1427, respectively.
