**WATER COMPANY 4,
NDI Pa-507.**

**PHASE I INSPECTION REPORT,
NATIONAL DAM INSPECTION PROGRAM.**

2 June 1978

PHASE I INSPECTION REPORT
NATIONAL DAM INSPECTION PROGRAM
CITIZEN'S WATER COMPANY DAM #4
NDI# PA-507, PENNDER# 63-3

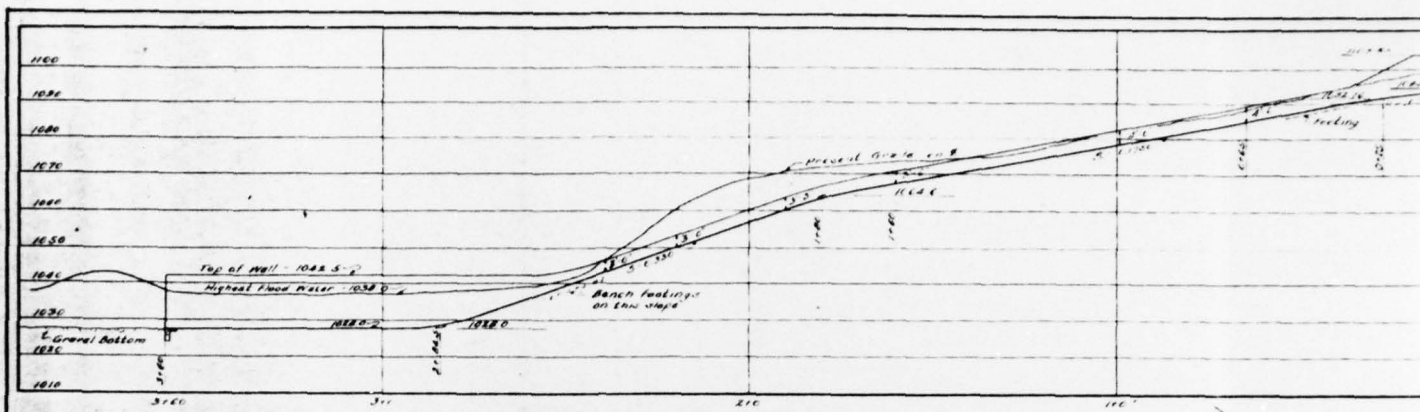
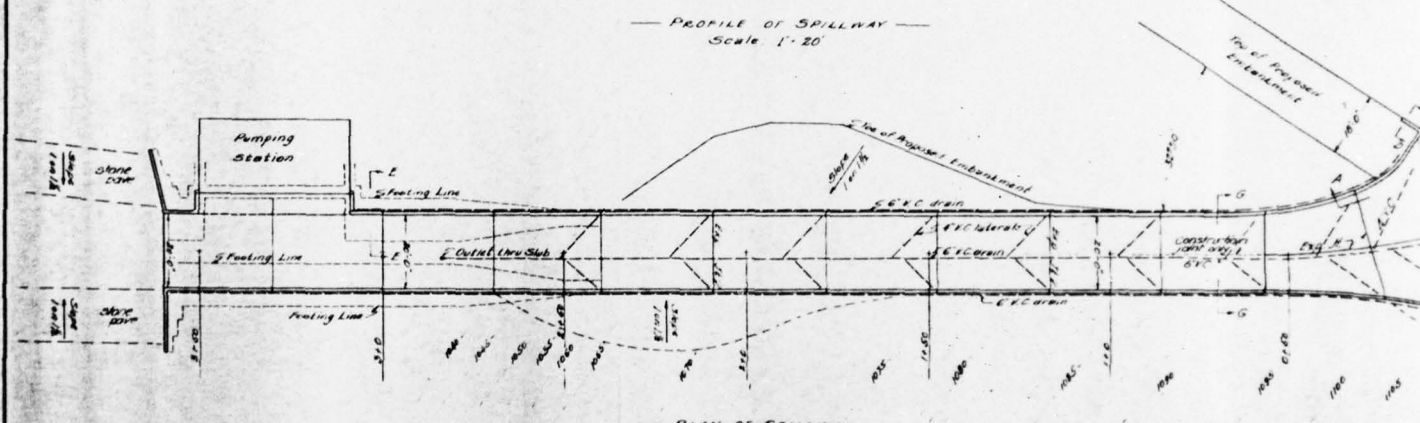
FIGURE 4

a) Spillway. The primary discharge is a reinforced concrete ogee spillway located adjacent to the left abutment (see Figure 4 and Photographs 5 and 6). Drawings indicate the spillway slab is keyed into impervious material at the entrance as shown on Figure 4. French drains extend along the outside base of both wing walls to divert water away from the spillway footings. In addition, there are drains beneath the spillway slabs, the main collector of which emerges through the concrete chute at approximately 50 feet above the stilling basin. The stilling basin is located adjacent the pump house at the base of the left abutment.

1. Spillway. The upper two-thirds of the spillway including the wingwalls and channel floor appeared to be in fair to good condition. Joints and popouts have been sealed with bitumen. The bottom third of the spillway chute above the stilling basin is in poor condition with random spalling and severe scaling evident. Leakage through the left spillway wall appears to be causing some concrete deterioration. The ogee portion of the spillway and plunge pool walls appear to be in good condition (see Photographs 5 and 6).

The lower third of the spillway chute has deteriorated and is in need of remedial maintenance. Seepage through and under the spillway near the embankment bench level should also be investigated and controlled.
