② BEAR GAP NO. 6

## ④ PHASE I INSPECTION REPORT

⑤ NATIONAL DAM INSPECTION PROGRAM

by  
BERGER ASSOCIATES, INC  
CONSULTING ENGINEERS  
HARRISBURG, PA

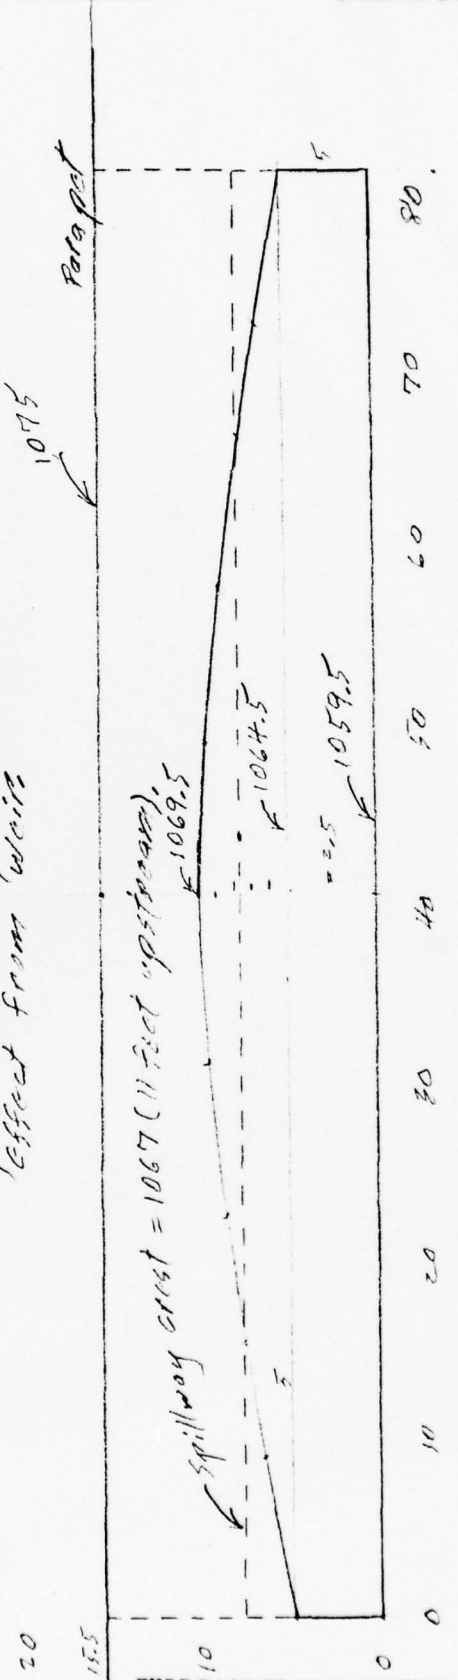
SECTION AT  
 STONE ARCH BRIDGE.  
 Scale 1" = 10'

Consider water level at top of arch (1069.5) and no effect from weir.

Graph at right shows elev. vs discharge rating for bridge opening, assuming no effect from weir. At maximum pool elev. 1075, discharge over weir would be 6120 cfs and head on weir would be 8 feet. (See sheet D). For flow of 6120 cfs back water from bridge would be 1067.5 elev., or 0.5 ft submerged on weir. This would be 6.25% and would have no effect on weir rating. Use weir rating directly. (See sheet H)
