Name Of Dam: RURAL RETREAT DAM

Location: WYTHE COUNTY, VIRGINIA

Inventory Number: VA 19701

PHASE I INSPECTION REPORT

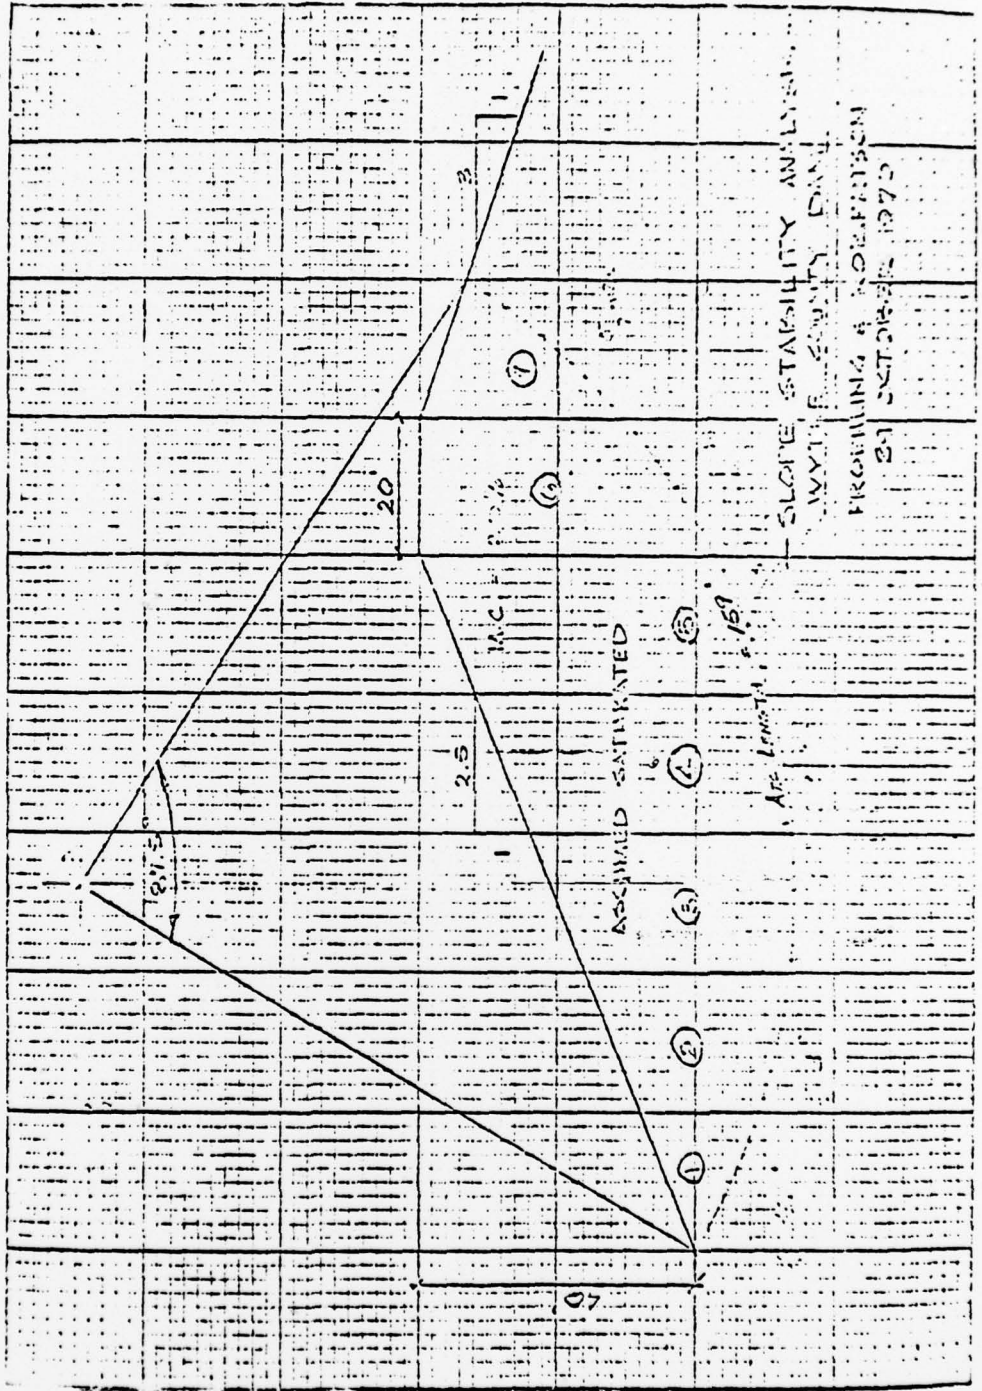
Fig. 10.3.10.30 THE FIGURE 10.3.10.30

A review of this material has revealed numerous errors and deficiencies such that the results of the analysis are not considered valid. A summary of their findings is given in paragraph 6.3 of this report.
