Name Of Dam: WOODSTOCK

Inventory Number: VA 17104

PHASE I INSPECTION REPORT NATIONAL DAM SAFETY PROGRAM

MICHAEL BAKER, JR., INC.

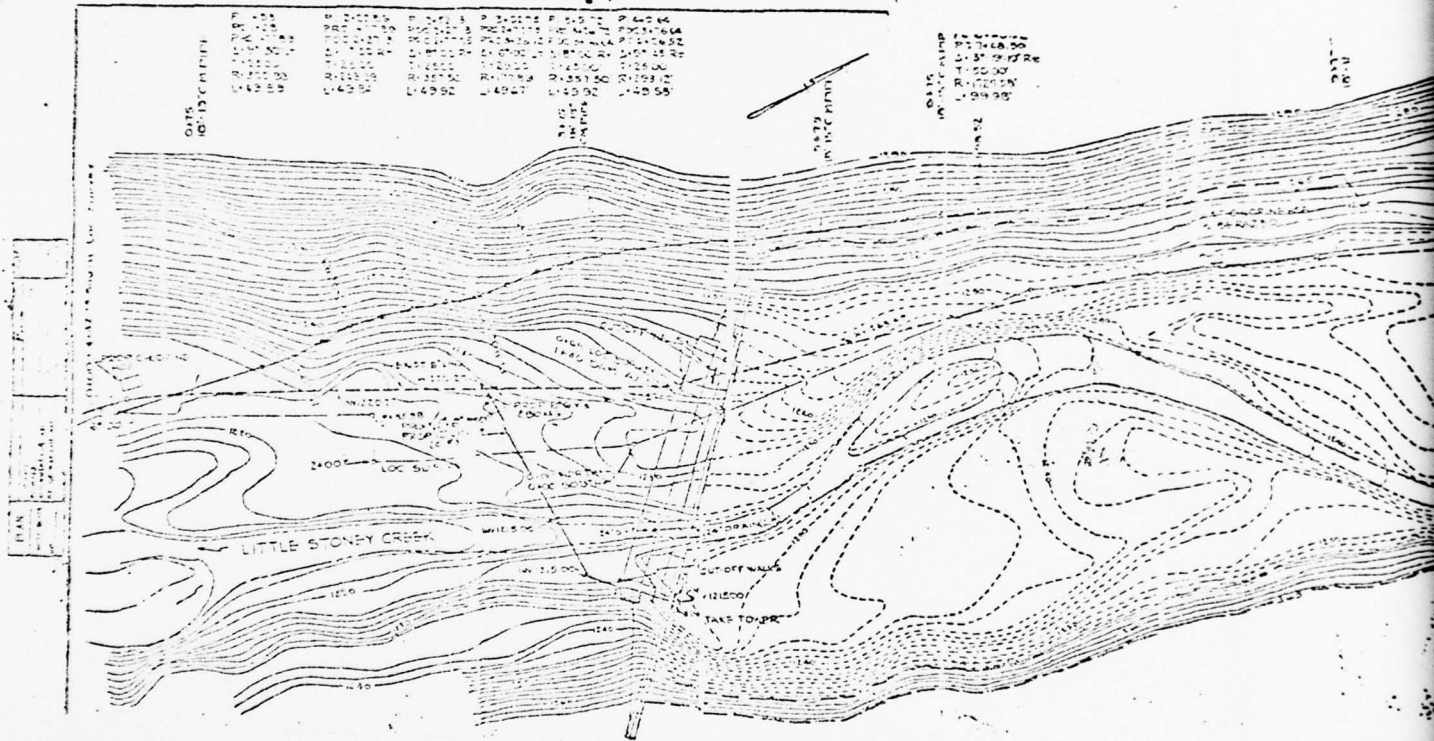
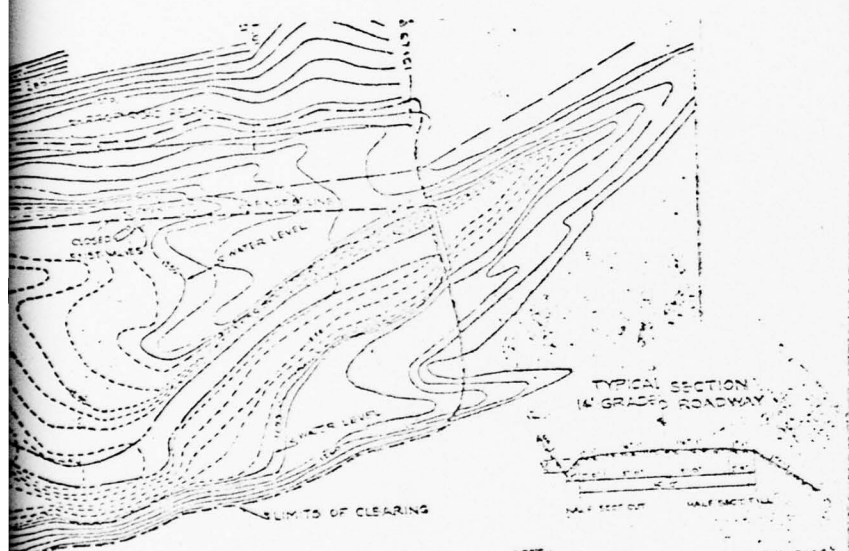
PLATE 1

as the water level drops. A 12 inch cast-iron pipe with an invert elevation of 1215.0 connects with an older eight inch cast-iron pipe which transports the water to the Town of Woodstock which is located over 10 miles east of the reservoir. Plate 1 shows this connection. No formal maintenance program exists for the dam other than the routine maintenance implemented by the town's water department to provide a functioning water supply source.

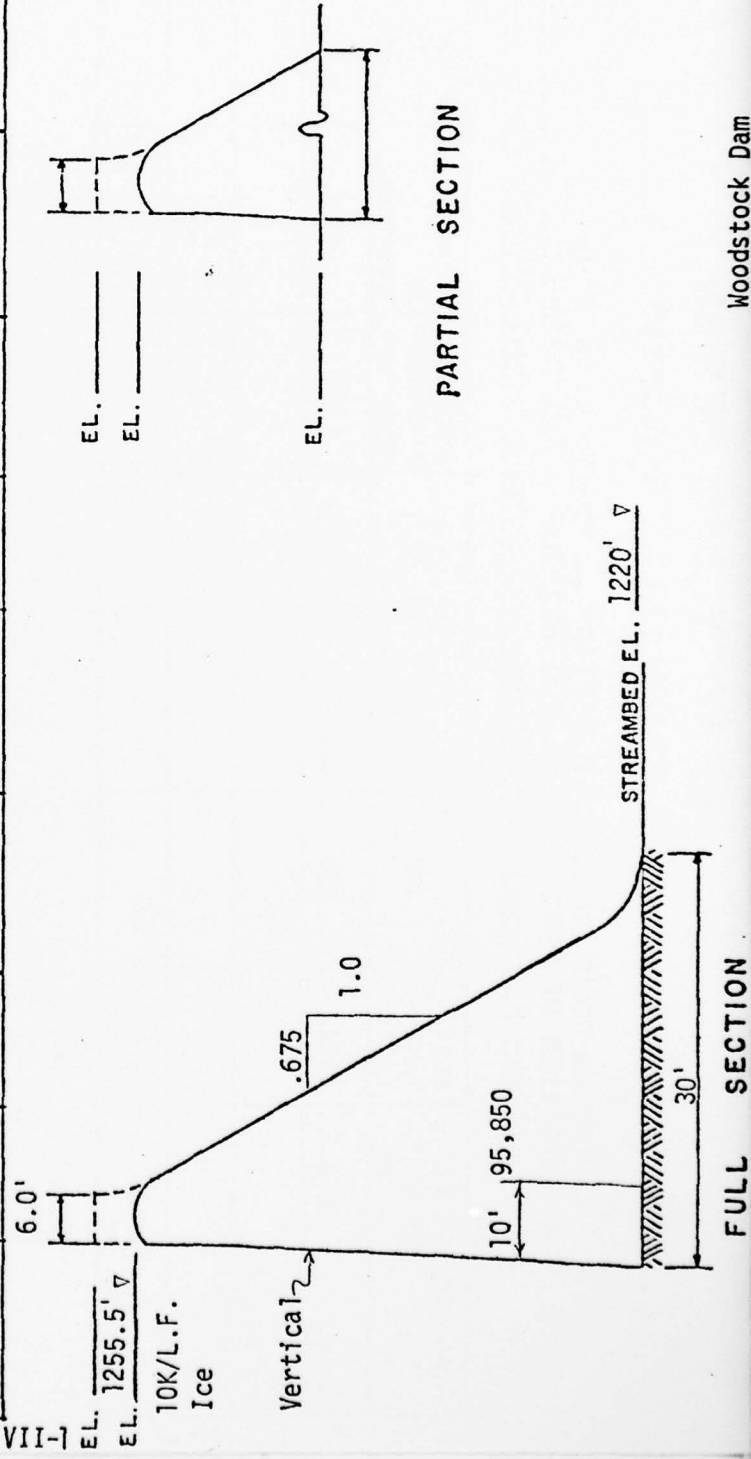
GRAVITY DAM DESIGN STABILITY ANALYSIS

LOADING CASE	ELEV. HEAD WATER	ELEV. TAIL WATER	ΣV	ΣH	$\frac{\Sigma H}{\Sigma V}$	LOCATION RESULTANT FROM TOE	% BASE IN COMPRESSION	FACTOR SAFETY SLIDING	FOUNDATION PRESSURE	
									TOE	HEEL
I	1255.5	1220	74,194	48,281	.65	9.39	94	10.8	5267	0
Ice Load Normal Pool

ANALYSIS DONE ON $\frac{X}{X}$ FULL SECTION PARTIAL SECTION
LOCATION OF SECTION At point of seepage 70' downstream from heel

Seepage control, tailwater during the Probable Maximum Flood, and detailed assessment of stability are items that should be further investigated by the owner. It is recommended that the owner install piezometers in the toe of the spillway to measure uplift pressures in the foundation bedrock.

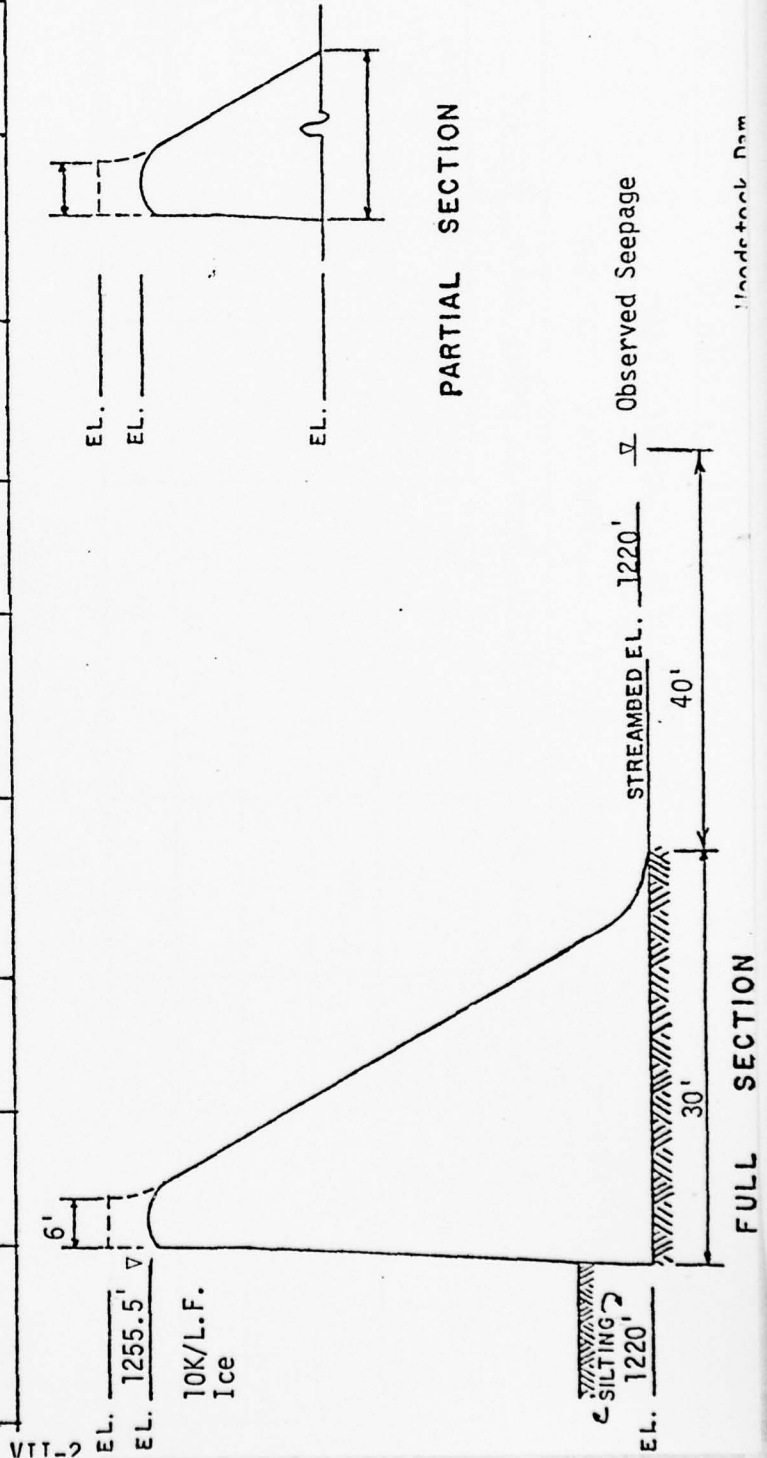
GRAVITY DAM DESIGN STABILITY ANALYSIS

LOADING CASE	ELEV. HEAD WATER	ELEV. TAIL WATER	ΣV	ΣH	$\frac{\Sigma H}{\Sigma V}$	LOCATION RESULTANT FROM TOE	% BASE IN COMPRESSION	FACTOR SAFETY SLIDING	FOUNDATION PRESSURE	
									TOE	HEEL
II Ice Load Normal Pool Added Uplift Pressure	1255.5	1220	61,286	48,281	0.79	9.22	92	10.5	4431	0

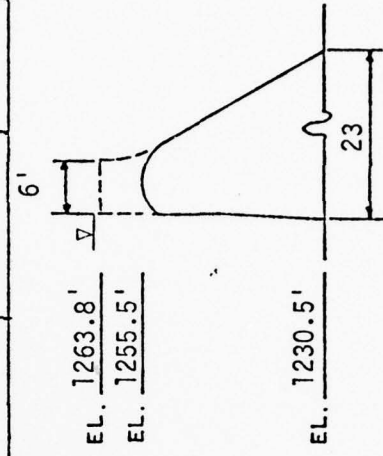
PARTIAL SECTION
CASE IIIA

LOADING CASE	ELEV. HEAD WATER	ELEV. TAIL WATER	ΣV	ΣH	$\frac{\Sigma H}{\Sigma V}$	LOCATION RESULTANT FROM TOE	% BASE IN COMPRESSION	FACTOR SAFETY SLIDING	FOUNDATION PRESSURE	
									TOE	HEEL
III	1263.8	1225	62,606	55,031	0.88	7.95	80	9.1	5250	0
Water at top of non-overflow section										
IIIA Partial Section	1263.5	-	41,290	32,030	0.78	7.1	92	47.8	-	-
