Name Of Dam: TALBOTT DAM

Location: PATRICK COUNTY

Inventory Number: VA 14101

# PHASE I INSPECTION REPORT NATIONAL DAM SAFETY PROGRAM

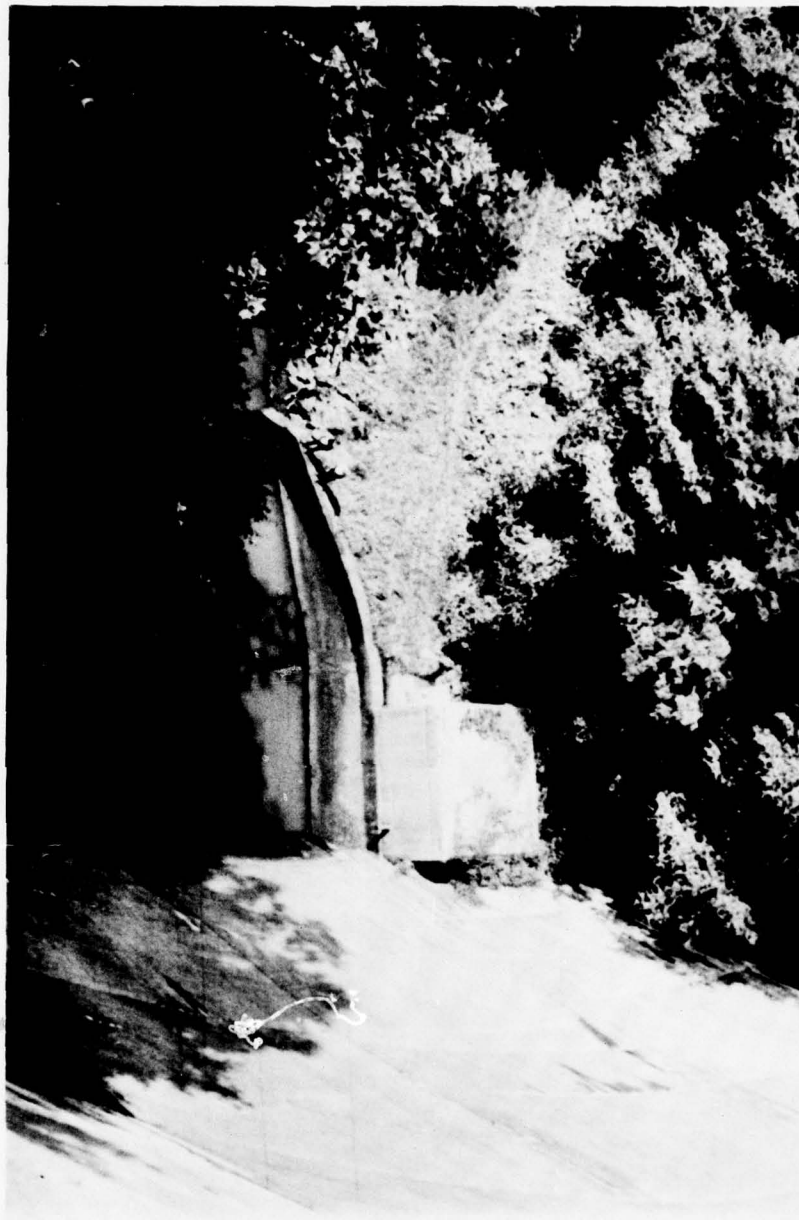
PHOTO 3

TALBOTT DAM-VIEW OF VALUE  
HOUSE AND STILLING BASIN TAKEN FROM  
THE TOP OF THE DAM
