PHASE I INSPECTION REPORT
NATIONAL DAM SAFETY PROGRAM

NAME OF DAM: CRYSTAL

Name of Dam: Crystal
State: Virginia
County: Frederick
Stream: Keckley Run
Date of Inspection: 20 July 1978

Crystal Dam is an earthfill dam approximately 48 feet high and 750 feet long, owned and operated by the Shawnee Land Corporation for recreational use.

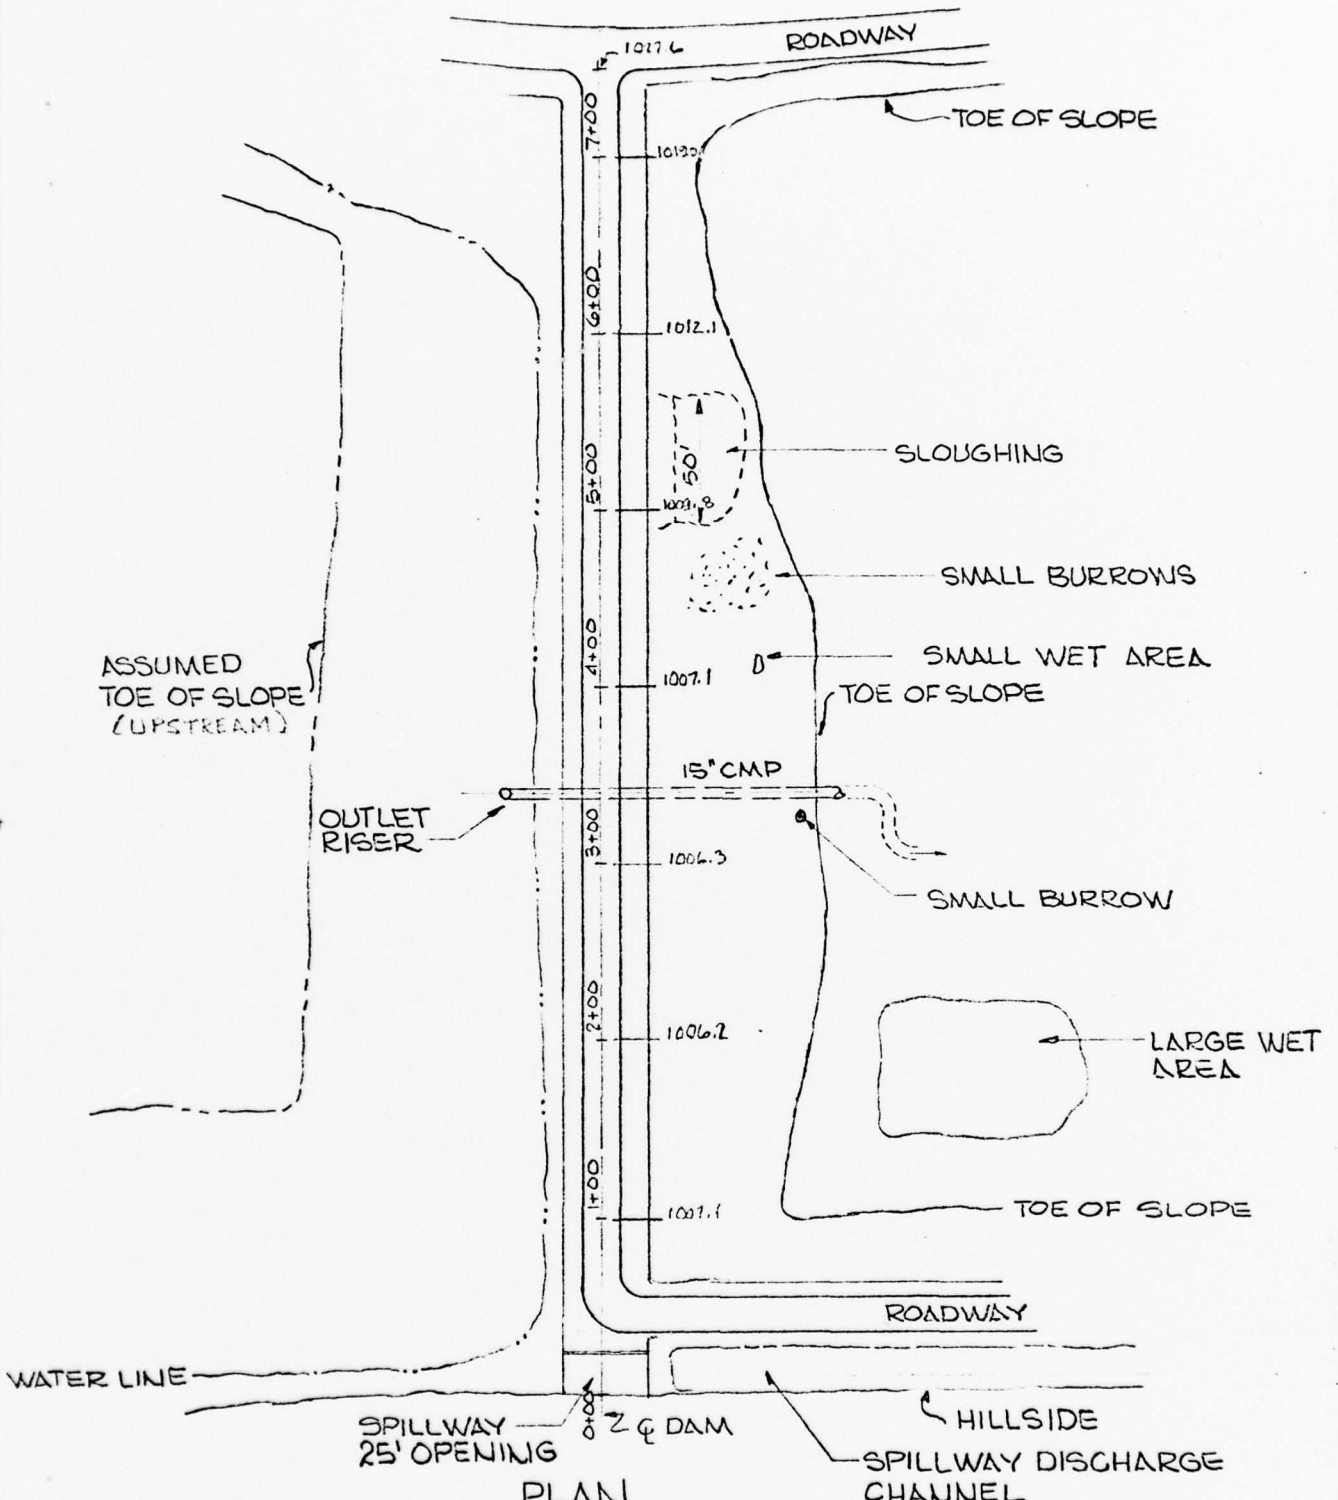
MICHAEL BAKER JR. INC.
 CRYSTAL LAKE DAM
 PLATE I
 8-15-78

NOTE: NO EMERGENCY DRAIN WAS FOUND
 SKETCH MADE FROM FIELD NOTES. NOT TO SCALE

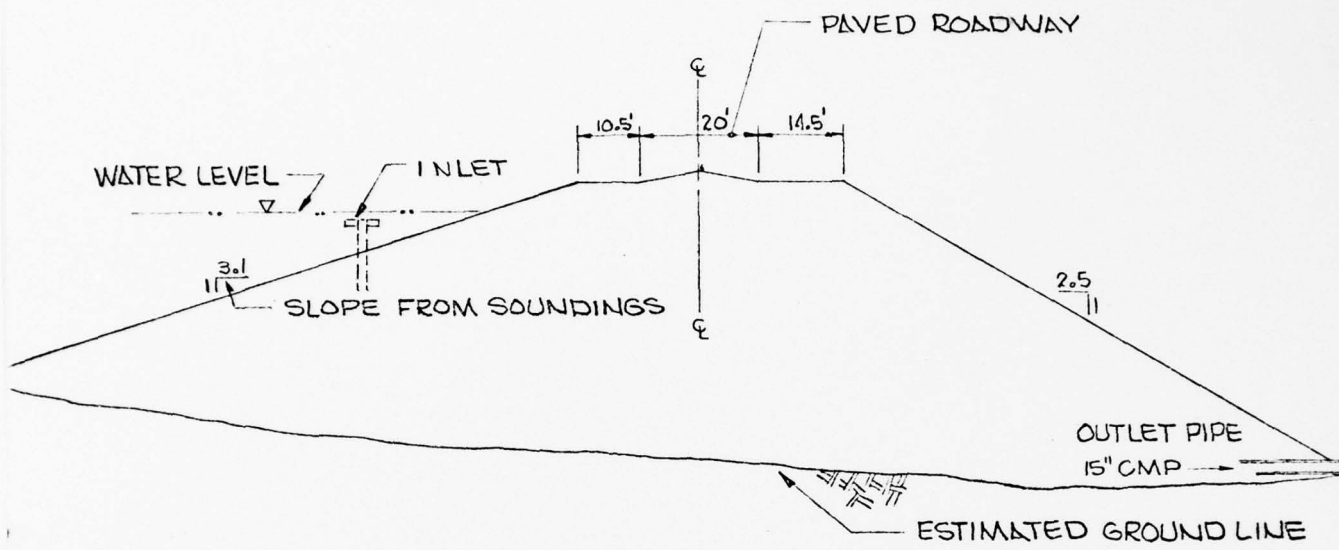
MICHAEL BAKER JR. INC.
CRYSTAL LAKE DAM
PLATE II
8-15-78

TYPICAL SECTION
THRU EMBANKMENT
SKETCH MADE FROM FIELD NOTES,
NOT TO SCALE
