KAUFFMAN DAM  
NDS ID NO. PA-00691  
DER ID NO. 54-54

SCHUYLKILL COUNTY MUNICIPAL AUTHORITY

PHASE I INSPECTION REPORT  
NATIONAL DAM INSPECTION PROGRAM

AUGUST 1978

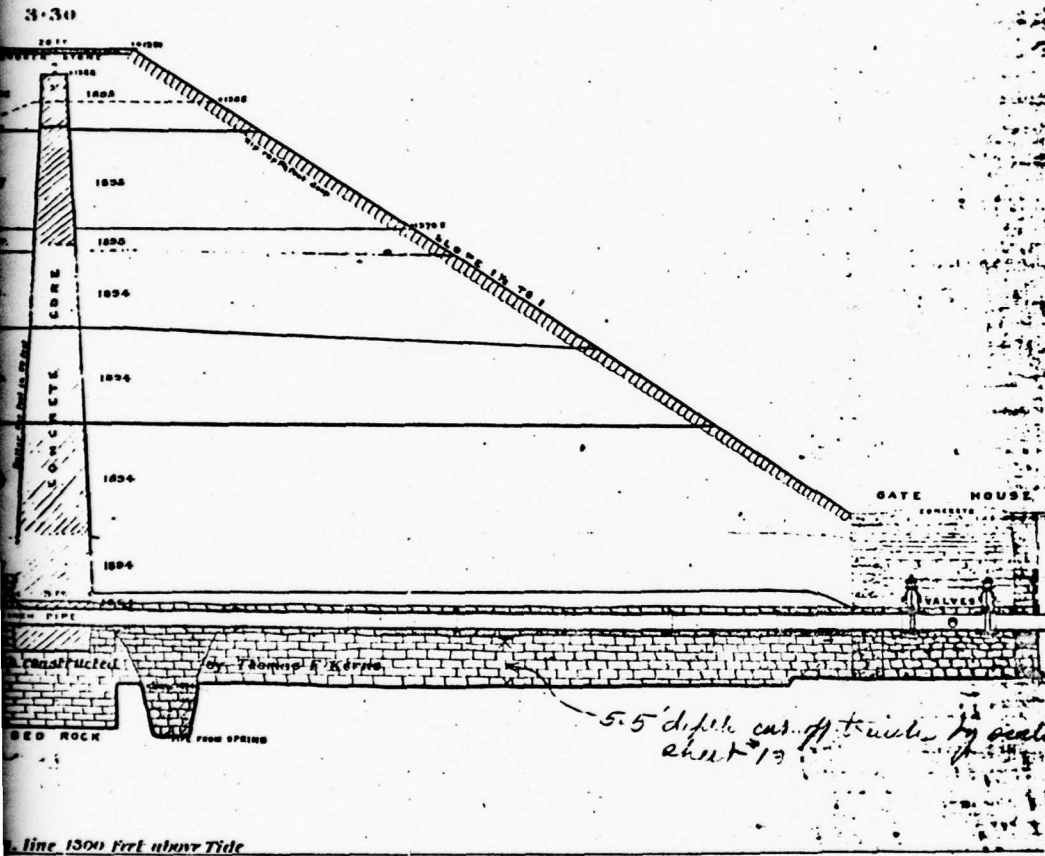
PHASE I INSPECTION REPORT  
NATIONAL DAM INSPECTION PROGRAM  
KAUFFMAN DAM  
SCHUYLKILL COUNTY MUNICIPAL AUTHORITY  
SECTION  
AUGUST 1978 PLATE 3

The masonry valve house is located at the downstream toe of the embankment (Plate 3 and Photographs C and J). Two 24-inch gate valves within the valve house are connected in series on the 24-inch diameter CIP. A 12-inch diameter CIP with 12-inch gate valves is connected to the 24-inch diameter line between the 24-inch valves. The 24-inch line extends from the valve house about 60 feet to a concrete headwall. At the headwall, the invert elevation of the 24-inch line is 1324.0. The headwall is also the point of discharge for a 4-inch diameter drain which extends from just downstream of the core wall. The 12-inch diameter CIP is a water supply line that extends to the Owner's distribution system.
