**LAKE KANAWAUKE DAM**  
ROCKLAND COUNTY, NEW YORK

NY 58  
**PHASE I INSPECTION REPORT**  
**NATIONAL DAM SAFETY PROGRAM**

Prepared by  
JOSEPH S. WARD & ASSOCIATES  
CONSULTING ENGINEERS  
91 ROSELAND AVENUE, P.O. BOX 91  
CALDWELL, NEW JERSEY 07006

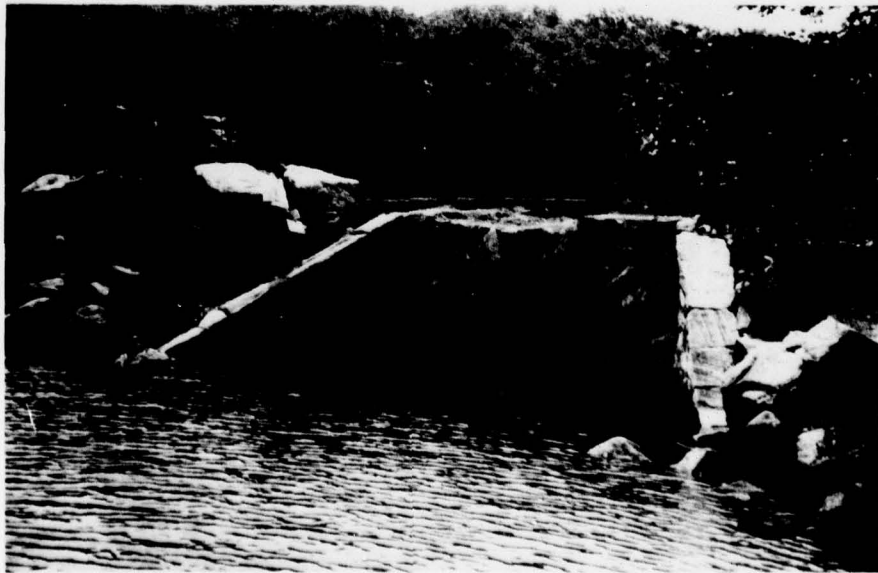
The northern portion of Lake Kanawauke and Little Long Pond are connected to the southern portion of Lake Kanawauke via an ungated semi-circular, stone-faced culvert, approximately 15 feet in diameter (refer to Fig. 2, Appendix D) that runs beneath State Route 210. The invert of the culvert was about 1 foot below the water surface on the day of the inspection. The northern portion of Lake Kanawauke is joined to Little Long Pond via a similar culvert approximately ¼-mile farther west on State Route 210.

FIGURE 2 CONNECTING TUNNEL BETWEEN NORTHERN AND SOUTHERN PORTIONS OF LAKE KANAWAUKE

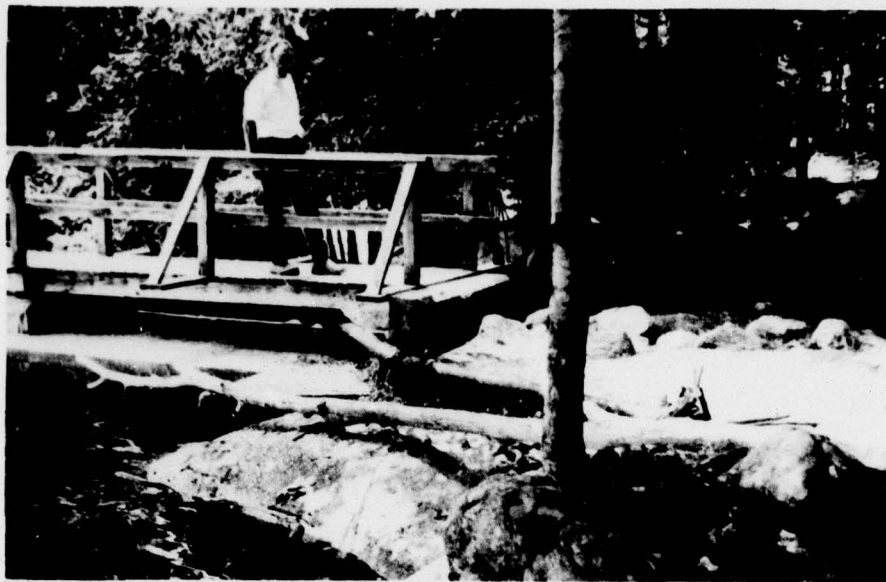
1) The abutments of the dam are part of the end concrete monoliths. The right abutment rests on a rock outcrop (Fig. 5, Appendix D) but it was not possible to determine if the abutment is anchored to the rock. There are no rock outcrops at the left abutment (Fig. 6, Appendix D). However, the existence of such outcrops nearby suggests that rock may be within several feet of the surface, and the design drawings indicate that the left abutment also rests on rock.

iii. would probably not be able to pass the SDF (in this case the PMF) without obstruction by the wooden walkway and breaching around the abutments. Water surface elevation is approximately 830.45 at the SDF, and although the top of the abutments is at elevation 830.75, the shoreline adjacent to the abutments is lower (see Fig. 5, Appendix D).

FIGURE 5 RIGHT ABUTMENT (UPSTREAM)

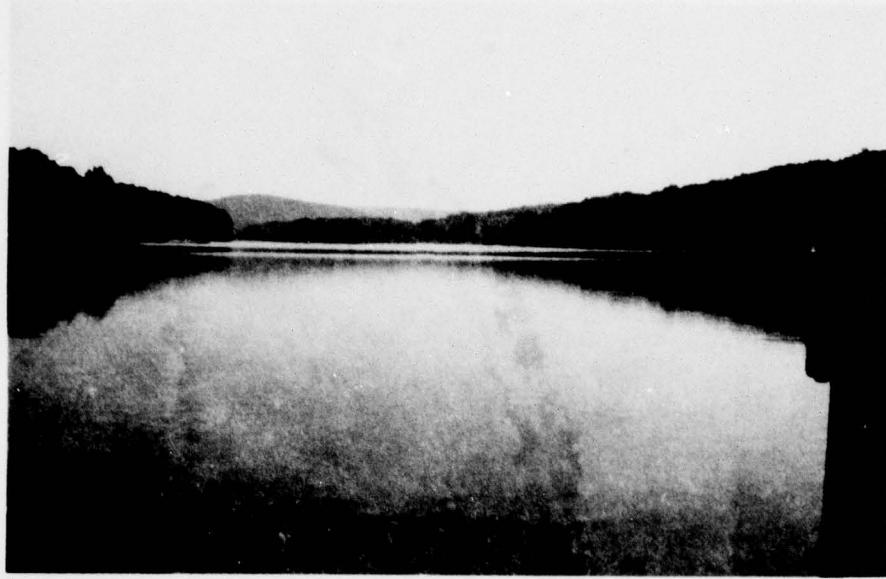
FIGURE 9 OVERVIEW OF RESERVOIR SHOWING SIDE SLOPES

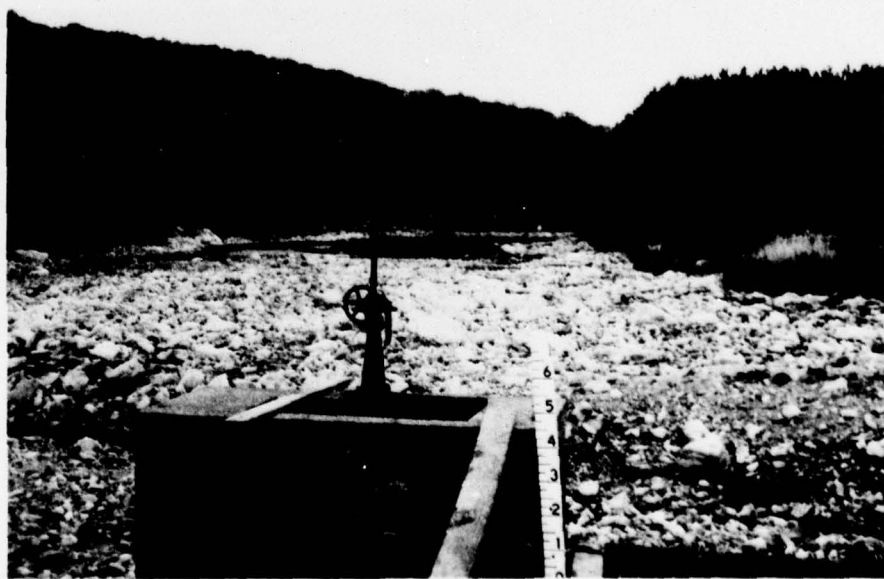
The downstream channel is about 30 to 40 feet wide with side slopes approximately the same as along the reservoir (Fig. 10, Appendix D). Numerous large boulders were observed in the channel out to about 30 feet from the toe of the dam. There is also a considerable amount of debris at the toe (Fig. 11, Appendix D). These serve as an apron and energy dissipator. A few large trees are in the channel and on the slopes farther downstream. The channel slopes appear generally stable, although some minor local slide scars were noted in the vicinity in air photos. About 500 feet downstream there is a large, boulder-covered detention basin (Fig. 12, Appendix D). This basin is used to store water and act as a flood control pond for Sebago Beach (Fig. 13, Appendix D) that lies downstream immediately beyond a two-lane paved road.

FIGURE 12 DETENTION BASIN AND CONTROLS DOWNSTREAM FROM LAKE KANAWAUKE DAM
