LITTLE PINE CREEK DAM

INVENTORY NUMBER NDS PA-351

PHASE I INSPECTION REPORT

by
BERGER ASSOCIATES, INC.
CONSULTING ENGINEERS
HARRISBURG, PA.

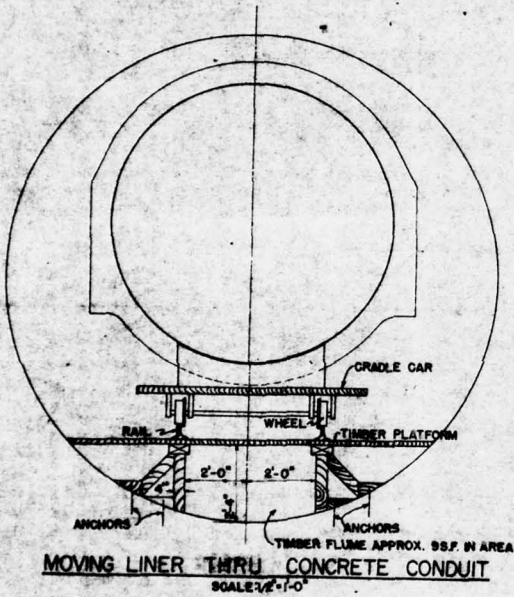
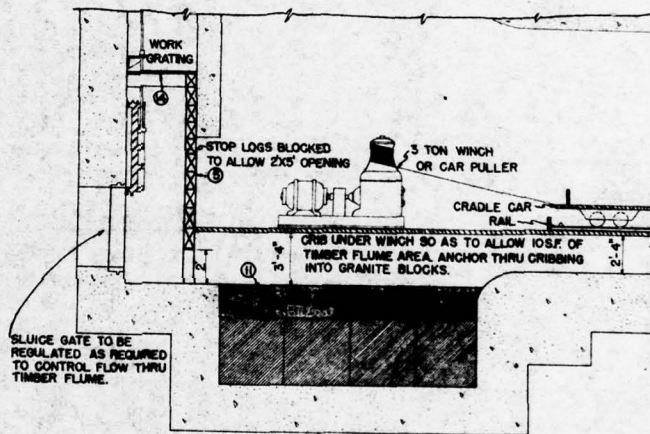
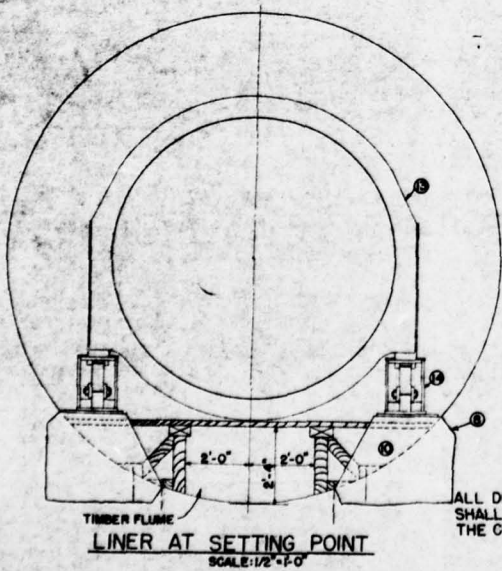
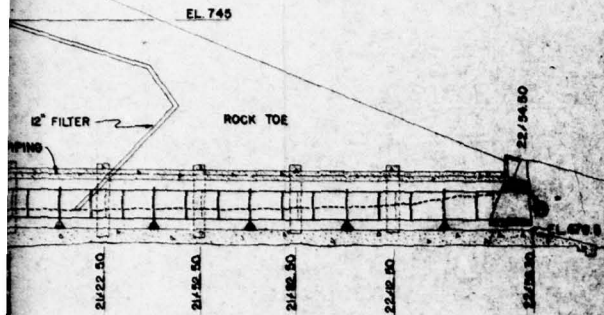
Several proposals for repair were made and in 1953 a 8.5 foot diameter steel conduit was installed inside the 15 foot diameter concrete pipe. This steel pipe is supported on saddles and a transition from the orifice to the steel pipe was poured in concrete. This steel pipe was damaged in 1973 and necessary repairs were completed in 1977.

CONCRETE COLUMNS FROM RIGHT SIDE
ELEVATIONS 692.62 AND 702.0
ADJACENT TO SIDES OF INTAKE STRUCTURE TO
BE REMOVED FOR POSSIBLE CONSTRUCTION OF A
DRAINAGE CANAL. AT TIME OF WORK INDICATE THAT PROTECTION
PLATES, ATTACHED TO STRUCTURE
BE IN PLACE.
DRAIN DOWNSTREAM OF STILLING BASIN, AS
REDUCE TAIL WATER DEPTH.
LOW FLOW AND CLOSE 5'X5' SLUICE GATE.
REMOVE BARS FROM INTAKE STRUCTURE AND CONDUIT,
REMOVE BARS AND PLACE FLOOR SLAB-EMPLOYING
WITH CONCRETE. PROVIDE ANCHOR BARS FOR
SLAB. WATER SHOULD NOT BE ALLOWED TO RUN
24 HOURS AFTER COMPLETION OF PLACEMENT.
KEEP THE GATE CLOSED BETWEEN 24 & 36 HOURS
DRAIN.
REMOVE TIMBER FLUME IN INTAKE STRUCTURE
AND STILLING BASIN TO WORK AND STORAGE AREA
WORK STARTING AT ELEVATION 694 IN INTAKE
AND THE STOP LOGS PLACED AND SO BLOCKED
LOGS TO 103E
DRAIN POOL TO DRAIN THEN WITH A CONTROLLED
TIMBER FLUME, WORK PLATFORM AND CAR RAIL
THEY CAN BE CONSTRUCTED IN THE DRY, AS
IN 30' SECTIONS AND UNLOADED IN WORK AREA
