**TROUT RUN DAM**

National Dam Safety Program. Trout Run Dam (NDI-Pa.-481), Ohio River Basin, Trout Run, Westmoreland County, Pennsylvania. Phase I Inspection Report.

**PHASE I INSPECTION REPORT  
NATIONAL DAM INSPECTION PROGRAM**

OCTOBER 1978

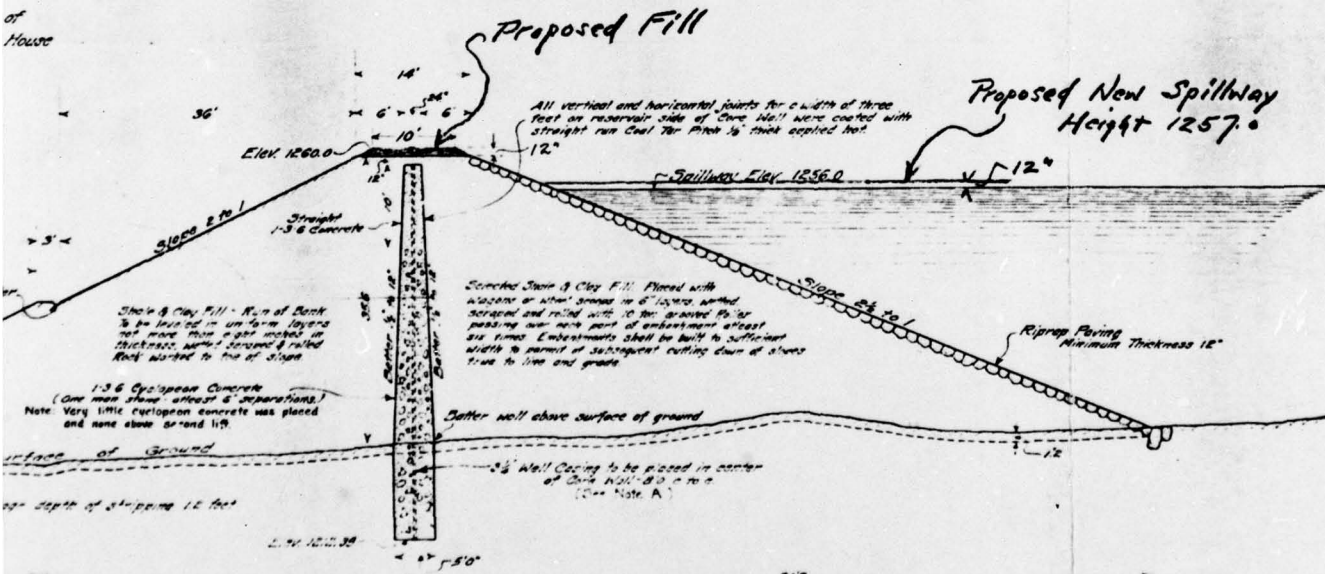
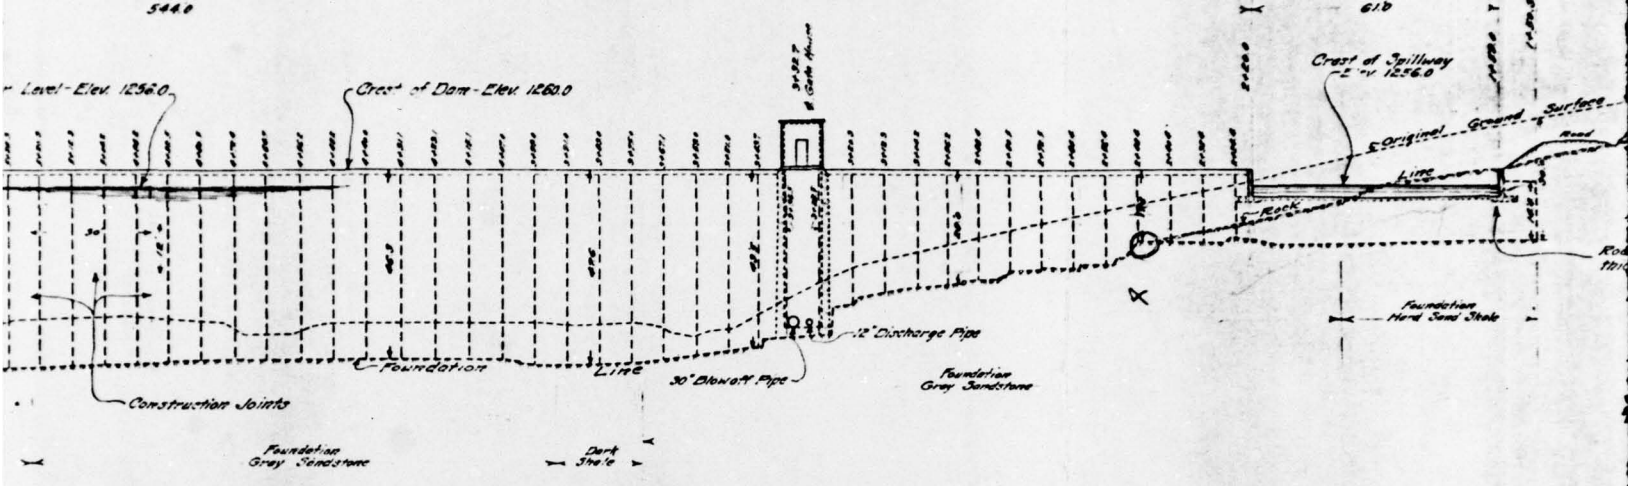
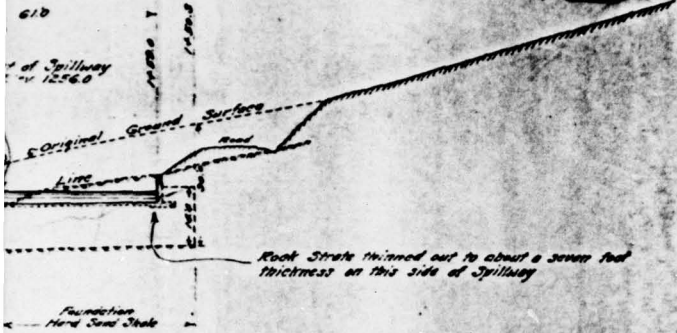
FIGURE 3 Sheet No. 3-B

1. Embankment. Contract drawings, specifications, and construction reports indicate that the structure is a rolled earthfill structure containing a concrete core wall which was carried down to rock (see Figure 3). The upstream face is mantled with a 12-inch thick layer of stone paving and is sloped at 2.5H:1V. The downstream face is sloped at 2H:1V and the downstream toe is composed of rockfill but it does not appear that any internal drainage system was incorporated into the structure.

Perusal of the contract drawings (see Figures 3 and 4) indicates that the shortest seepage path through the embankment is at a position just to the right of the spillway. It seems possible that water is passing along or below the dam-foundation contact in this area and emerging in the area just above the berm. It is of further interest to note that boring records (see Figure 6) indicate that drilling water was lost and a broken sandstone encountered while drilling

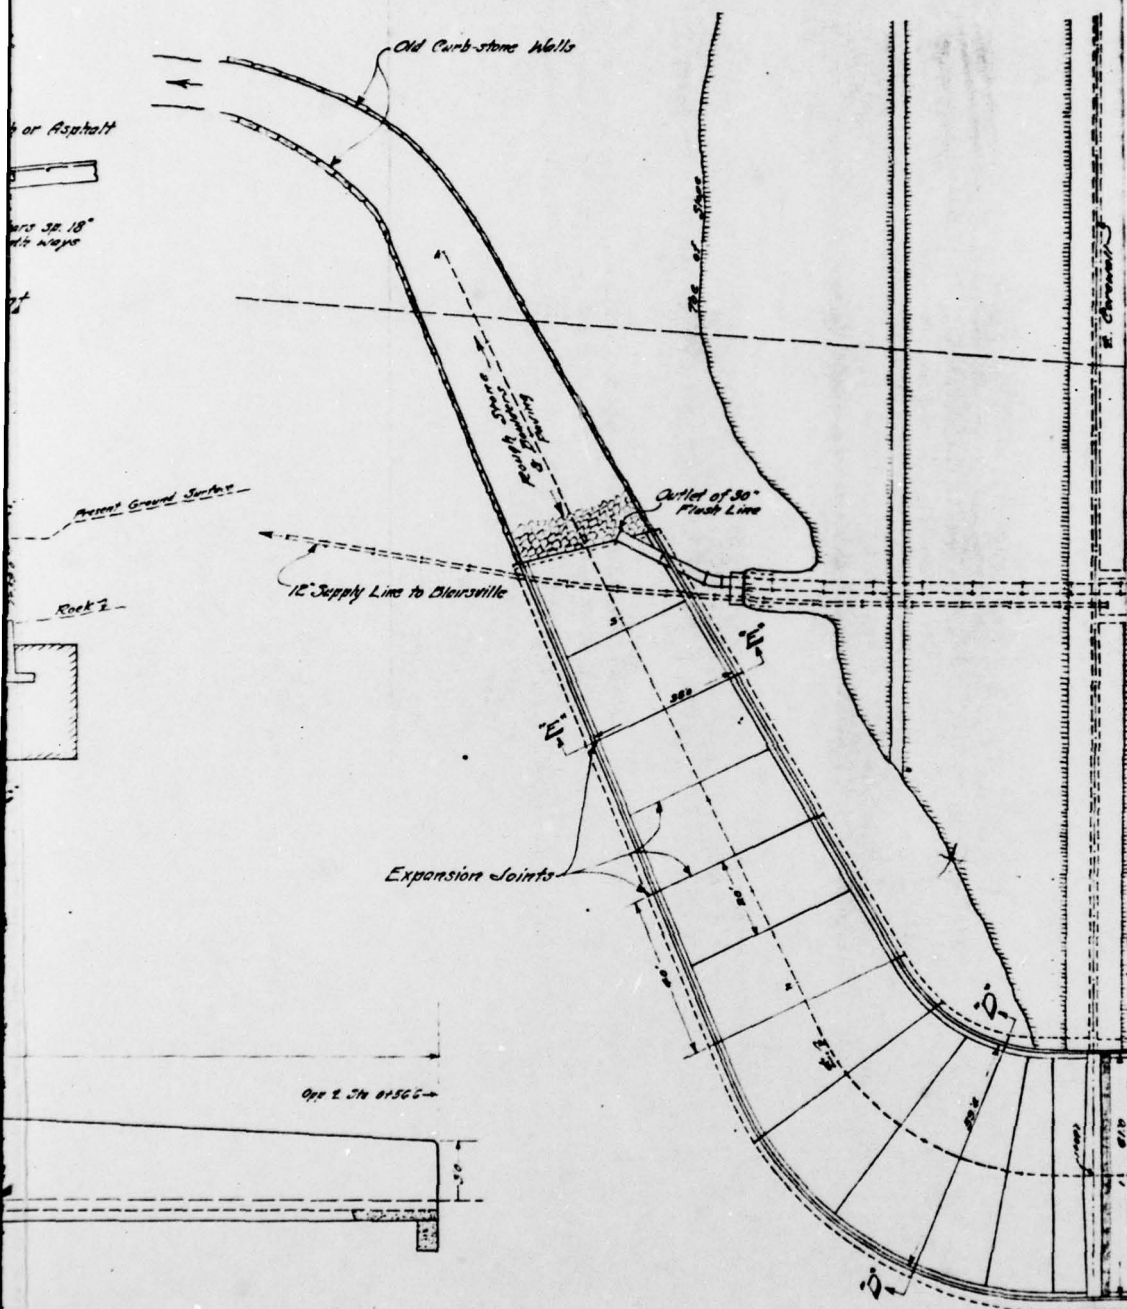
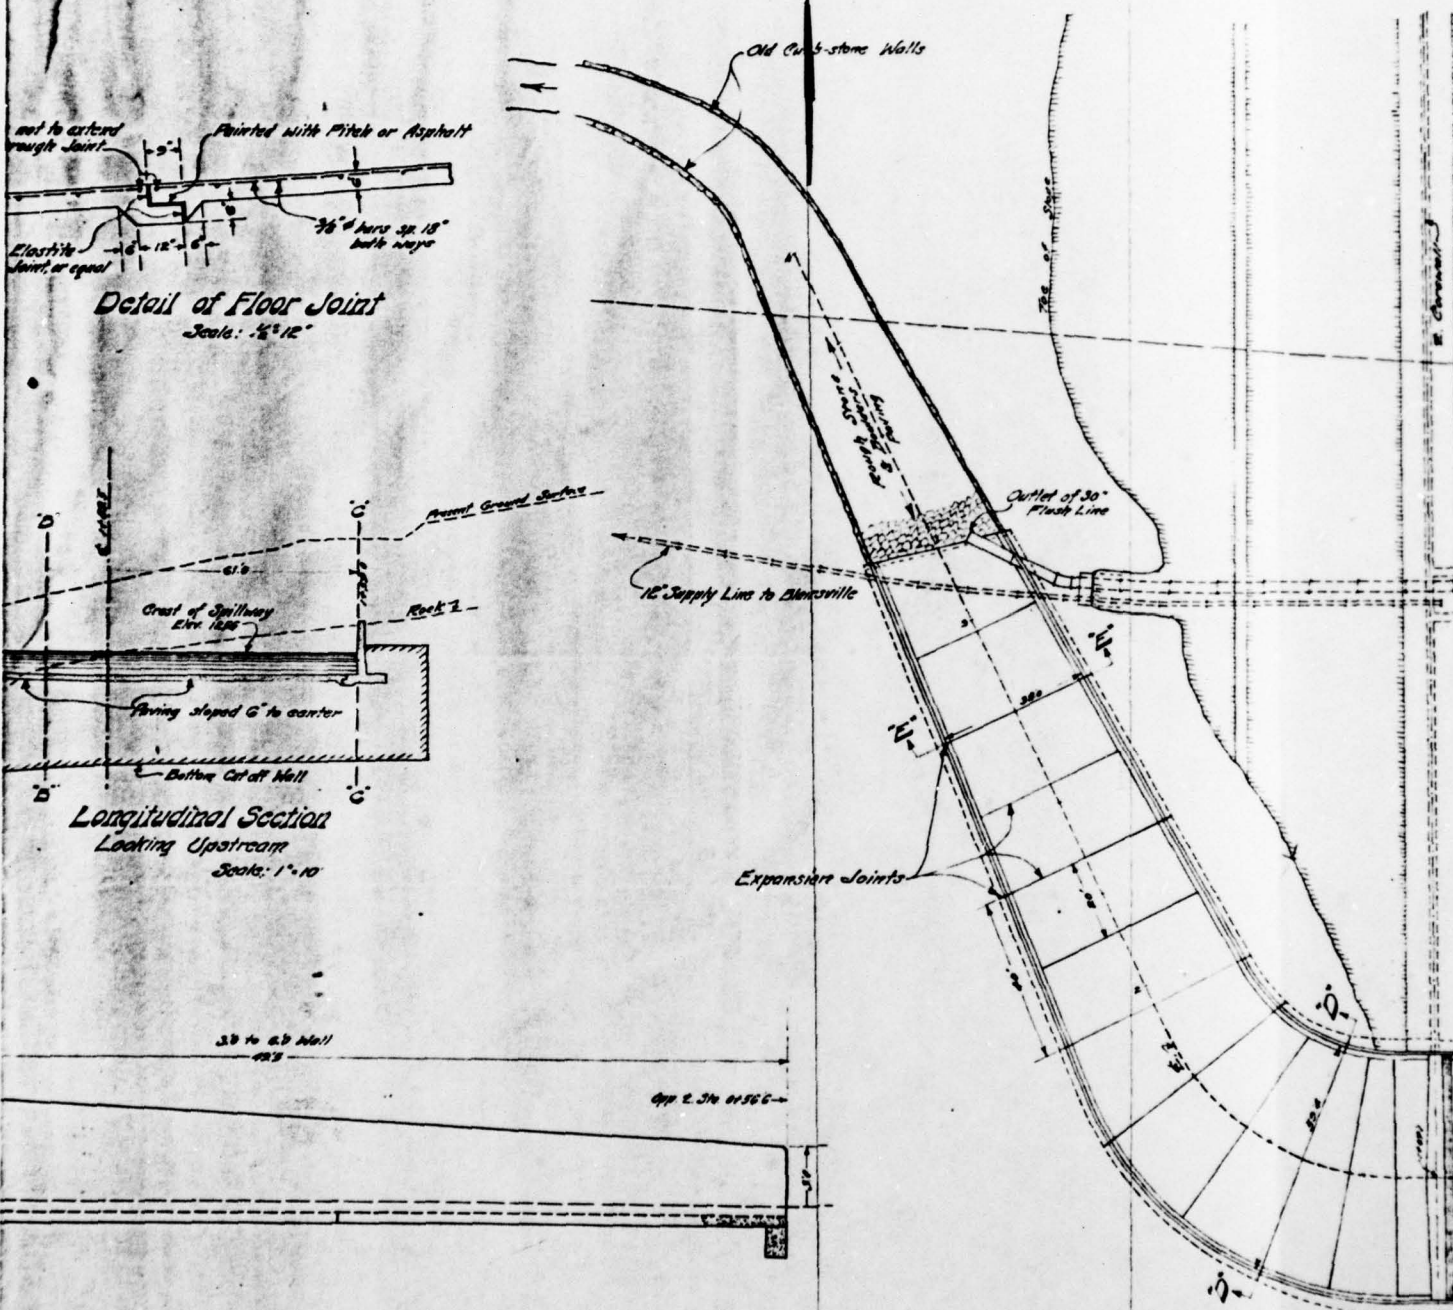
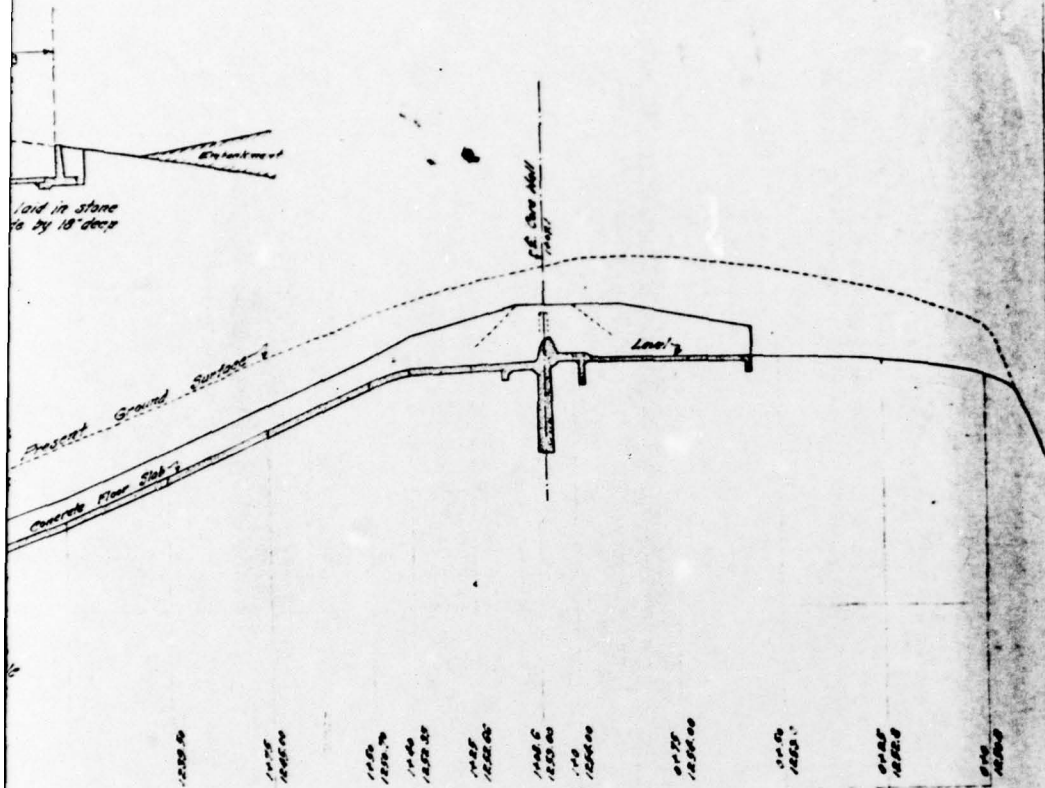
FIGURE 4 (2 of 2)

a) Spillway. The spillway is an uncontrolled concrete chute type structure with an ogee-shaped crest. A concrete cut-off wall extends beneath the spillway to rock as shown on Figure 4. Two smaller concrete cutoffs were constructed in the approach channel of the spillway. The spillway chute is characterized as a curved rectangular channel which empties into a rock-lined portion of the Trout Run channel approximately 260 feet downstream of the crest.

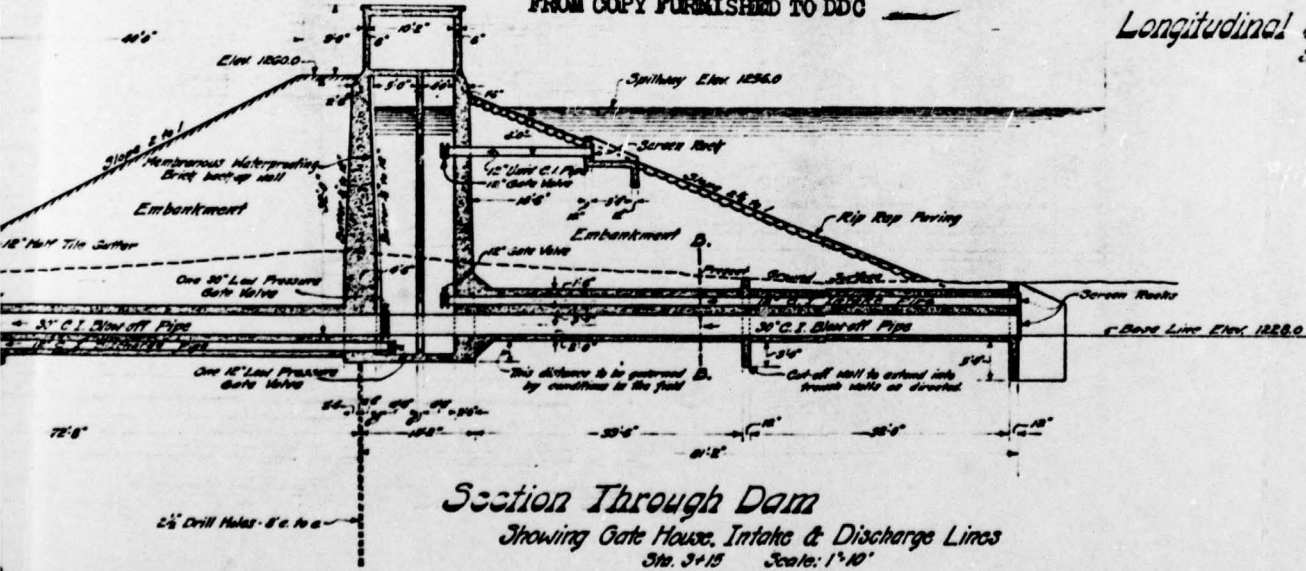
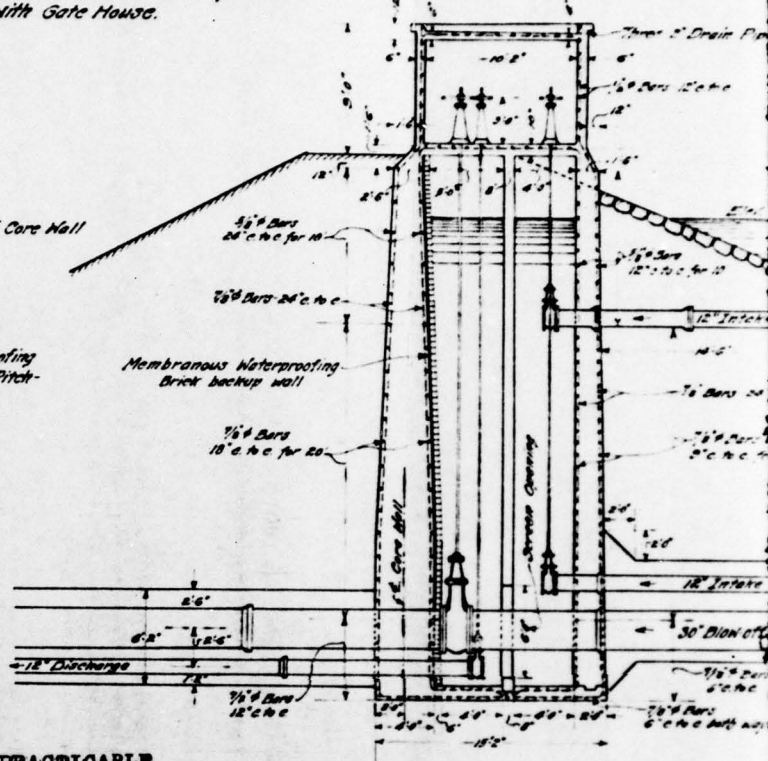
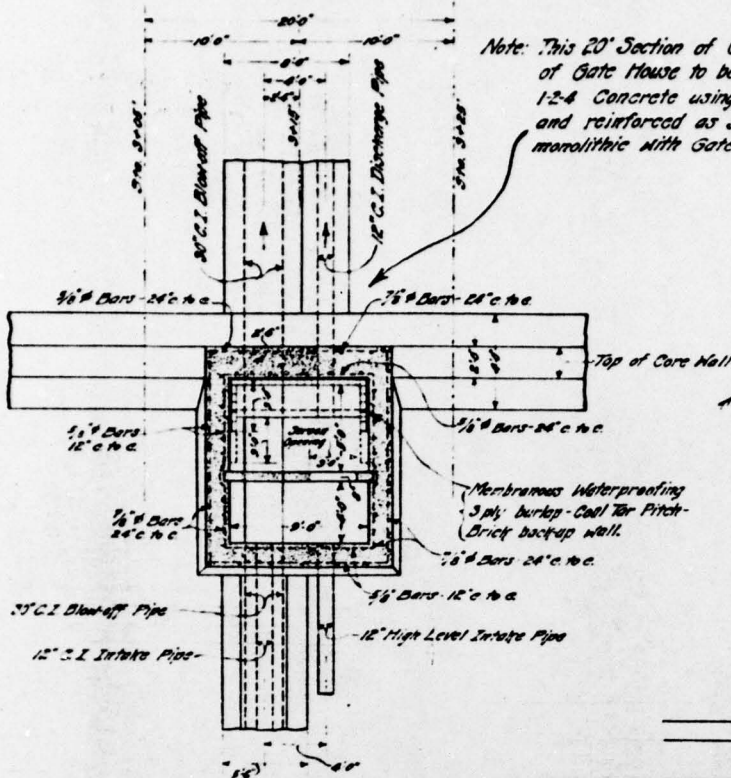
**FIGURE 5** Sheet No. 4-A

j. Regulating Outlets. The 30-inch diameter blow-off line is controlled by a gate valve on the operating floor of the gate house. The 12-inch diameter supply line is controlled in a similar manner; however, water can enter the gate house structure from two elevations within the reservoir (see Figure 5).

b) Outlet Works. The facility is provided with a 30-inch diameter blow-off pipe which discharges into the spillway outlet channel. A 12-inch diameter supply line conveys water to a chlorination building located about 150 yards downstream of the dam. Both of these lines are gated within a concrete gate house located atop the dam crest. Details of the outlet system are shown on Figure 5.
