**OHIO RIVER BASIN  
WEST PENN RUN, WESTMORELAND COUNTY**

**NDI No. Pa. - 452**

**WEST LEECHBURG RESERVOIR DAM**

**PHASE I INSPECTION REPORT  
NATIONAL DAM INSPECTION PROGRAM**

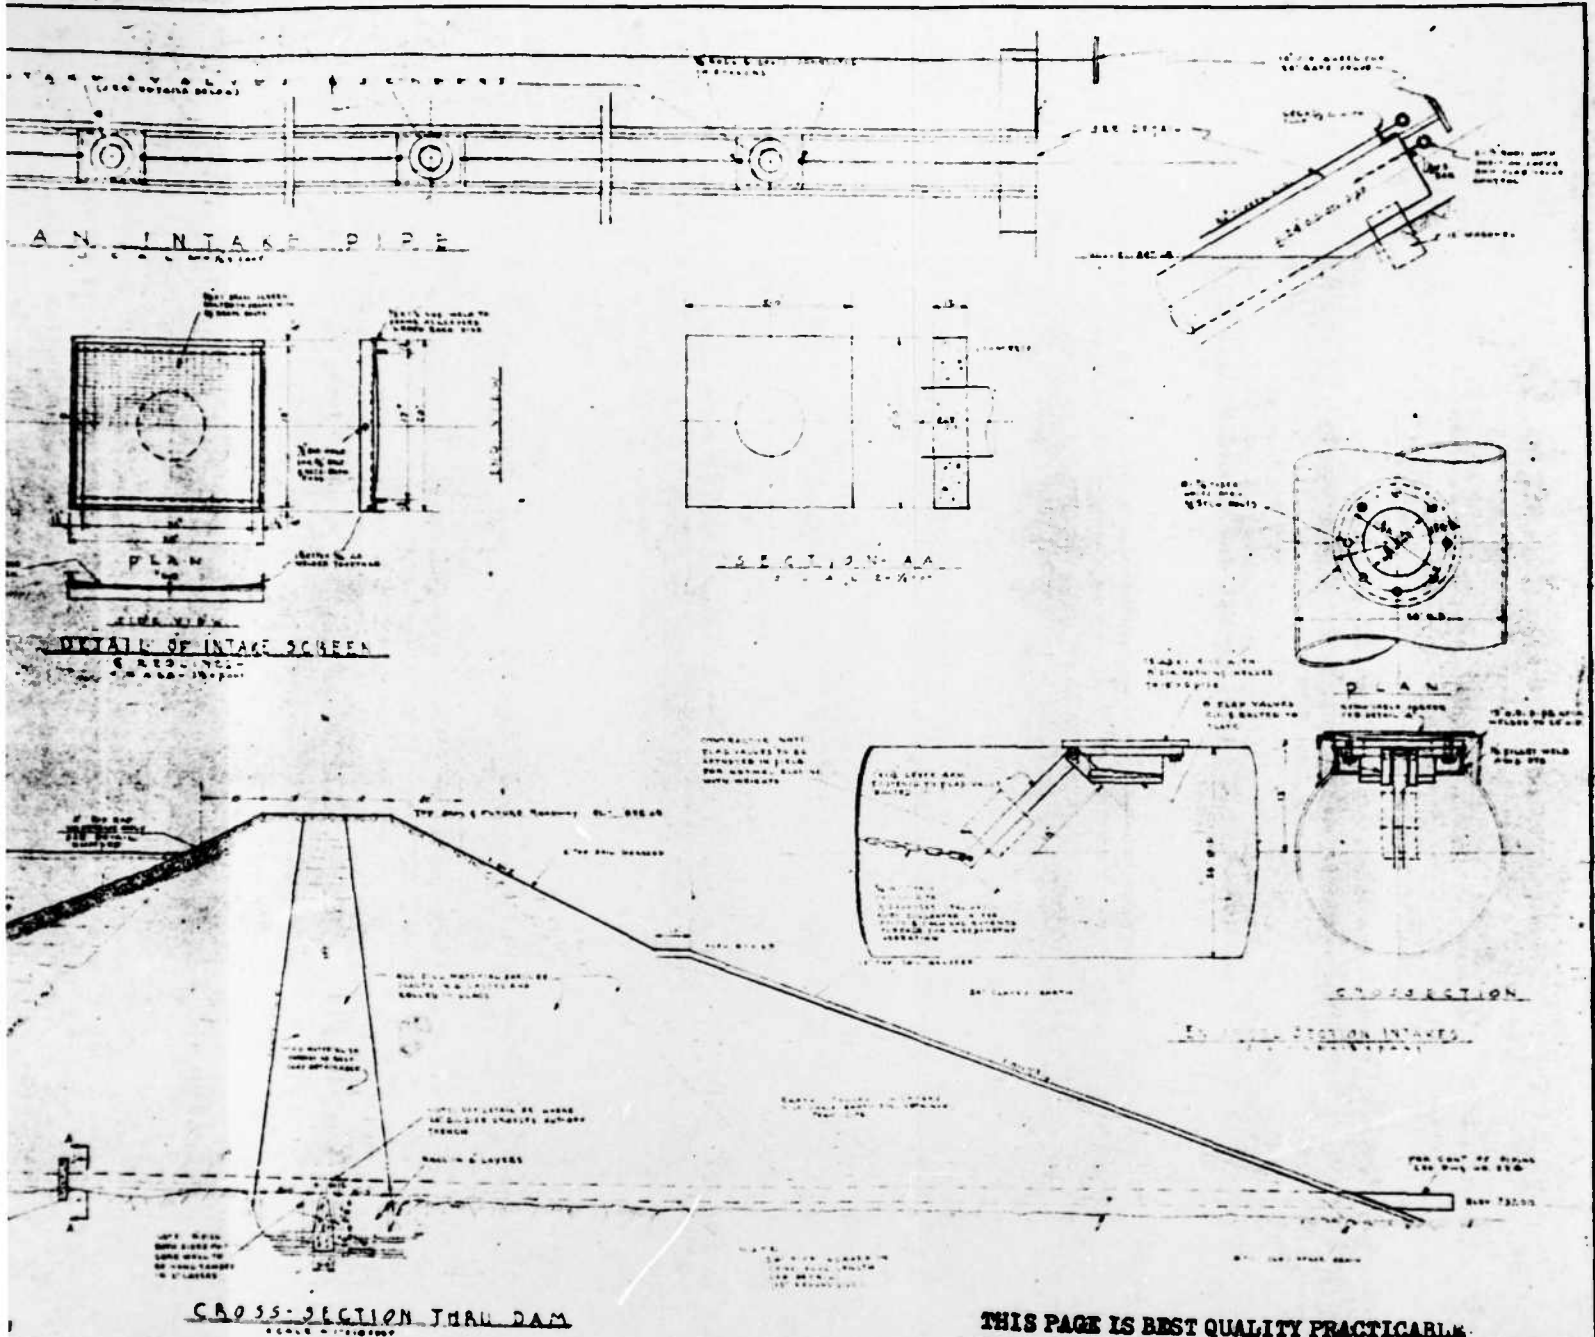
CONTRACT No 1 **FIGURE 4**

Closure - Gate valve at tee on inlet end. Five sluice gate type openings along the riser pipe at heights of 5, 15, 25, 35, and 43 feet above the centerline of the outlet pipe (see Figure 4). The outlet pipe is also gated at its outlet end. All of the sluice gates in the riser pipe are reported to be currently inoperable.

inlet end of the system (as shown on Figure 4) was provided with a tee. The straight section of the tee is valved whereas the section at right angles was provided with a 24-inch steel riser pipe that rested on the left abutment and protruded from the water at a point above 175 feet upstream of the dam centerline. The riser pipe was equipped with five openings, thus allowing the water authority to decant water from several elevations within the reservoir. The gate controls for these openings are presently open and are no longer functioning. Thus, flow through the 24-inch outlet pipe cannot be controlled at the inlet end.

c. Modify or repair the outlet system so as to provide a method for controlling discharge at the inlet end of the 24-inch diameter outlet pipe.
