PHASE I REPORT
NATIONAL DAM INSPECTION PROGRAM

NAME OF DAM: Indian Lake Dam
STATE LOCATED: Pennsylvania
STREAM: Calendar Run, secondary tributary of Stoney Creek, a tributary
of the Conemaugh River
DATE OF INSPECTION: (May 17 and 30, 1978),

INDIAN LAKE DAM
MAY 16, 1978

PHASE I
NATIONAL DAM INSPECTION PROGRAM
INDIAN LAKE DAM
NDI I.D. NO. 228
DER I.D. NO. 56-103

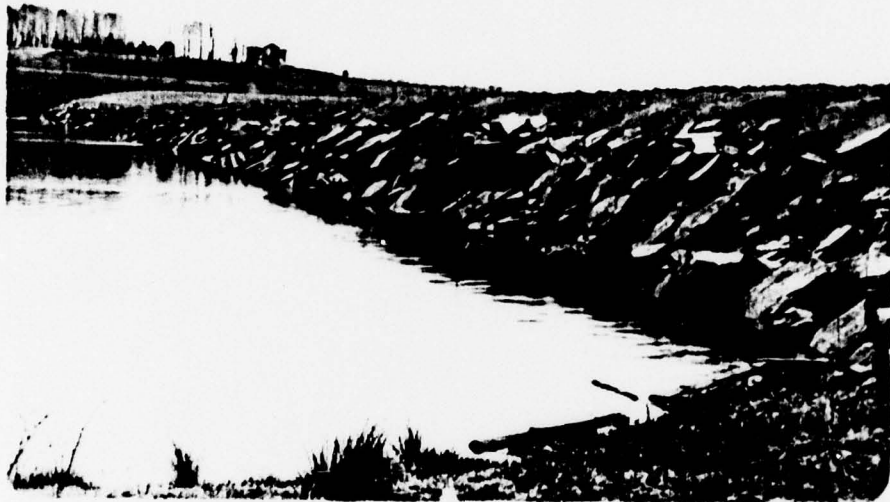
Upstream Face
