TECHNICAL REPORT E-79-6

FAILURE ANALYSIS INVESTIGATION OF NIKE-HERCULES HOISTING CHAIN

U.S. ARMY
MISSILE
RESEARCH
AND
DEVELOPMENT
COMMAND

22 December 1978

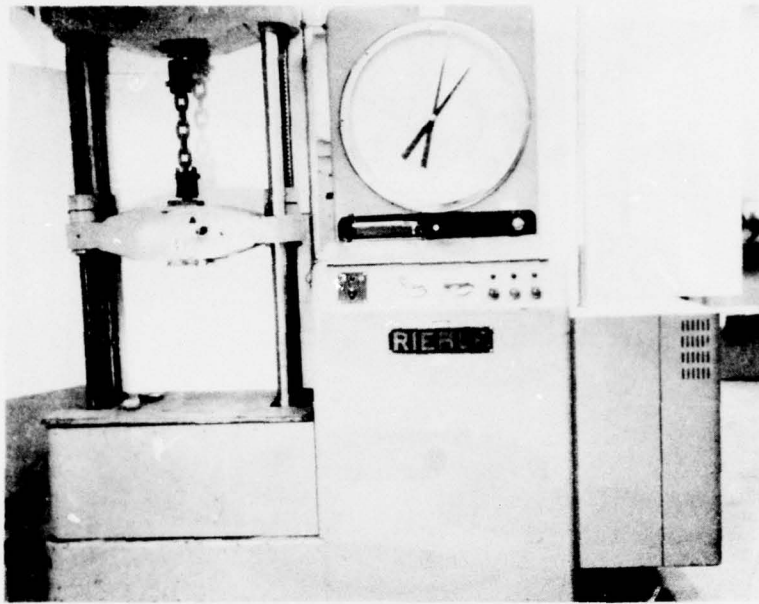
Two sections of the old chain and the one section of the new chain were loaded in tension to failure. Figure 7 shows a typical test setup. One other section of chain with the midpoint chain link cut through its weld area was loaded to failure (Figure 8). Rockwell hardness values were run on the old and new chain indicating values of RC 35 and 31, respectively. All of the previously mentioned mechanical test results are presented in Table 1.

Figure 7. Typical tension to failure test setup.
