CEEDO-TR-78-16

Evaluation of Materials for Post-Attack Pavement Repair

U. S. ARMY ENGINEER WATERWAYS EXPERIMENT STATION
GEOTECHNICAL LABORATORY
P.O. BOX 631, VICKSBURG, MISS. 39180

SEPTEMBER 1978

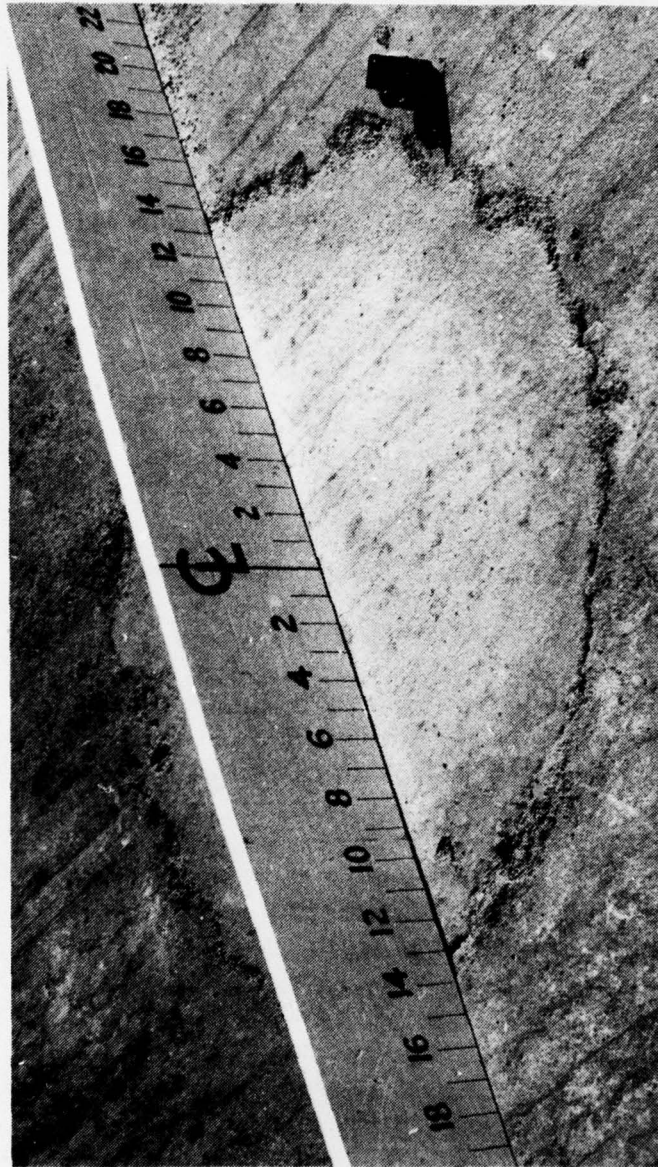
Traffic was applied to the repaired areas 42 minutes after placing. No damage was noted after 20 coverages (192 passes in 10-foot-wide traffic lane) as shown in Figures 13 and 14 for 2- and 5-foot repair area, respectively.

Figure 13. Surface of Darex 240 in 2-Foot-Diameter Area After 20 Coverages

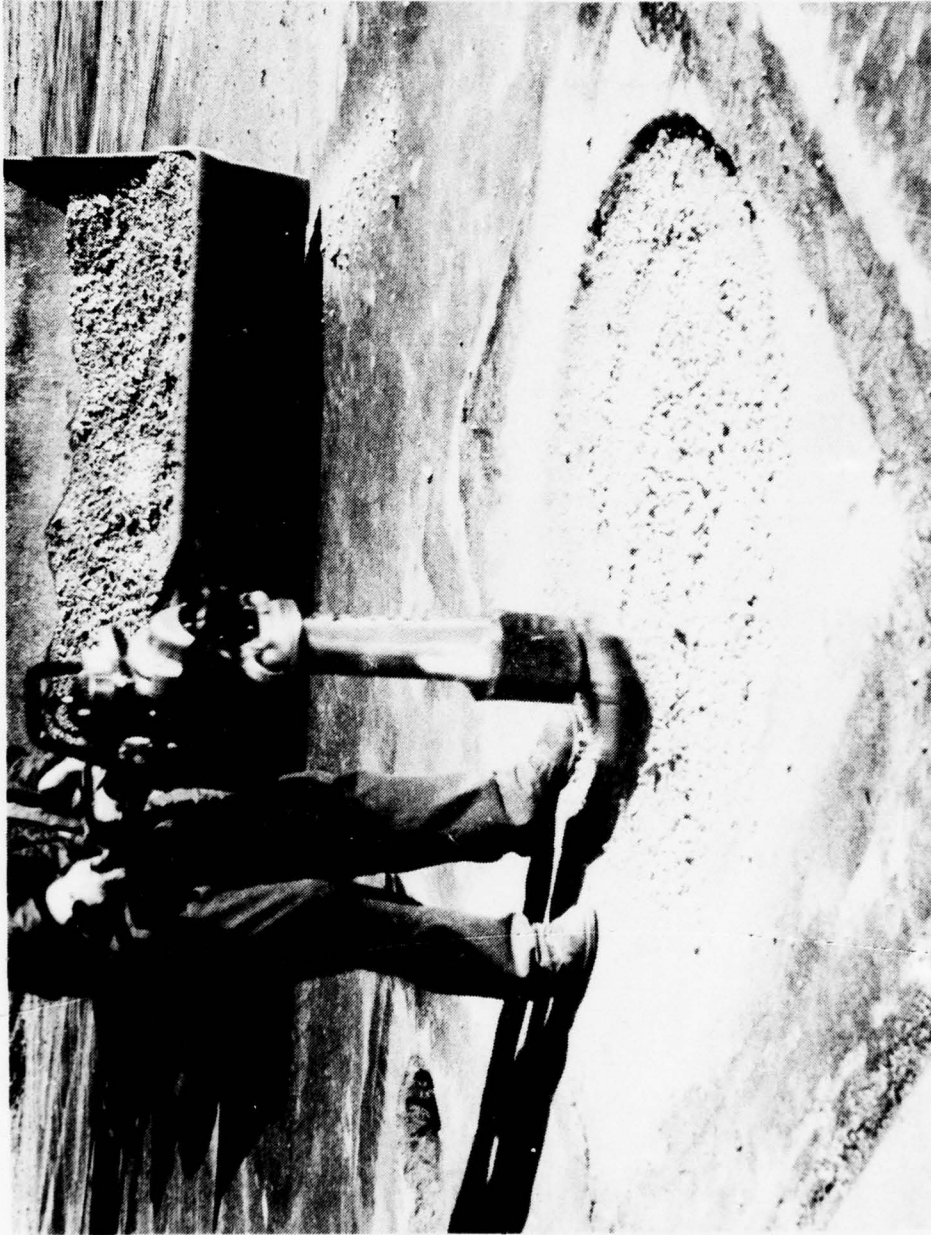
The crushed limestone was placed and compacted in two lifts with a mechanical impact-type compactor as shown in Figure 15. A base course was not used in the 2-foot-diameter area. Water content of the crushed limestone when placed and compacted was about optimum (4.7 percent). Zor-X was placed directly on the base course, as shown in Figure 16, because literature furnished by the manufacturer stated that a prime or tack coat was not necessary. After placing, Zor-X was compacted with a mechanical tamper (Figure 17) and finished rolled with a 30-ton pneumatic-tired roller (Figure 18) having a tire pressure of 90 psi.

Figure 15. Compacting Crushed Limestone Base Course for Zor-X Repair

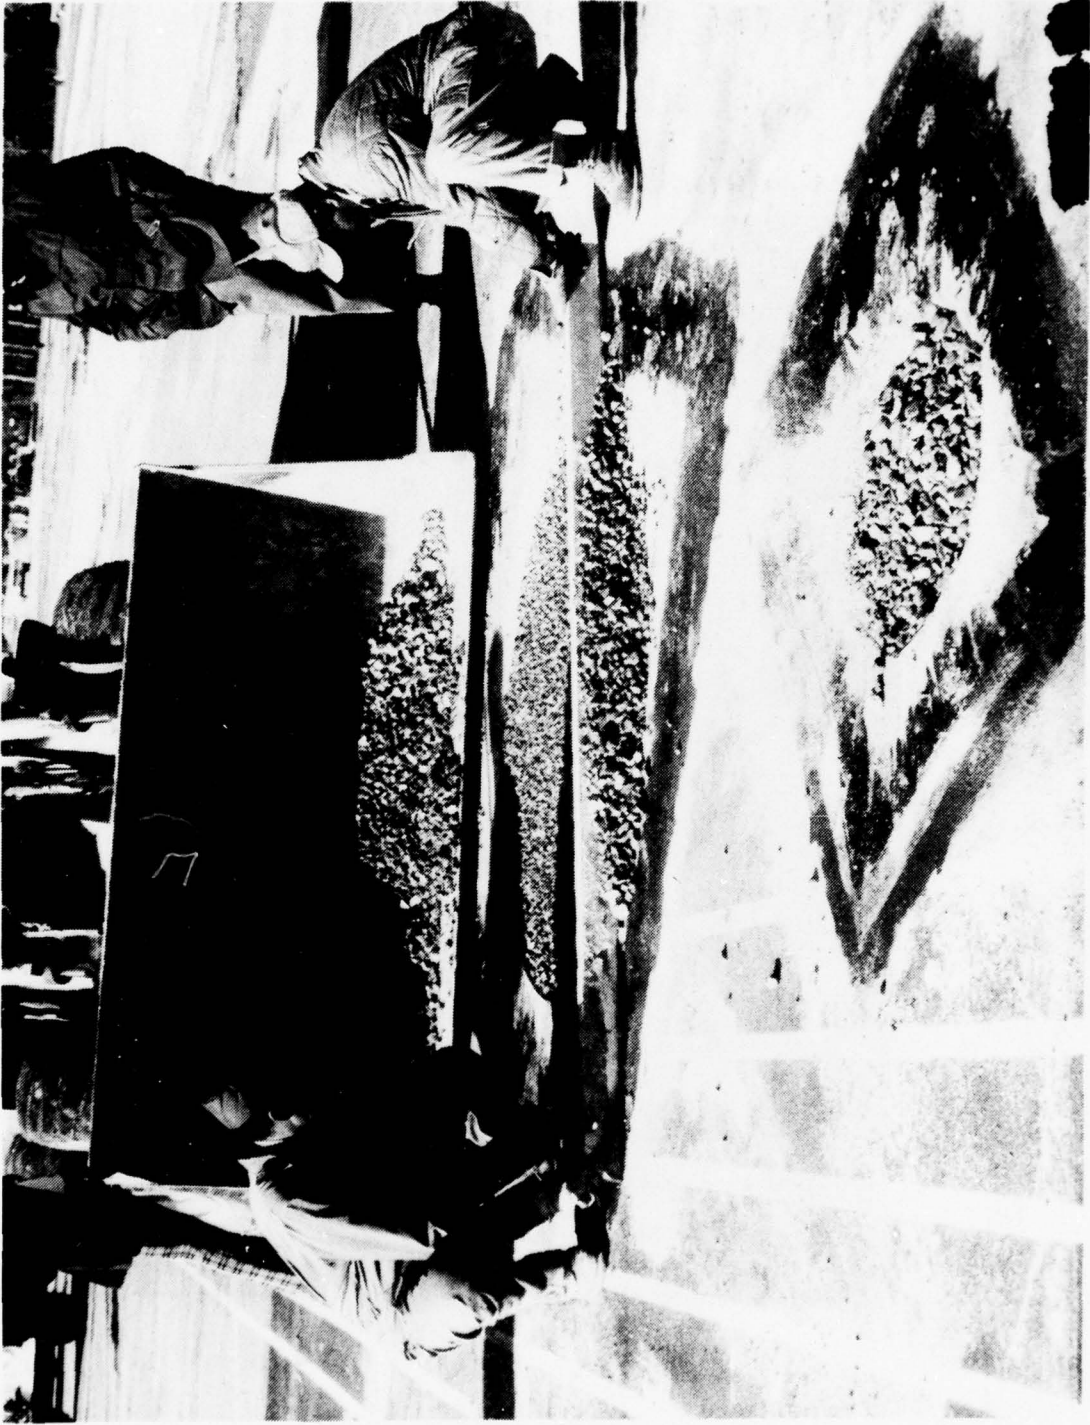
Hathane 1600A was used to repair 5-foot- and 2-foot-diameter areas in flexible pavement. Areas to be repaired were filled with an open-graded washed gravel having a maximum size of 1 inch. Gravel was placed loose in the holes and screeded level with the surrounding surface as shown in Figure 21. The gravel used to fill the holes was damp on the surface but did not contain free water.

Figure 21. Screeding Washed Gravel Fill Material Before Placing
Hathane 1600A

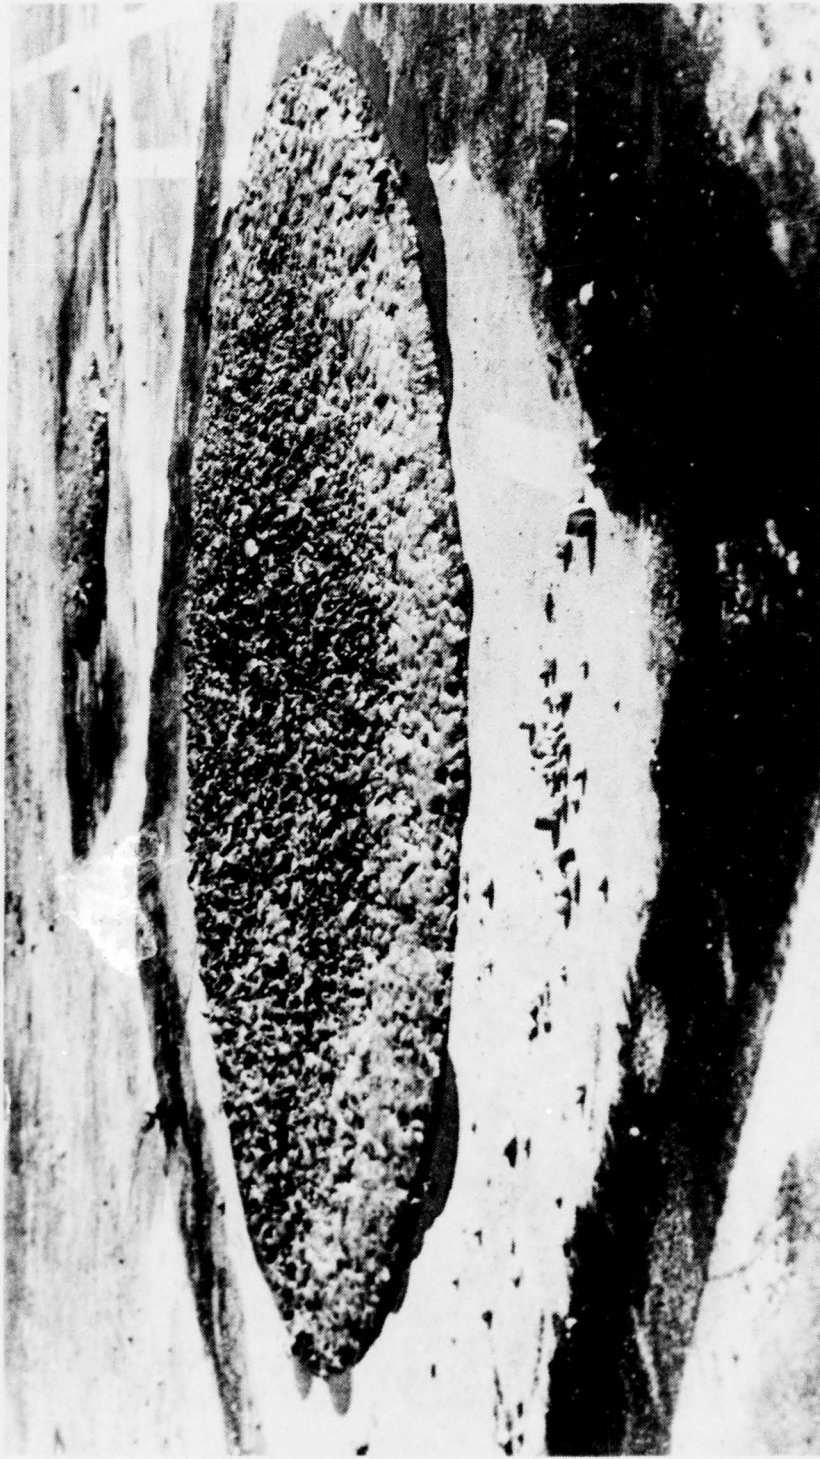
The two components of Hathane 1600A were mixed 15 seconds with a hand-operated electric mixer as shown in Figure 22 immediately before placing. The material was poured over the open-graded gravel (see Figure 23). The material penetrated the full depth of the gravel. During curing, the material foamed and swelled approximately 6 inches above the surrounding area (see Figure 24). This foaming was possibly caused by the moisture on the surface of the gravel.

Figure 24. Hathane 1600A During Curing
