**SODOM DAM  
(EAST BRANCH RESERVOIR)  
PUTNAM COUNTY, NEW YORK  
INVENTORY NO. 31**

**PHASE I INSPECTION REPORT  
NATIONAL DAM SAFETY PROGRAM**

Name of Dam: SODOM DAM (I. D. NO. 31)  
EAST BRANCH RESERVOIR

Date of Inspection: 27 APRIL 1978

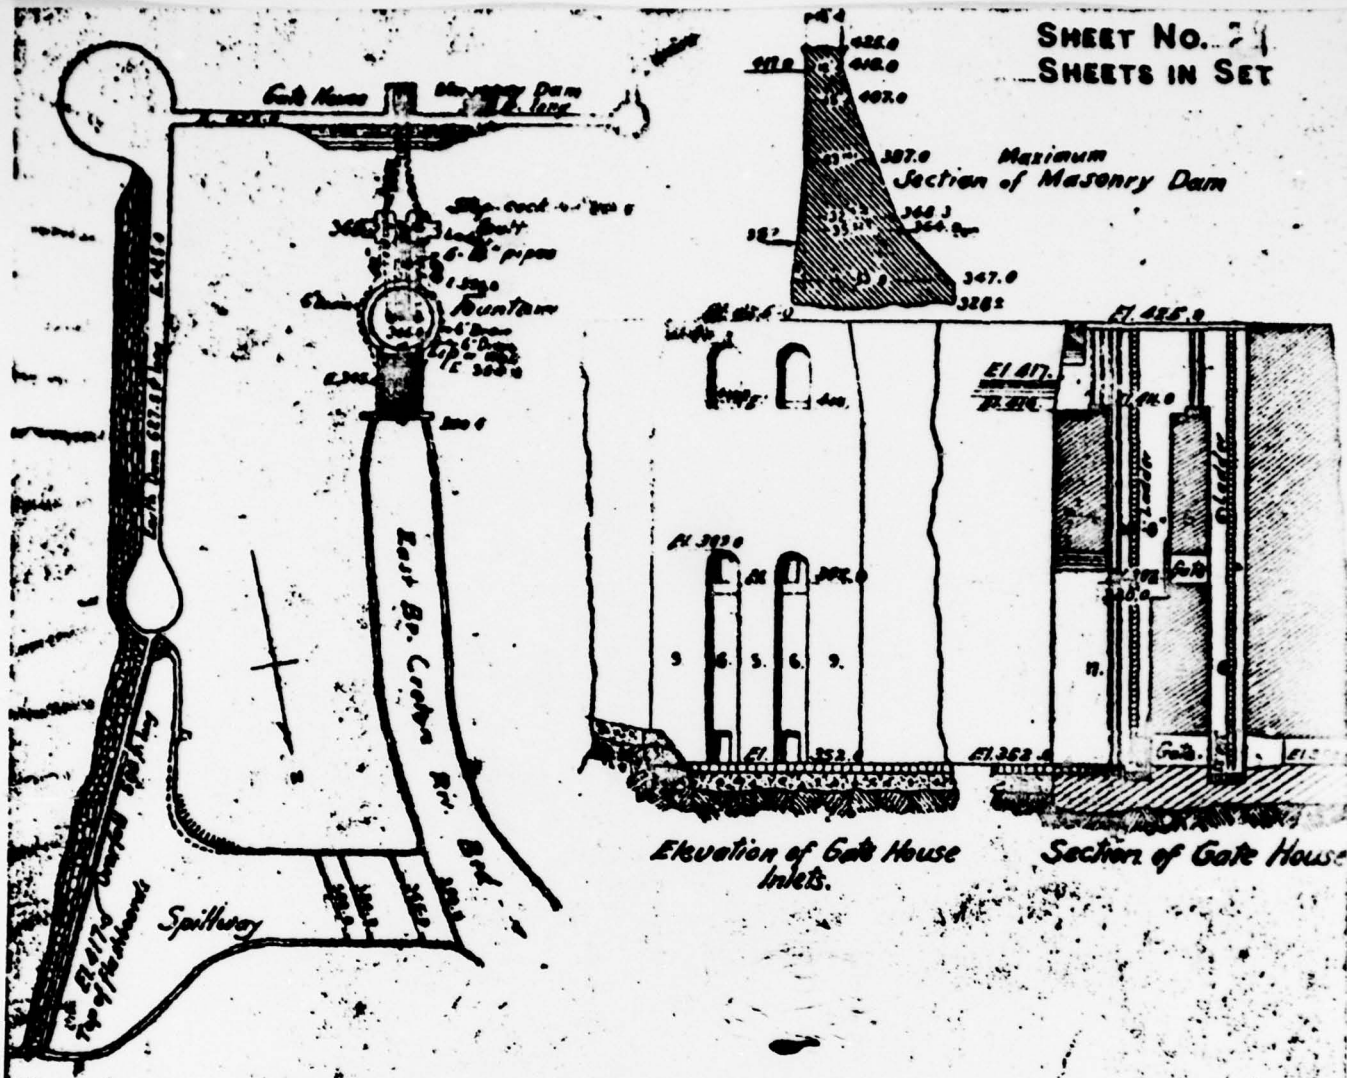
Drawings found in (c) are considered to be most representative of the project as built. Early drawings indicate steps in spillway tailrace channel. The steps do not exist. Notes in (c) and on (e) indicate that spillway crest level was permanently raised from El 415 to El 417 in 1905. Drawing (a) notes location of "soundings" and depths to rock and "hardpan".

Inlets		Outlets		Gates		Stop-cocks		Remarks.
Number	Shape and Dimension	Number	Shape and Dimension	Number	Size	Number	Diam.	
2		2		2	2.5' x 6'	2	48"	NOTE - These Elevations refer to Croton Datum which is 3.61' below City Datum.  Crest of Spillway repaired by D.W.S.G. & E. & flash boards permanently erected to El. 417.0 El. of Fountain = 351. Lip El. of Spillway was 415.0
				2	2.5' x 5'	2	36"	
2				5	12"	5	12"
