NRL Memorandum Report 656

# TANKAGE FAILURES OF AEROBEE-HI AND VANGUARD ROCKETS

J. E. Srawley

December 1956

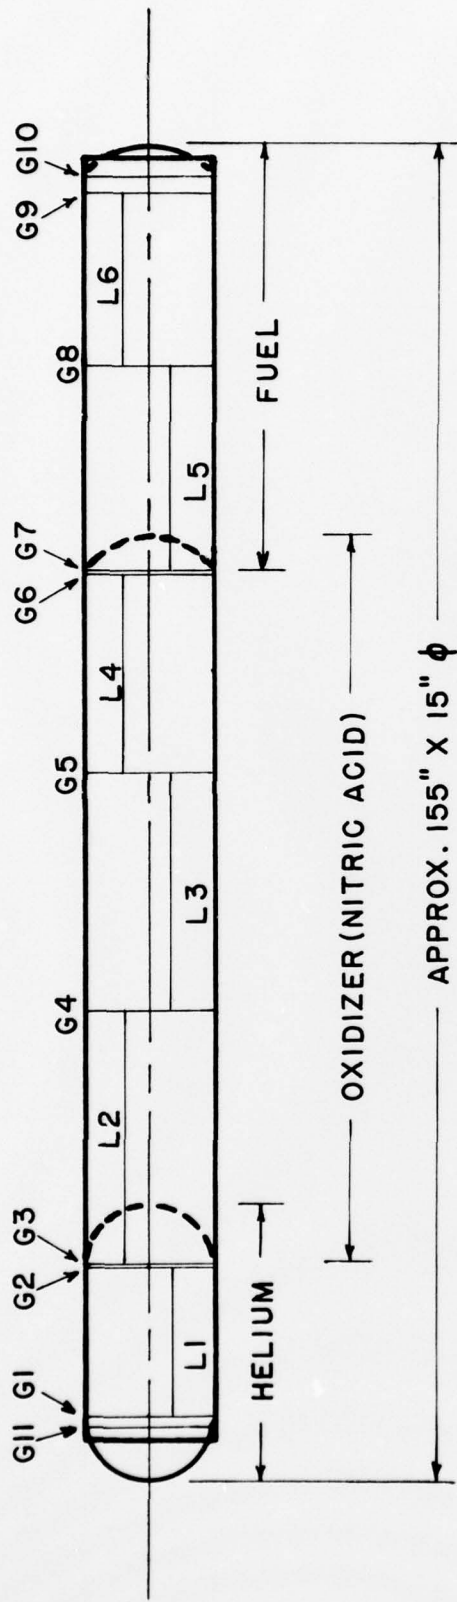
Figure 1 - Schematic Drawing of Aerobee - Hi Tank Assembly Showing Locations of Principal Welds

A schematic drawing of the Aerobee - Hi, showing the locations of some of the welded joints, is shown in Figure 1. Details of the weld joints G2 and G3 are shown in Figure 2. The brief description given in the manufacturer's specification AES-A2821.6a reads as follows:

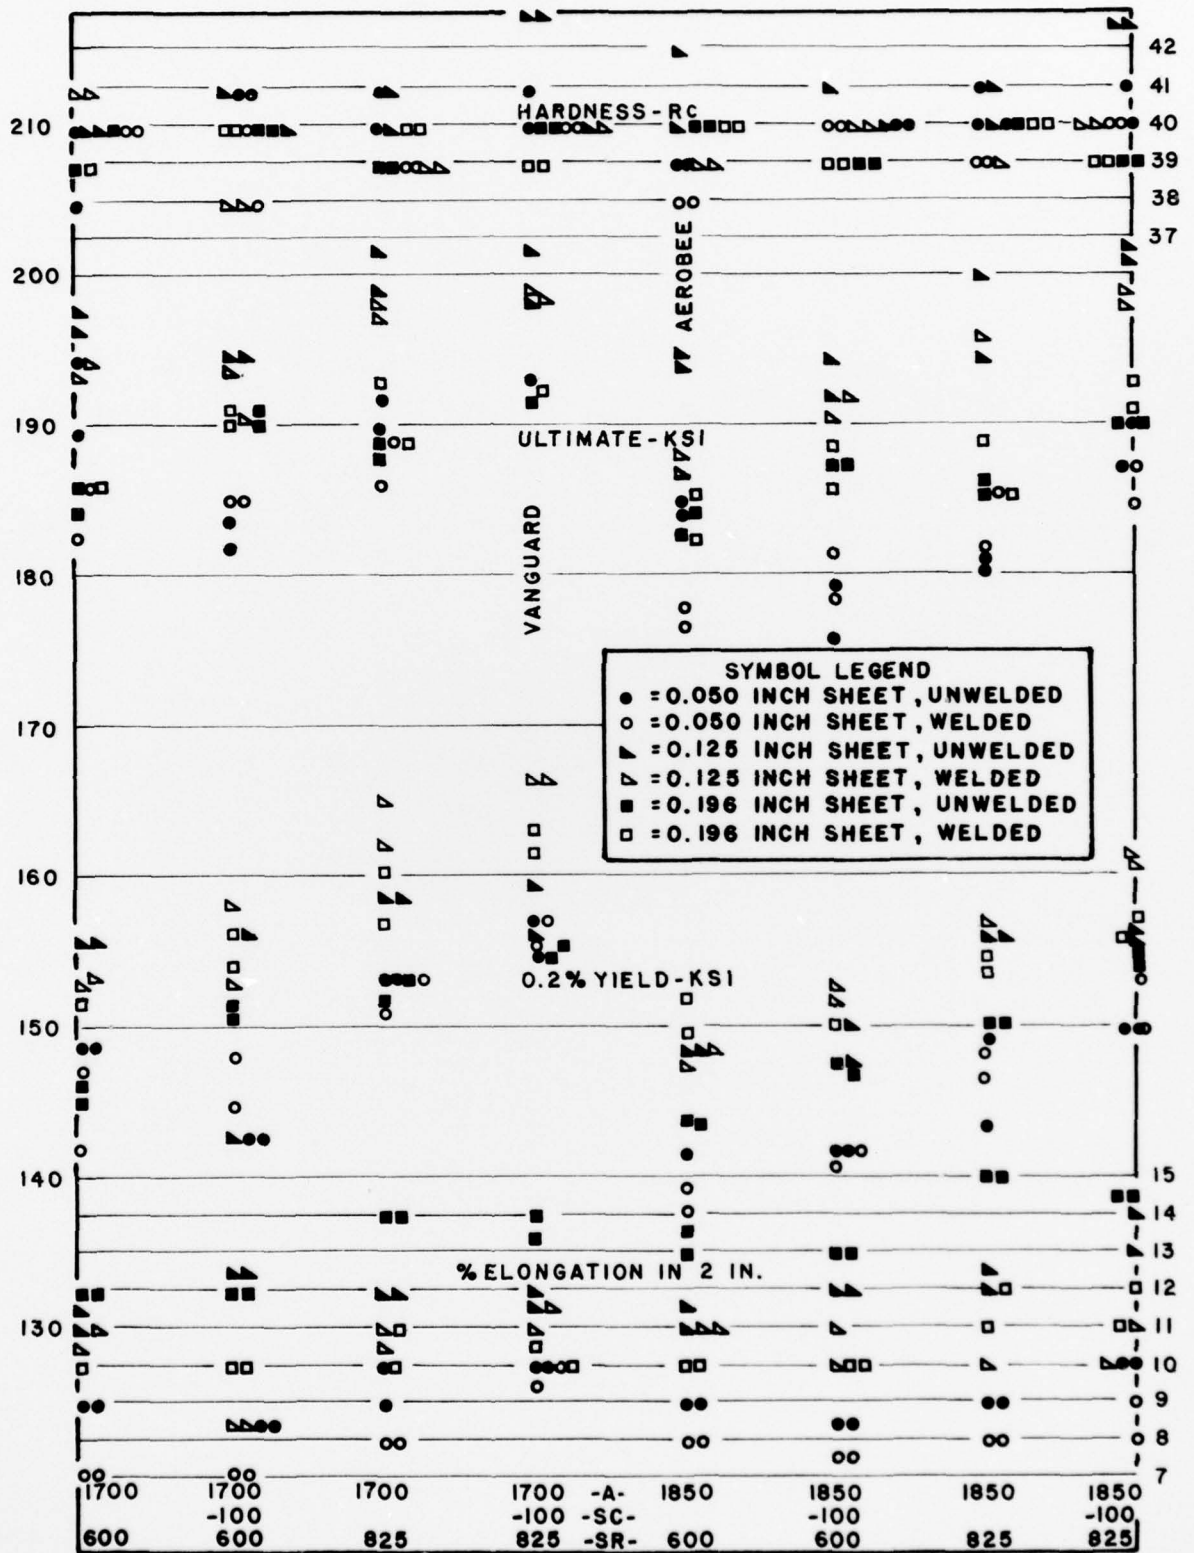
Figure 18 - Heat Treatment Condition vs Properties Type 410

The superior tensile properties for the Vanguard heat treatment have been substantiated on 11 lots of material, including three different thicknesses, by A. Co. The properties obtained in tensile tests of welded and not-welded test pieces are shown in Figure 18 for six different combinations of heat

treatment variables. The code at the bottom of each column of points in Figure 18 indicates austenitizing temperature, cold treatment and tempering temperature. Examination of this data indicates that little or none of the improvement is associated with the subzero treatment, whereas the effect of the lower austenitizing temperature and the higher tempering temperature both contribute to improve the yield strength. Ductility does not appear to depend strongly on the heat treatment variables, although there does appear to be an average improvement in Elongation of 1% between Aerobee and Vanguard.
