CALSPAN CORP BUFFALO N Y

MAR 79 E J MACK, R J ANDERSON, D H BOCK

*AN OPERATIONAL RESEARCH INVESTIGATION OF THE
ICE-DETECTION CAPABILITY AND UTILITY OF THE
SURFACE CONDITION ANALYZER (SCAN) SYSTEM
AND ITS APPLICABILITY TO NAVY-WIDE USE*

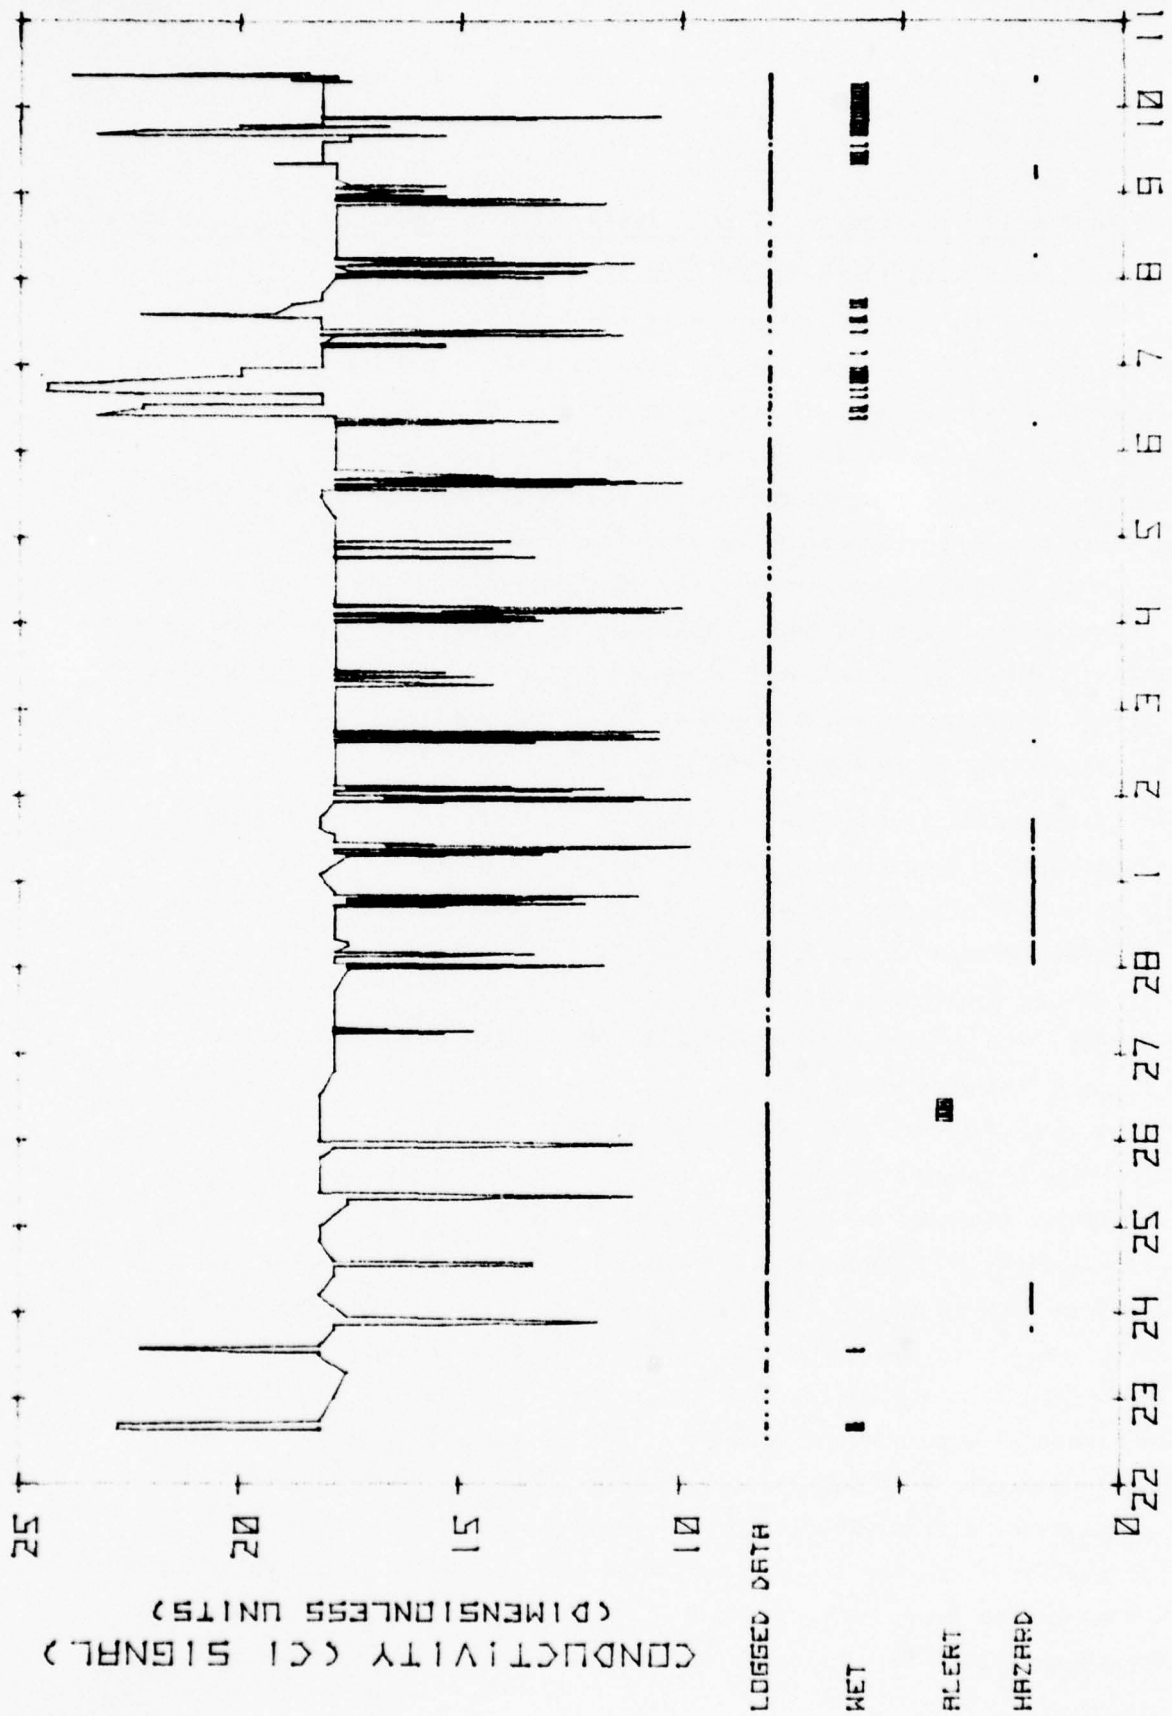
Figure 15: RECORD OF THE CONDUCTIVITY SIGNAL OF SCAN #4 AT KEFLAVIK, 22 FEBRUARY - 10 MARCH 1978

The recording system at SCAN sensor #4 was installed on the afternoon of 22 February, and, as an initial test, the sensor was splashed with water to depth of ~ 0.5 mm from $\sim 1530-1700$ GMT. The response of the conductivity and capacitance sensors to the layer of water can be seen in the spikes in Figures 15 and 16, respectively. On the following afternoon (23 Feb.) at ~ 1400 , an attempt was made to calibrate the surface temperature probe* of #4 by creating a puddle of water ~ 10 mm deep over the sensor and measuring the temperature of the water with a thermometer. Again, note the spikes in the records shown in Figure 15 and 16 on the afternoon of 23 February. In both tests (i.e., on the afternoons of 22 and 23 Feb.) the SCAN sensor responded to the presence of a substantial layer of water, measuring, as expected, increases in both capacitance and conductivity.

Throughout the above described frost event, during which runway traction dropped below MU-Meter values of 30 (indicating fair-to-poor and poor braking action), all four SCAN sensors remained in the CLEAR-condition readout on the display terminal. Inspection of Figures 15 and 16 also shows that no increases in either capacitance or conductivity occurred during the period. Hence, SCAN was unable to detect this type of frost event, probably as a result of the frost's low density.

The conductivity record (Figure 15) for the night of 23-24 February shows the initial observation of a series of almost daily periods of apparent reduced conductivity. A total of 19 such episodes are evident in the record, ranging in duration from 1.5 to 5.5 hr and averaging 3.75 hr. The episodes of reduced conductivity were statistically well-distributed throughout the day, with 26% occurring during the first 6 hours of the day, 26% during the second quarter, 21% during the third quarter, and 26% during the fourth quarter of the day. Inspection of these records, as well as weather and SIRC activity records, revealed that the indications were neither diurnal in nature nor related to any weather or SIRC event. We have not been able to attribute these periods of "reduced conductivity" to anything other than electrical "noise" in the circuitry of the SCAN conductivity probe.

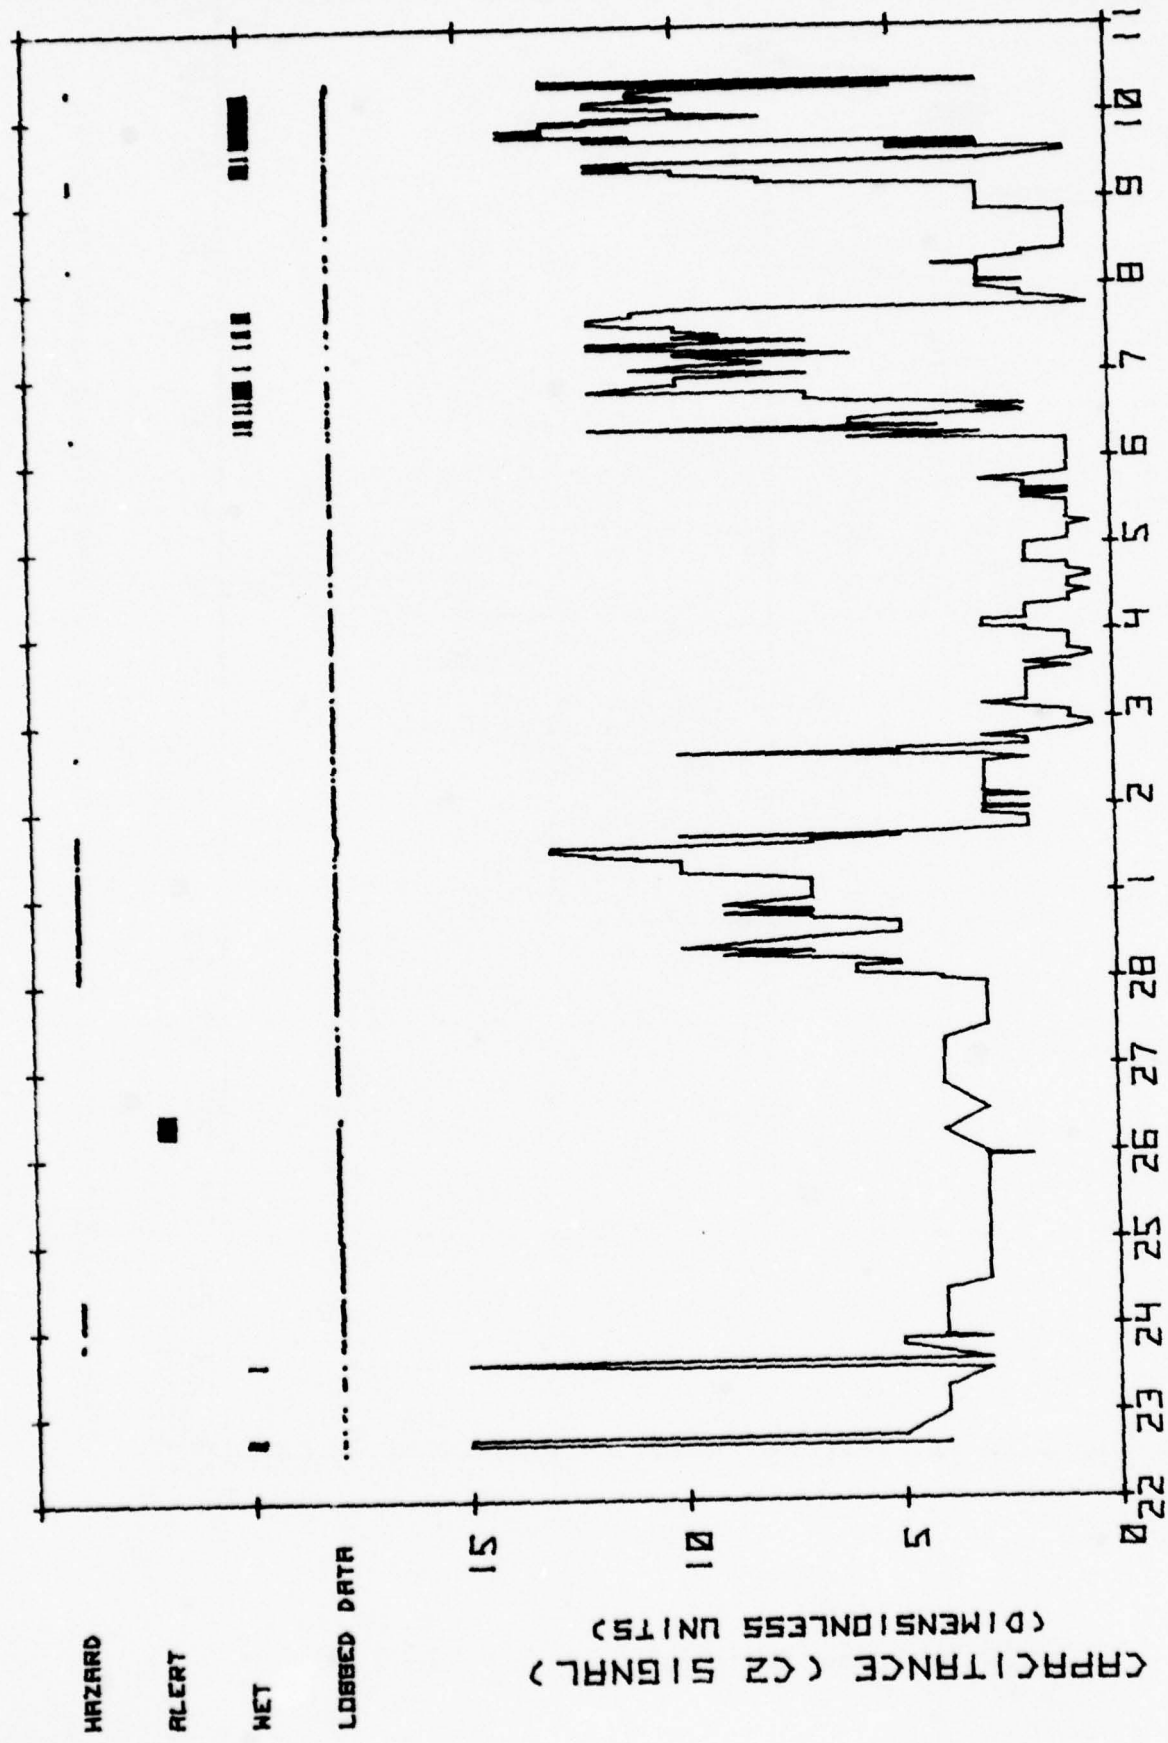
Figure 16: RECORD OF THE CAPACITANCE SIGNAL OF SCAN #4 AT KEFLAVIK, 22 FEBRUARY-10 MARCH 1978

The records reproduced in Figures 15 and 16 reveal that the capacitance signal increased slightly, barely registering the presence of the thin ice film on the surface of sensor #4. Such thin films of ice on the sensor, which caused no obvious reduction in runway traction and which may be the result of differences in radiation color and thermal properties of the sensor head and runway surface, may be the cause of some of the "false alarms" experienced at Keflavik and elsewhere (see Appendix B).

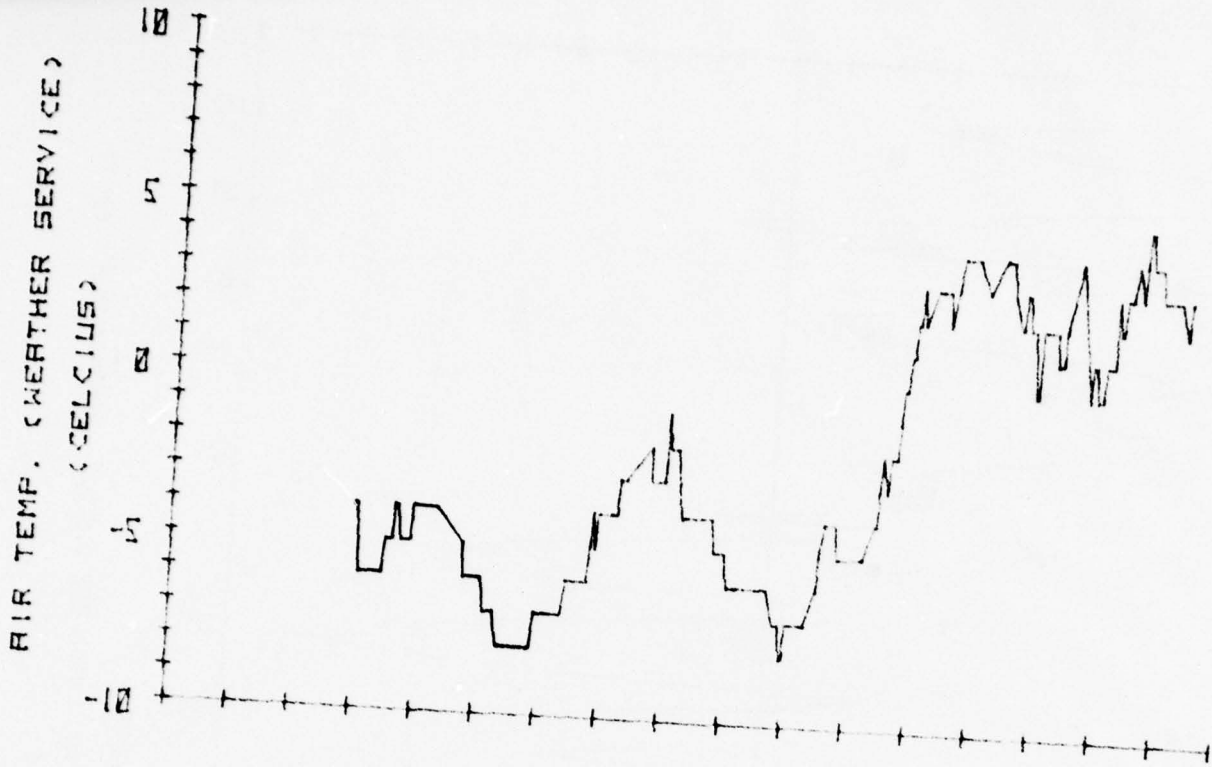
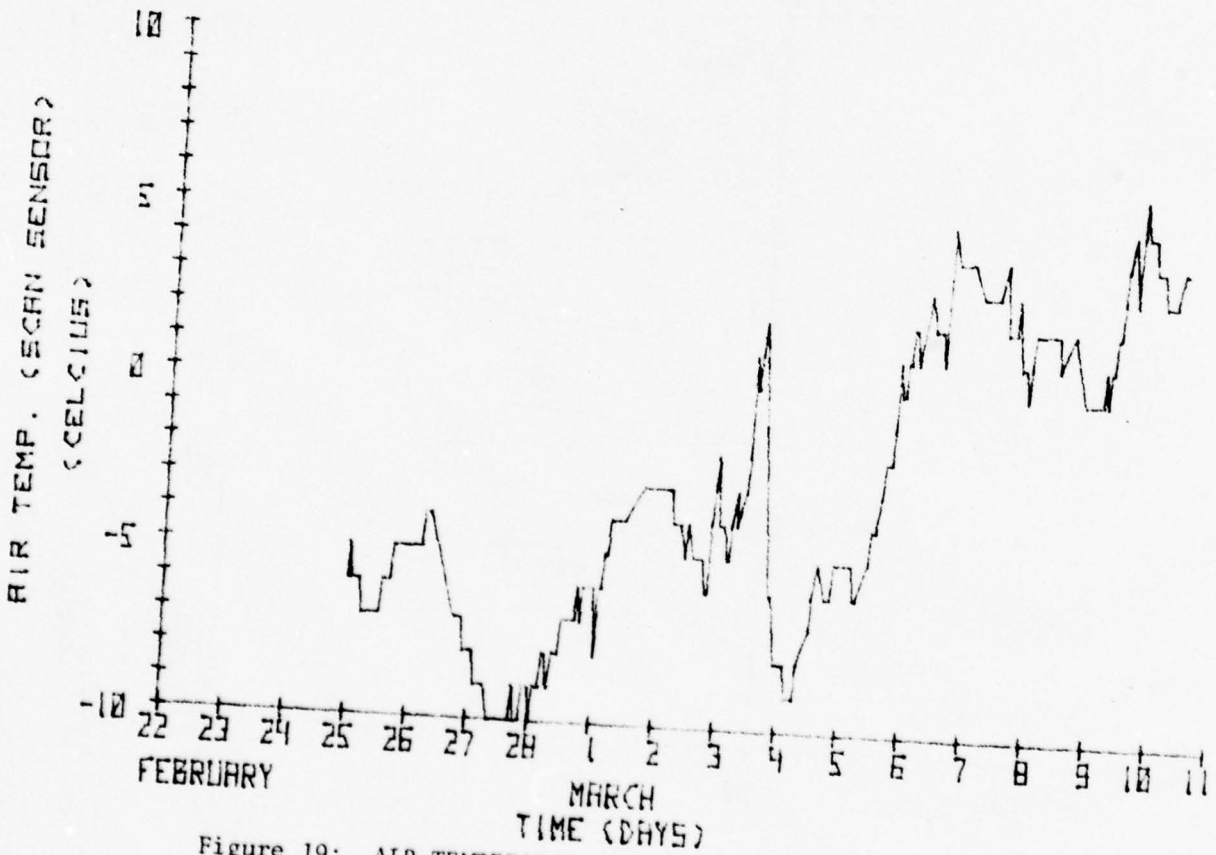
Figure 19: AIR TEMPERATURE RECORDS FROM THE SCAN SENSOR AND THE NAVAL WEATHER SERVICE

Hourly data from the SCAN air temperature sensor and similar data from the Naval Weather Service records are compared in Figure 19. Given the differences in exposure of the two instruments, the air temperature data exhibit reasonably good agreement.

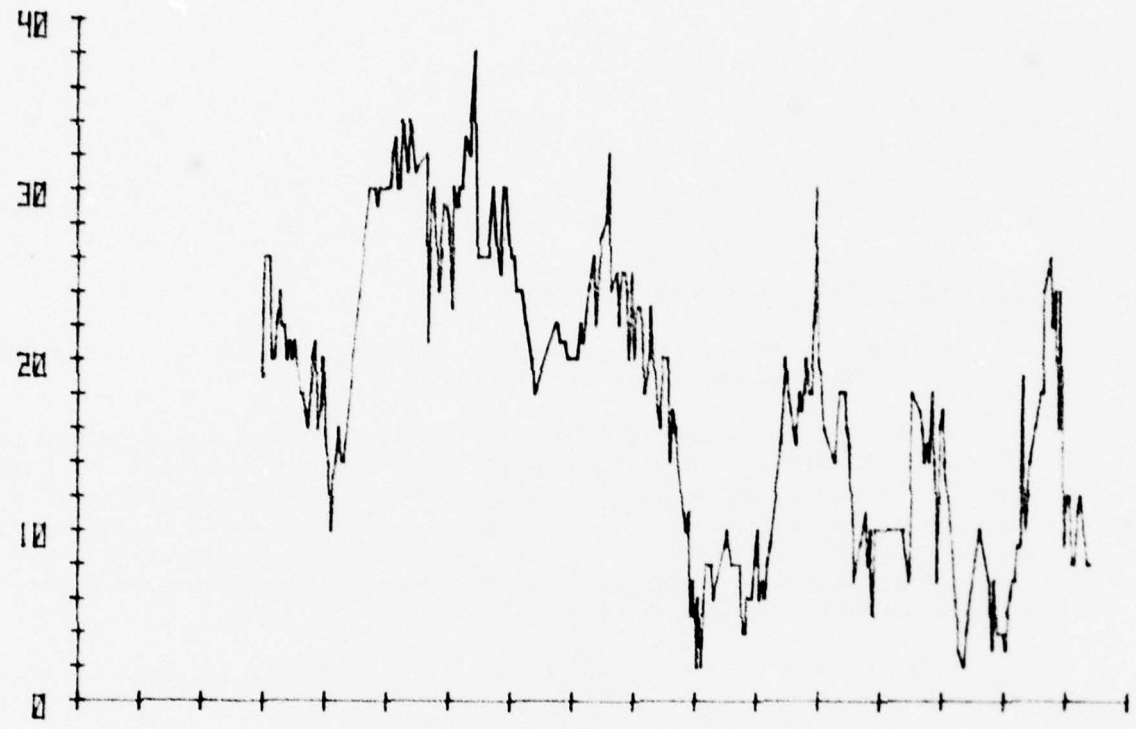
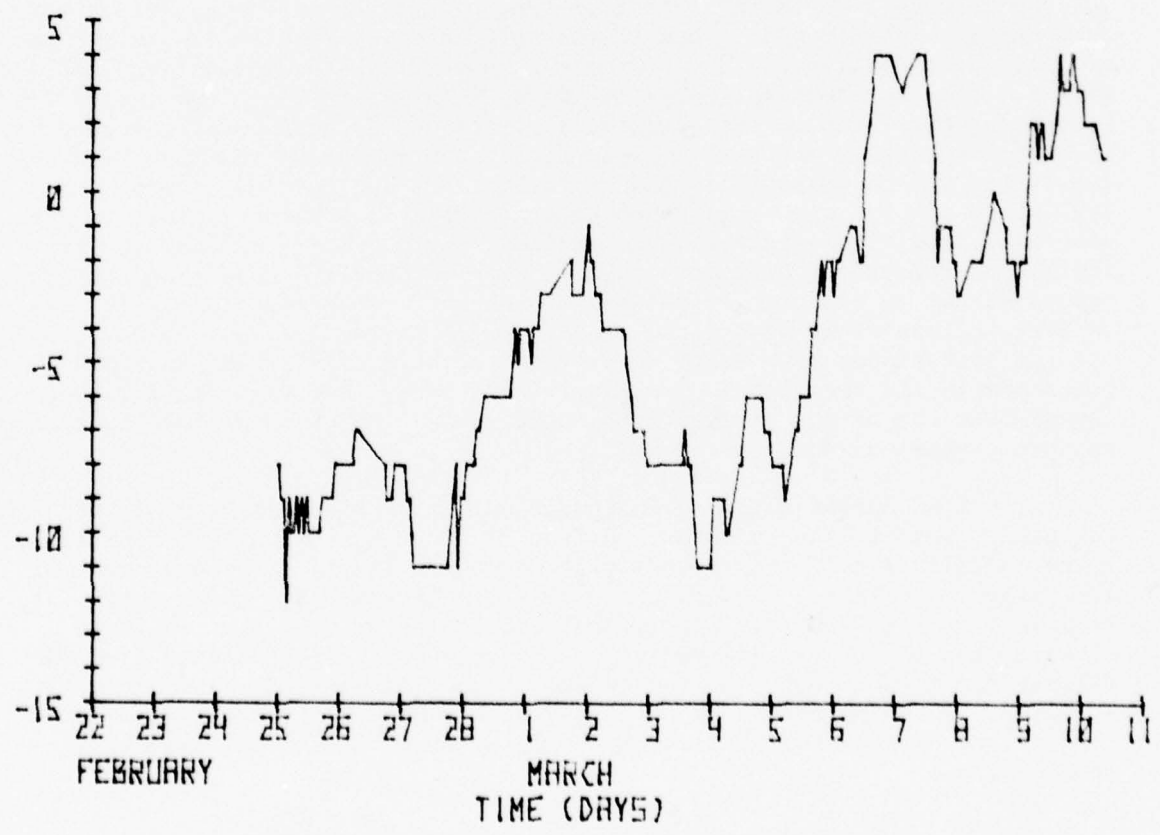
DEWPOINT AND WIND RECORDS--NAVAL WEATHER SERVICE
KEFLAVIK NAS--25 FEBRUARY-10 MARCH 1978
