**HISTORIC STRUCTURE REPORT**

# GRUBER WAGON WORKS

**PHILADELPHIA DISTRICT  
U.S. ARMY CORPS OF ENGINEERS**

**JOHN MILNER ASSOCIATES  
WEST CHESTER, PENNSYLVANIA**

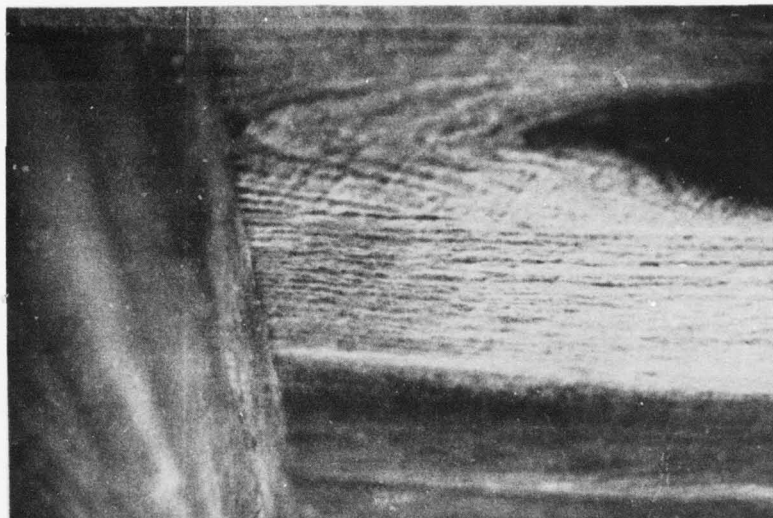
A) Fungus Indicating Early Rotting
