MISCELLANEOUS PAPER GL-79-4

## EVALUATION OF THE EFFECTIVENESS OF MEMBRANES FOR PREVENTION OF CRACK REFLECTION IN THIN OVERLAYS

March 1979

Interim Report

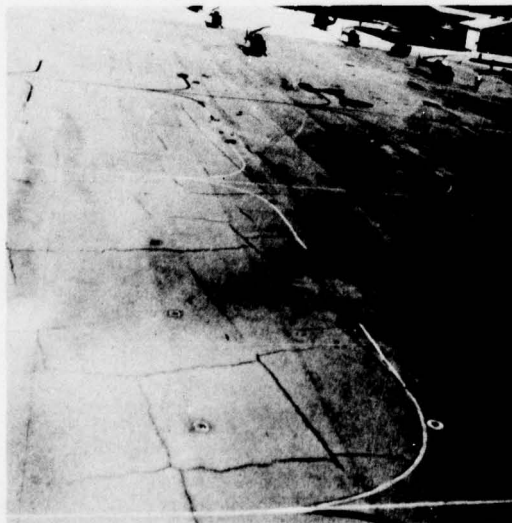
21. Background data for the pavements on Wright AAF were obtained from evaluation reports. The west apron was constructed in 1971 and consisted of 10-in. soil-cement base course with a 1-1/2-in. asphaltic concrete surface. Reflective cracking had occurred in the asphaltic surface as a result of cracks in the soil-cement base (Photo 20). The cracks had not been sealed and were about 1/4-1/2 in. wide. The pavements appeared to be structurally adequate to carry the aircraft loads.

Photo 20. Fort Stewart--crack pattern  
from soil-cement base

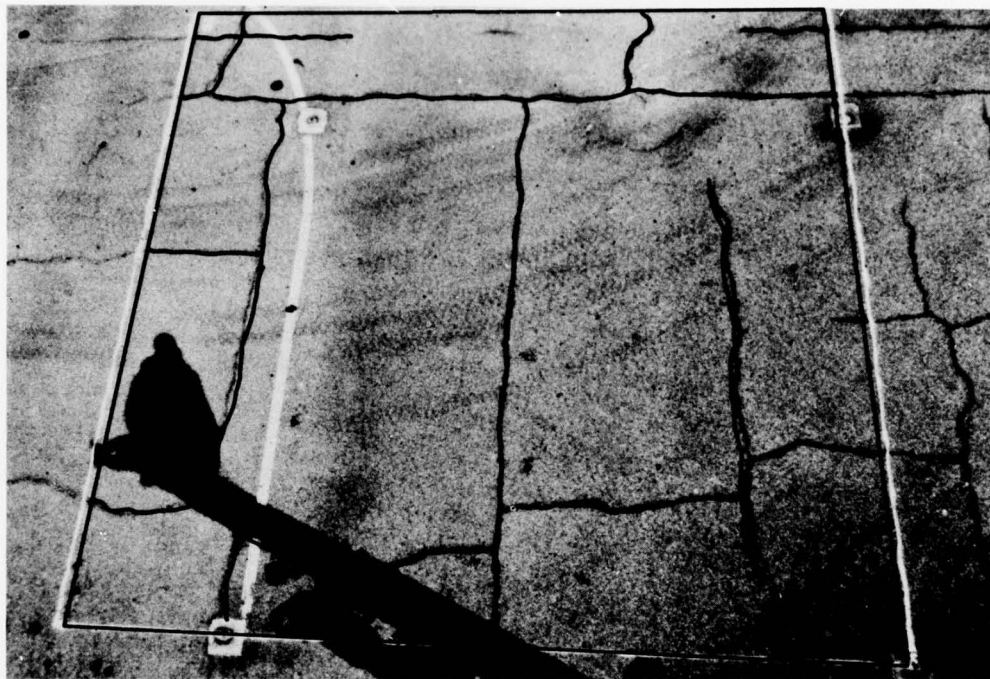
Photo 81. Fort Stewart--test square in south end  
of U. S. Rubber section
