ATLANTIC COAST BASIN
COHANSEY RIVER
CUMBERLAND COUNTY
NEW JERSEY

**SEELEYS MILL DAM
NJ 00065**

**PHASE 1 INSPECTION REPORT
NATIONAL DAM SAFETY PROGRAM**

April, 1979

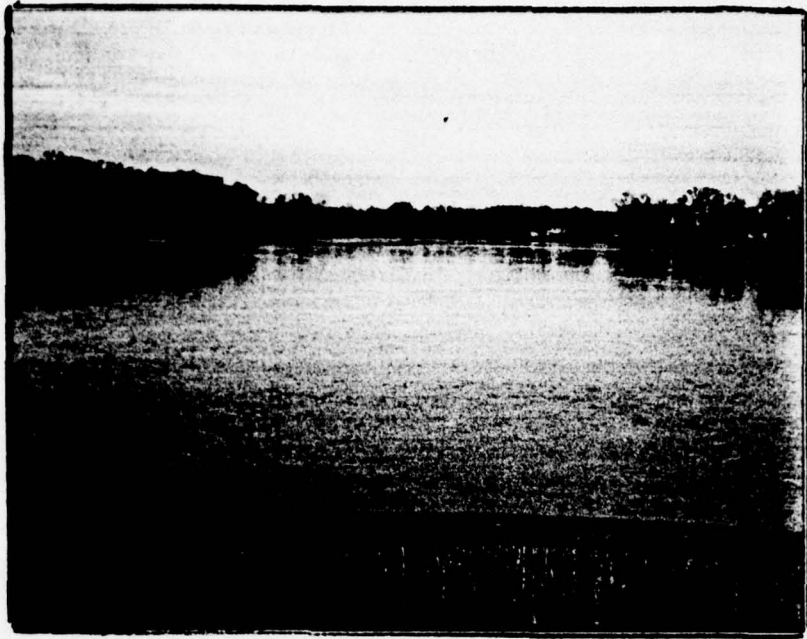
Seeleys Mill Lake

January 1979
