**LOWER LAKE NIMHAM DAM
PUTNAM COUNTY, NEW YORK**

NY 137

**PHASE I INSPECTION REPORT
NATIONAL DAM SAFETY PROGRAM**

JOSEPH S. WARD & ASSOCIATES
CONSULTING ENGINEERS
91 ROSELAND AVENUE, P.O. BOX 91
CALDWELL, NEW JERSEY 07006

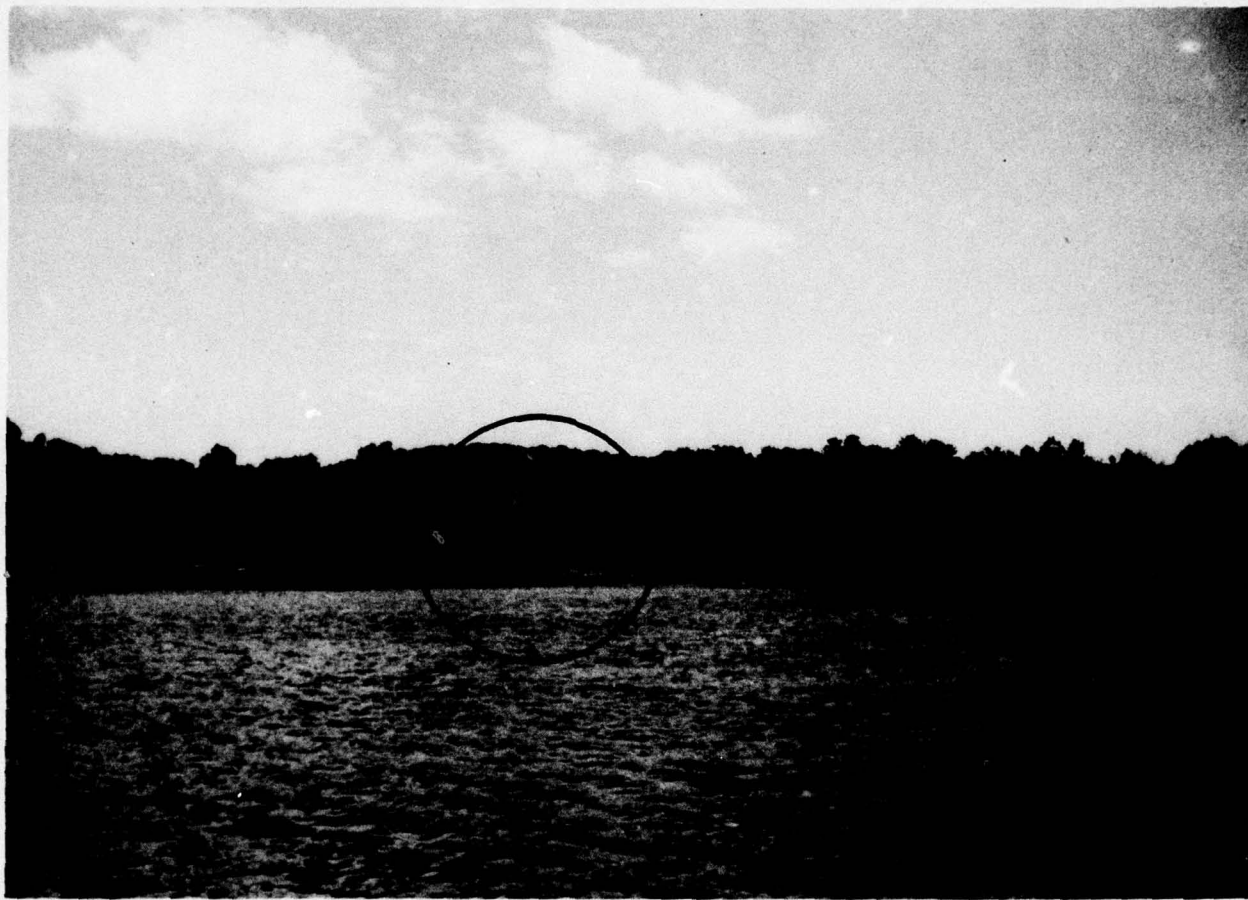
OVERVIEW - LOWER LAKE NIMHAM DAM

Based on our visual inspection, a review of the available data, and calculations performed as part of this study, the Lower Lake Nimham Dam is judged to be in generally good condition and functioning satisfactorily at this time. The spillways (drop inlet and emergency) will not collectively pass the Spillway Design Flood (SDF) without the dam being overtopped. Based on the screening guidelines established by the Department of Army, Office of the Chief of Engineers (OCE), the spillway capacity is therefore rated as inadequate. However, because there is not a high hazard to loss of life from large flows downstream of the dam at this time, the discharge capacity is not considered to be seriously inadequate based on the OCE guidelines for determining seriously inadequate spillway capacity. However, it could become seriously inadequate as future development of the area occurs. Since this assessment was based on OCE screening criteria, a detailed hydrologic and hydraulic evaluation of the watershed and spillway should be performed by the use of more precise and sophisticated methods and procedures. Following such an investigation, the need for, and type of, mitigating measures should be determined. Until such a study is completed and the spillway adequacy issue resolved, around-the-clock surveillance of the dam should be provided during periods of unusually heavy precipitation.

1. The heavy brush on the embankment and emergency spillway must be cut as soon as possible, and the condition of the vegetation maintained that way in the future. Shallow rooted trees on the embankment should be cut down; deep rooted trees should remain.
2. The gate control wheel or wrench should be located, and the two 24-inch diameter sluice gates operated to the satisfaction of NYSDEC personnel.
