**IMPACT DAMAGE ON TITANIUM LEADING EDGES FROM
SMALL HARD OBJECTS**

University of Dayton Research Institute
300 College Park Avenue
Dayton, Ohio 45469

November 1978

TECHNICAL REPORT AFML-TR-78-173

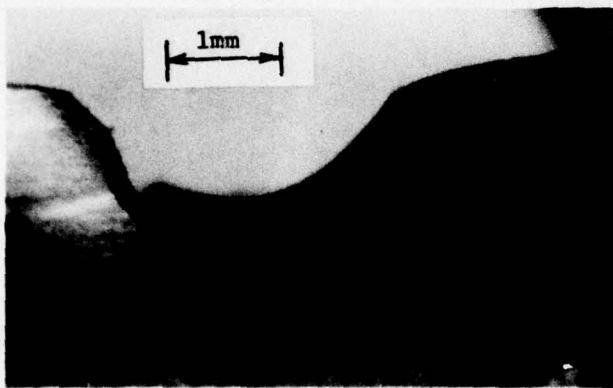
this shot was, in any case, three times the dimensions of that in Shots 8368 and 8444. Shots 8433, 8434, and 8432 all represent impacts of the largest projectile 0.125" (3.22 mm) at approximately 800 ft/s (240 m/s). Note that the worst case of damage, Shot 8432, represented a situation where the material first bulged and then apparently ripped from the extensive local deformation. The fatigue crack initiated at the rip in this case.

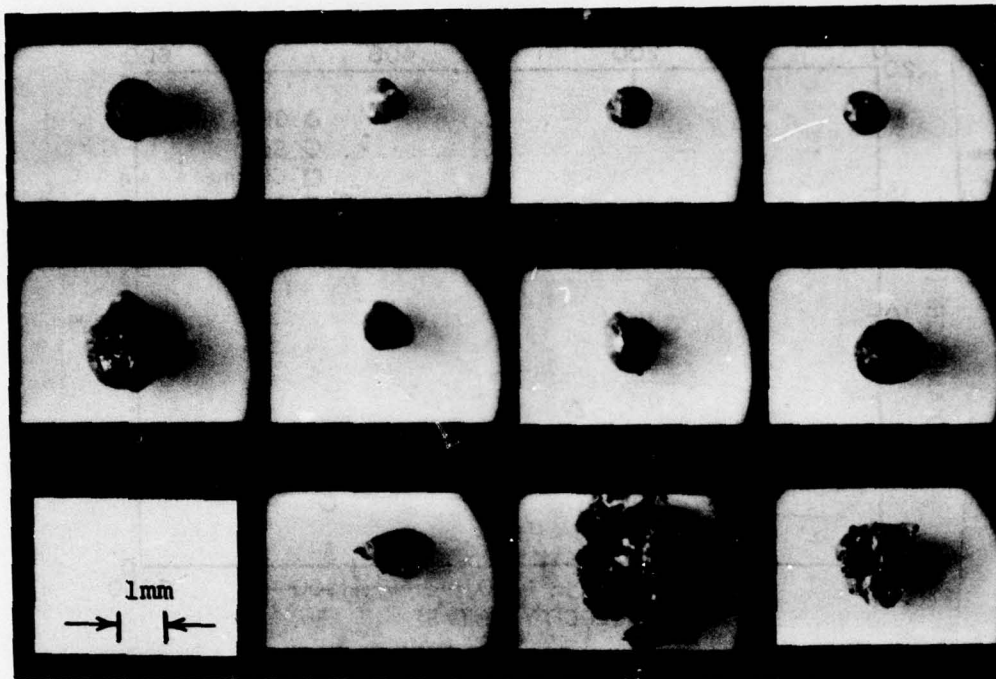
11

such matter. From each bag of debris available, a number of particles were chosen to cover the size range of the debris, not including small particles, dust, and dirt under 0.030" (0.8 mm). The particles were photographed and measured and are designated as Post-Test No. 11, 18, and 23; each particle within the group being numbered. The particles are shown in Figure 20. The test data are summarized in Table 4. Photographs of the damage as seen from the impacted side are presented in Appendix B.

Figure 20. Photographs of particles from Post-Test No. 11, 18, and 23 debris.

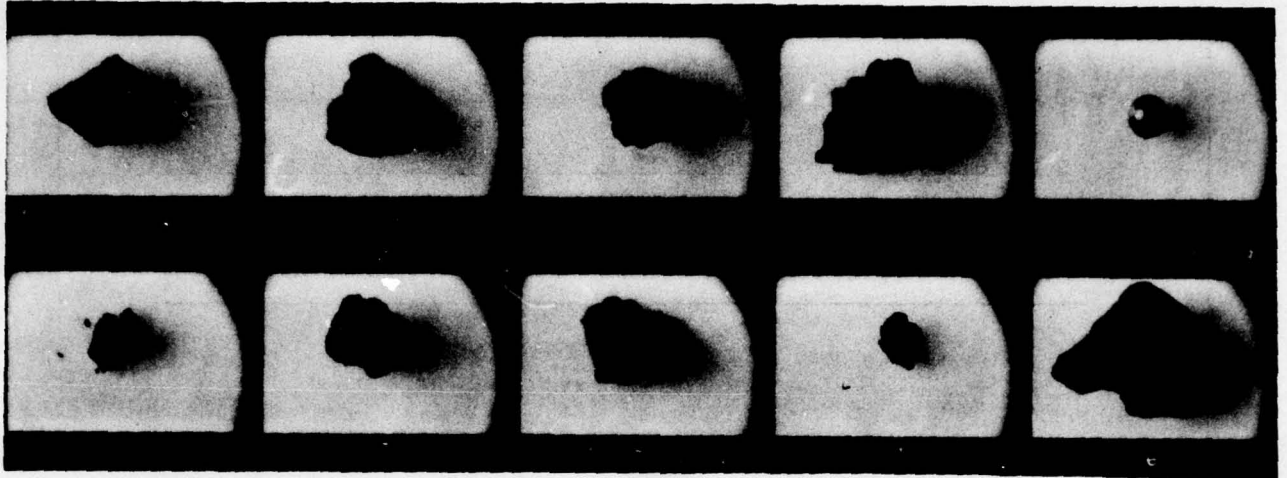
Figure 20 (Cont'd). Photographs of particles from Post-Test No. 11, 18, and 23 debris.

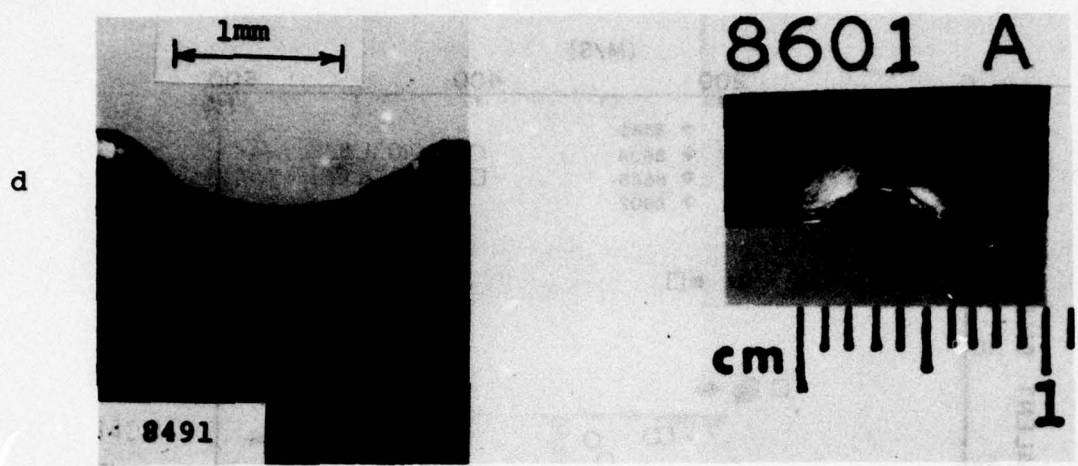
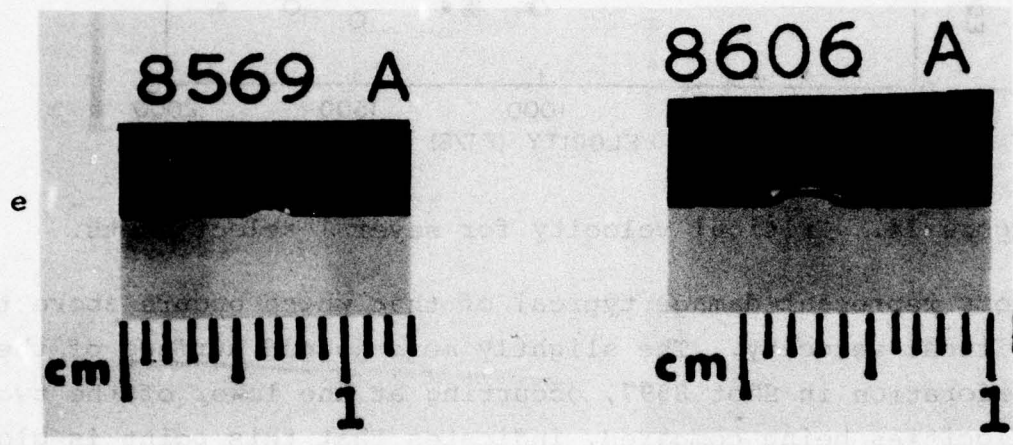
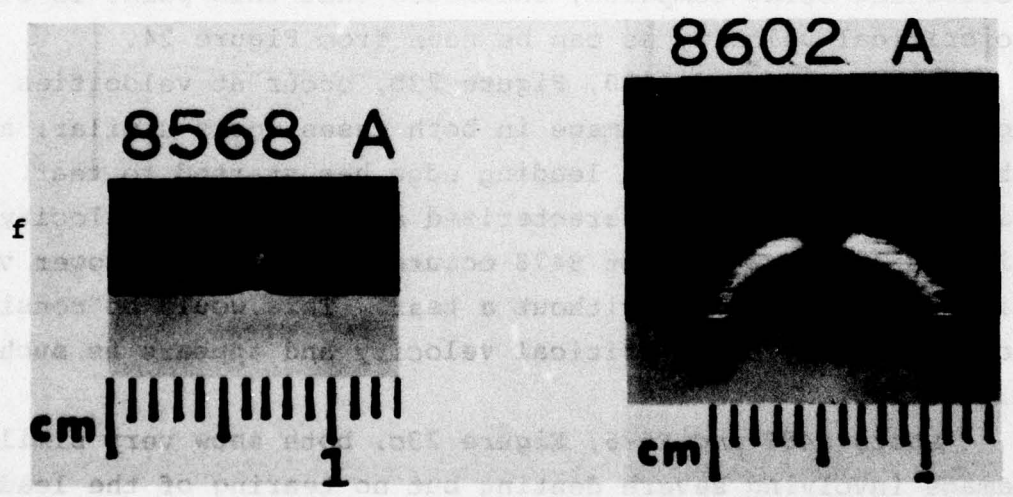
Photographs of pairs of specimens showing similar damage.

Shots 8478 and 8590, Figure 23b, occur at velocities close to one another. The damage in both cases looks similar, although in Shot 8590 the leading edge has started to tear. This was one of the shots characterized as at critical velocity, in Figures 22 and 24. Shot 8478 occurs at a slightly lower velocity and shows a dent without a tear. This would be considered to be slightly below critical velocity and appears as such in Figure 24.

Shots 8488 and 8576, Figure 23c, both show very similar damage involving severe denting but no tearing of the leading edge. The velocities of these shots are close to one another and are considered to be slightly below critical. These points, plotted in Figure 24, fall within or to the left of the scatter

Shots 8491 and 8601, Figure 23d, are a pair of shots showing very similar damage in the form of complete perforation with material removal. These points would both be expected to fall above the critical velocity. Note, however, the great difference in velocities. Although, as expected, Shot 8491 is well to the right of the critical velocity scatter band in Figure 24, Shot 8601 falls within the band. Shot 8601 is a good example of the variability in damage which can be expected and the difficulty in determining the critical velocity with a great deal of accuracy from a limited number of shots.

Shots 8569 and 8606, Figure 23e, occurred at almost identical velocities and look very similar in type of damage. Both show a crater, indicating complete perforation, although both have rather jagged features along the crater. This indicates that the critical velocity has just been exceeded. The plot of Figure 24 appears to verify this information, the two points falling within or slightly to the right of the critical velocity band.
