**INDIAN LAKE STONE DAM**

**HAMILTON COUNTY  
NEW YORK**

5 **PHASE I INSPECTION REPORT**

1 **NATIONAL DAM SAFETY PROGRAM**

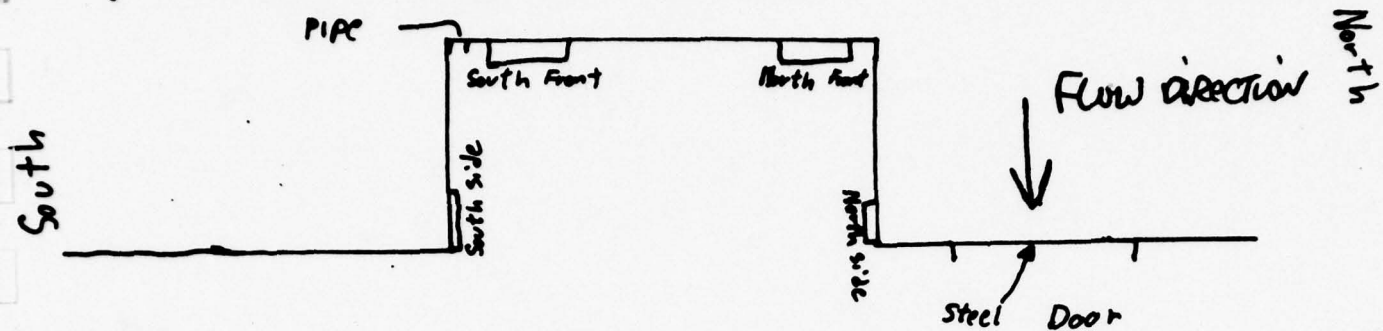
Fig. 1: Gate Location UPSTREAM

Three of the four upstream gates (North side, North front, South side) were obstructed by lake debris (see figure 1). Debris consisted mostly of broken tree limbs, logs, leaves, etc. The limbs and logs intertwined to form a net-like structure in such a fashion that the three blocked gates were not visible. (See figure 2)

Adjacent to the south front gate is a pipe opening approximately 5 inches in diameter. It is located between the south front gate and the south front corner approximately 2 inches from the bottom. It is free of any obstructions (see figure 1).

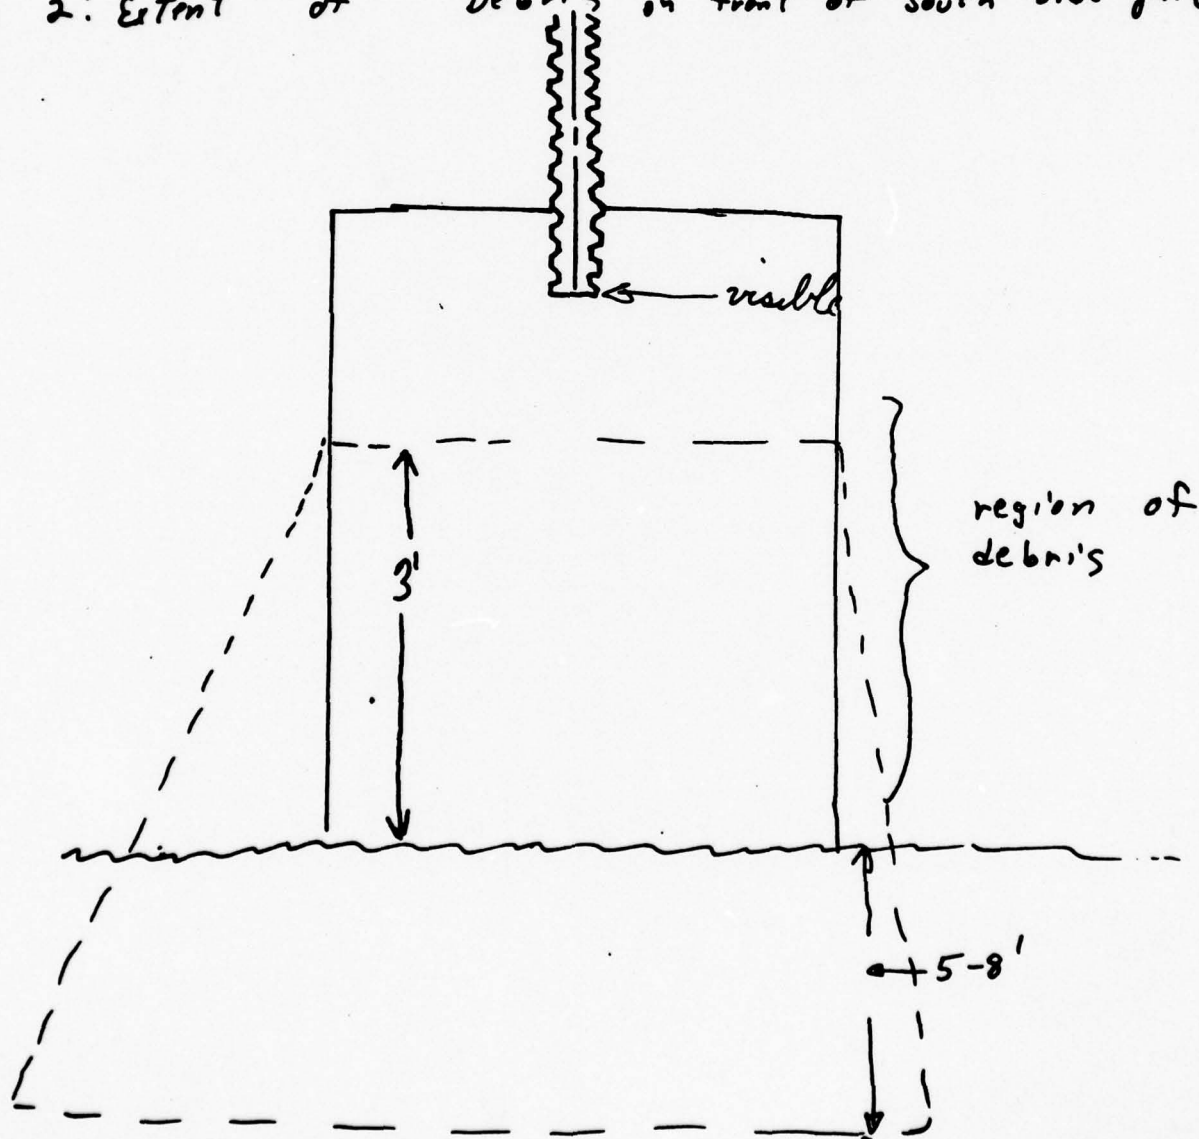
Fig. 2: Extent of Debris in front of South Side gate

DEBRIS: BROKEN TREE LIMBS, PULP WOOD, MISC HEAVY TRASH - GATE SEATS & TRACKS

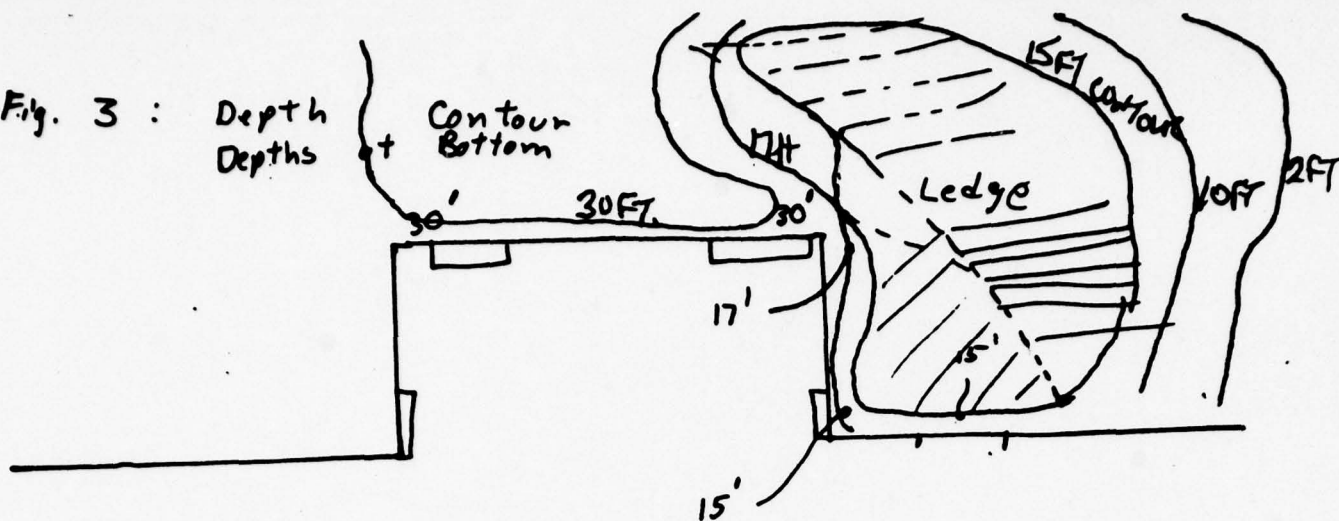
Fig. 3 : Depth  
Depths

Figure 3 shows bottom depths around the gate house structure. It also shows the steep ledge near the north gates. The ledge could act to funnel the flow of water and debris to the north gates. It is also possible that the south front gate is not operational, thus no flow and no debris. The south side gate is located at a dead flow zone. This would act to concentrate debris on the south side.

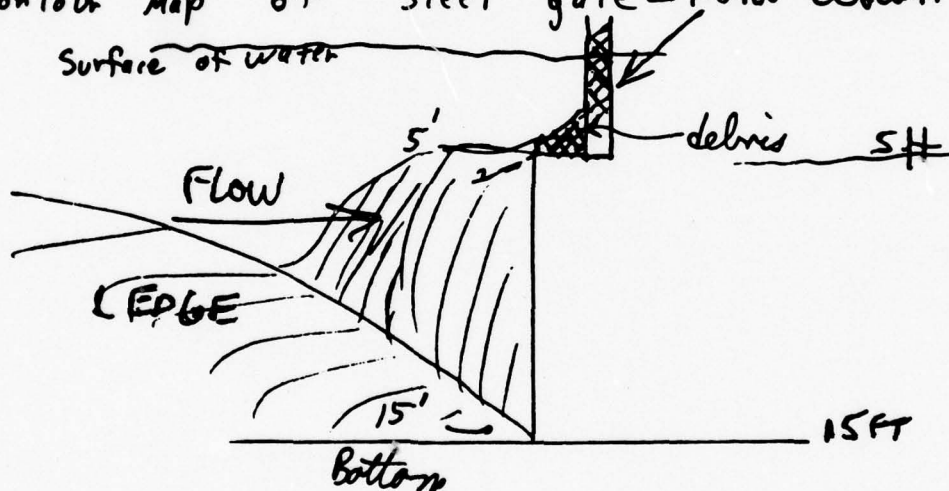
Fig. 4: Contour Map of Steel gate - MAN LOGWAY  
Surface of water

Figure 4 illustrates a profile of the steel door. The wood debris located at the obstructed gates was not evident at the base of the steel door. Salt and dirt filled in the lip as illustrated in figure 4.
