CHEMICAL AND METALLURGICAL ANALYSIS OF PROPELLANT STORAGE VESSELS

FINAL REPORT - MARCH 1978 - OCTOBER 1978

BELL AEROSPACE TEXTRON
DIVISION OF TEXTRON, INC.
P. O. BOX ONE
BUFFALO, NEW YORK 14240

FEBRUARY 1979

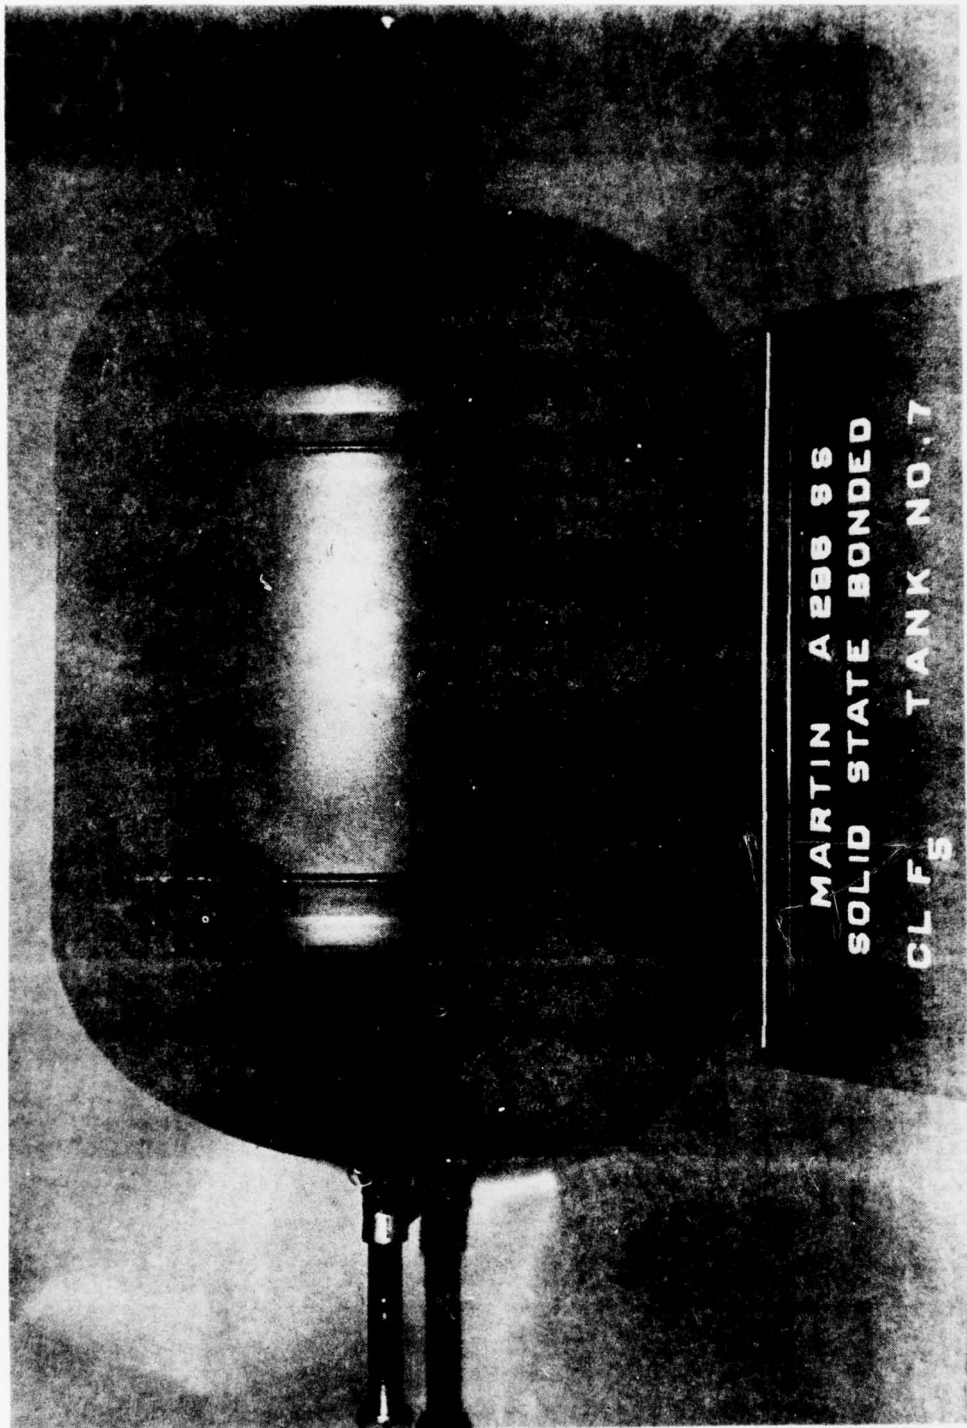
FIGURE 7. TANK NO. 7, SOLID STATE BONDED A-286, SHOWING NO APPARENT CORROSION OR OTHER DAMAGE ON EXTERIOR.

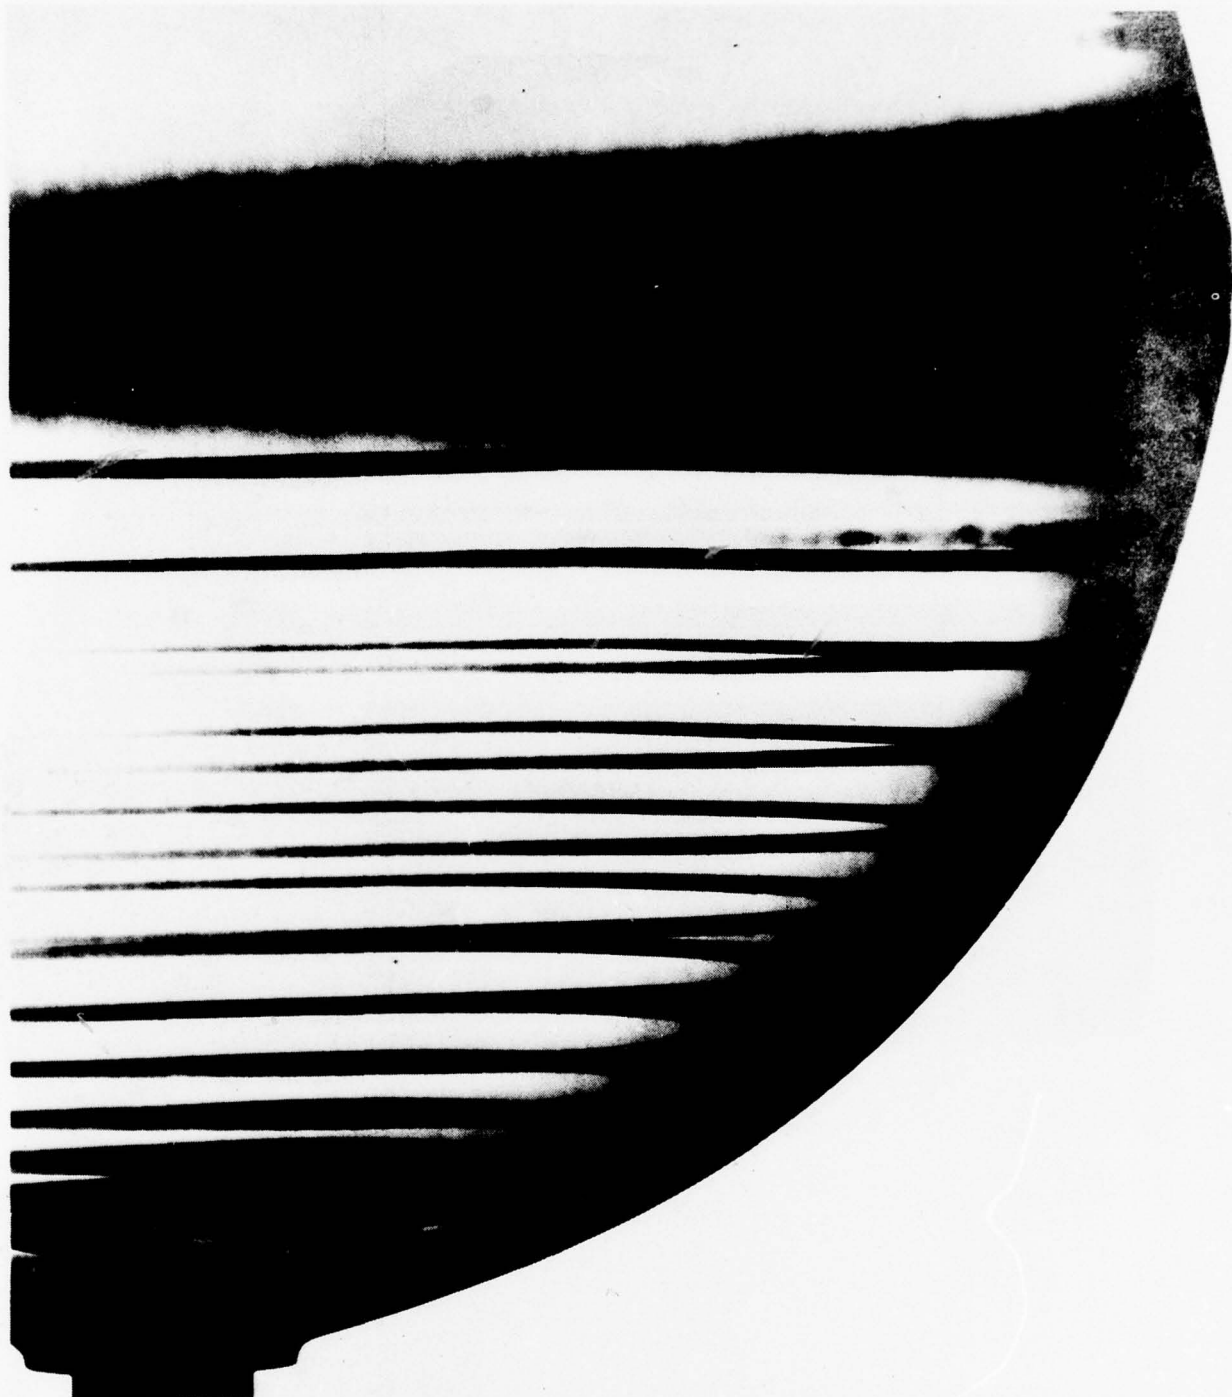
During the initial visual examination of the Arde spheres, with their internal ring-stiffened diaphragms, probing of the interior showed some of the diaphragms to be in unexpected positions. Therefore, all of these spheres were X-rayed to determine the exact location and configuration of the diaphragms. Contact prints of the X-ray film of each of these tanks in the as-received condition are presented in Figures 10 through 14. Taking the appearance of

FIGURE 10. CONTACT PRINT OF RADIOGRAPH OF TANK NO. 1, AN ARDE RING STIFFENED DIAPHRAGM TANK IN THE AS-RECEIVED CONDITION SHOWING COMPLETE EXPULSION.

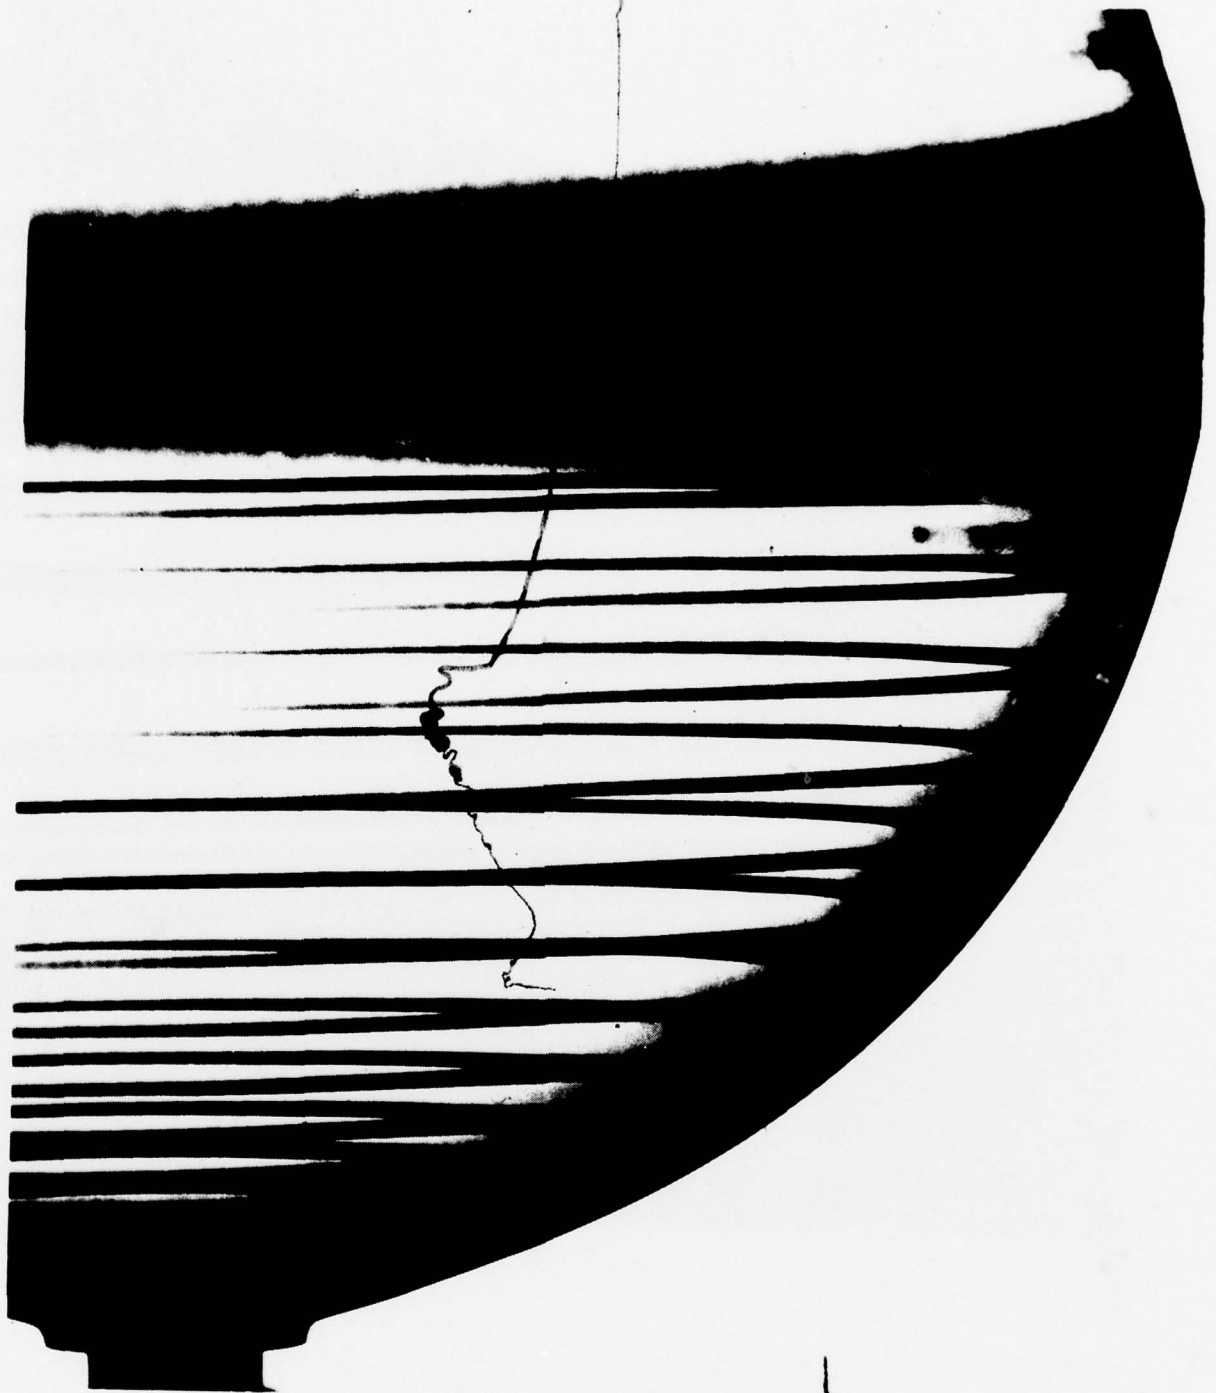
FIGURE 13. CONTACT PRINT OF RADIOGRAPH OF TANK NO. 4, AN ARDE RING STIFFENED DIAPHRAGM TANK, IN THE AS-RECEIVED CONDITION SHOWING COMPLETE EXPULSION.

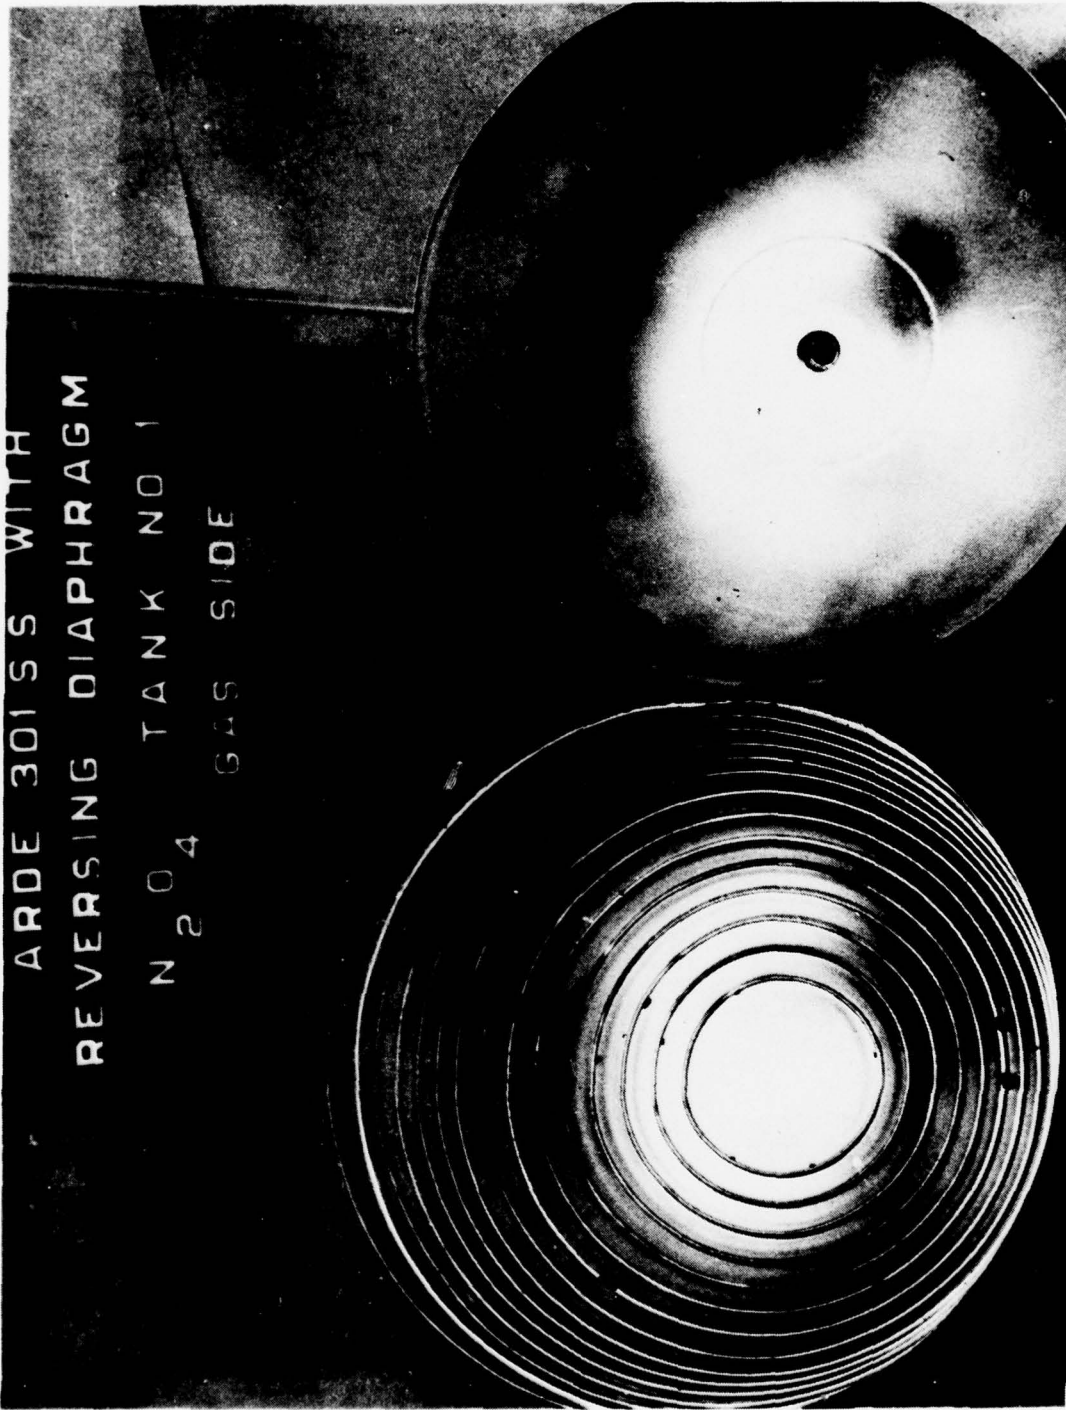
ARDE 301 SS WITH
REVERSING DIAPHRAGM
N 2 0 4 TANK NO 1
GAS SIDE

FIGURE 16. GAS SIDE OF ARDE TANK NO. 1 SHOWING INTERIOR SURFACE OF SHELL AND THE DIAPHRAGM AFTER EXPULSION.

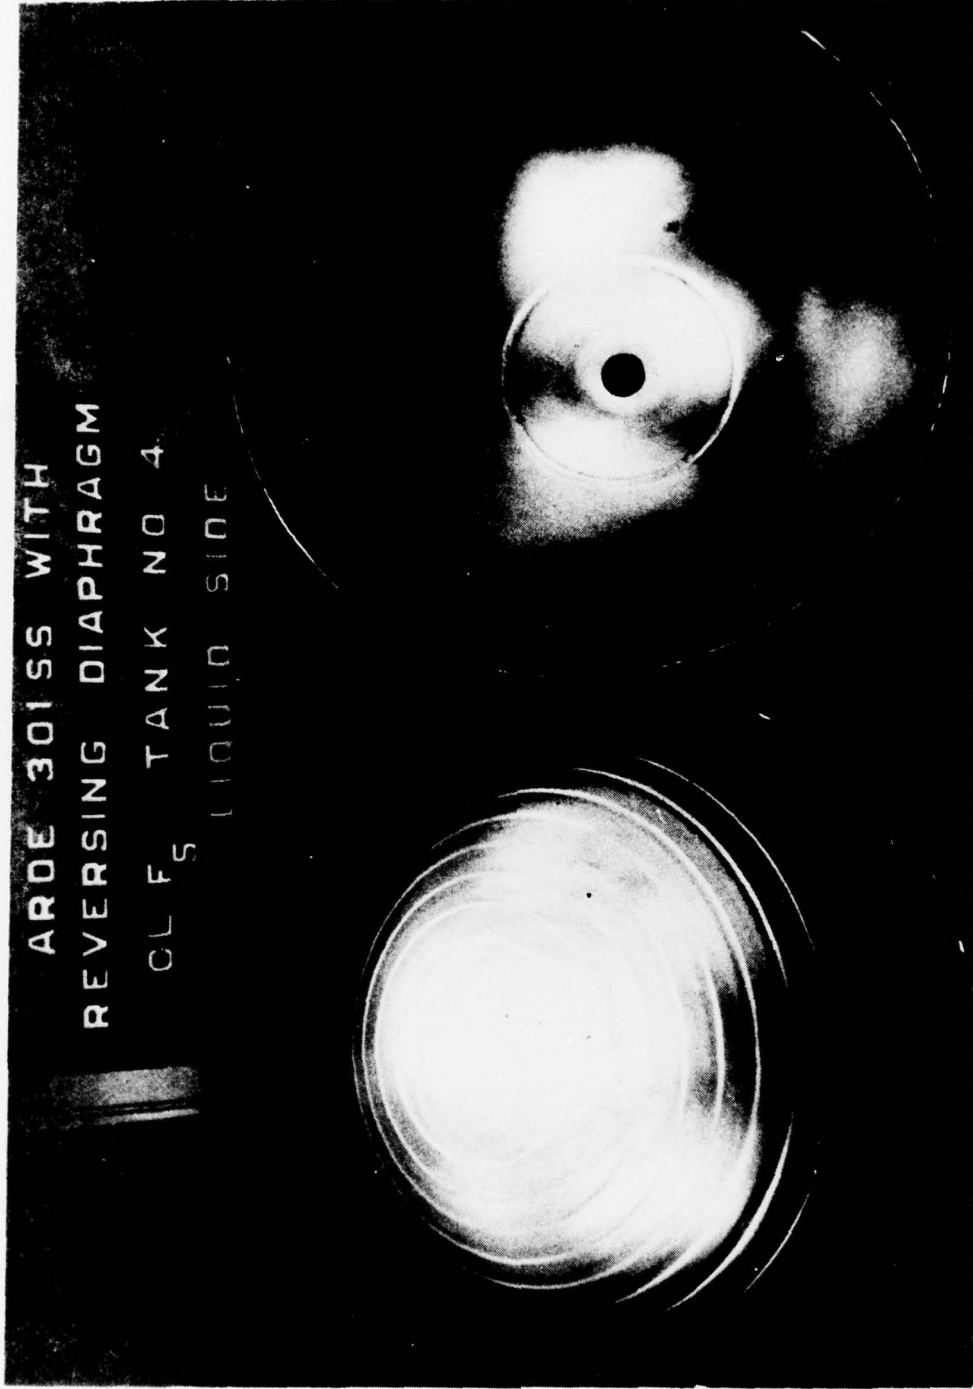
FIGURE 21. LIQUID SIDE OF ARDE TANK NO. 4. THIS TANK WAS RECEIVED IN THE FULLY EXPULLED CONDITION. SURFACES OF SHELL AND DIAPHRAGM WERE FOUND CLEAN AND FREE OF CORROSION FROM STORAGE.

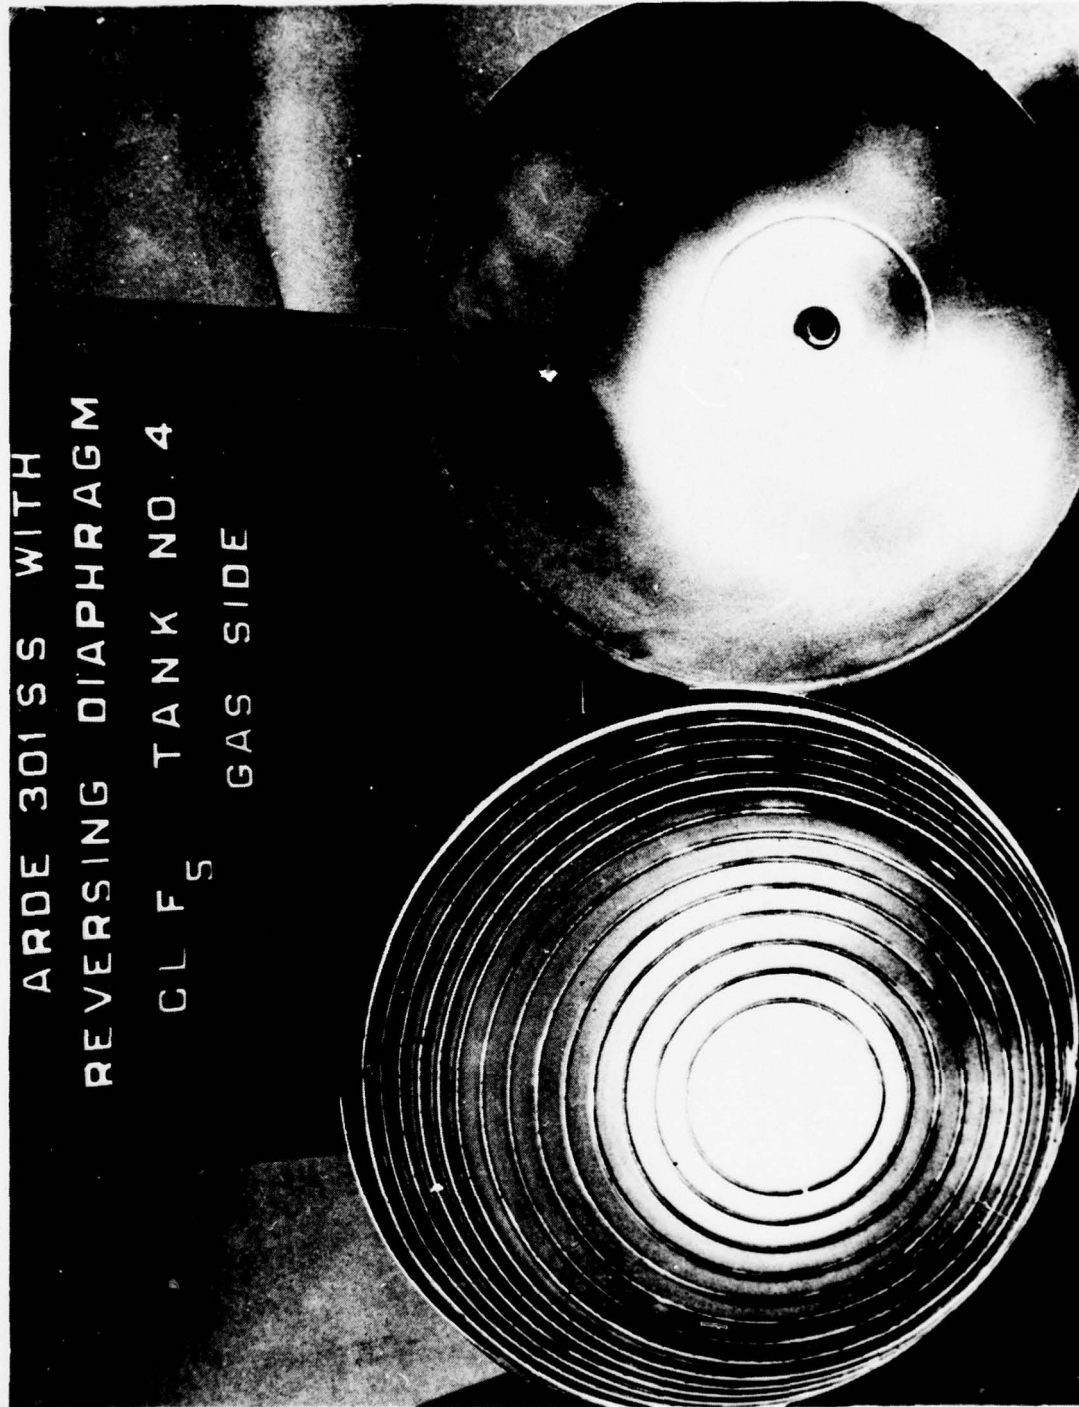
ARDE 301 SS WITH
REVERSING DIAPHRAGM
CL F₅ TANK NO 4
GAS SIDE

FIGURE 22. GAS SIDE OF ARDE TANK NO. 4. NO EVIDENCE OF CORROSION OR STAINING WAS FOUND.

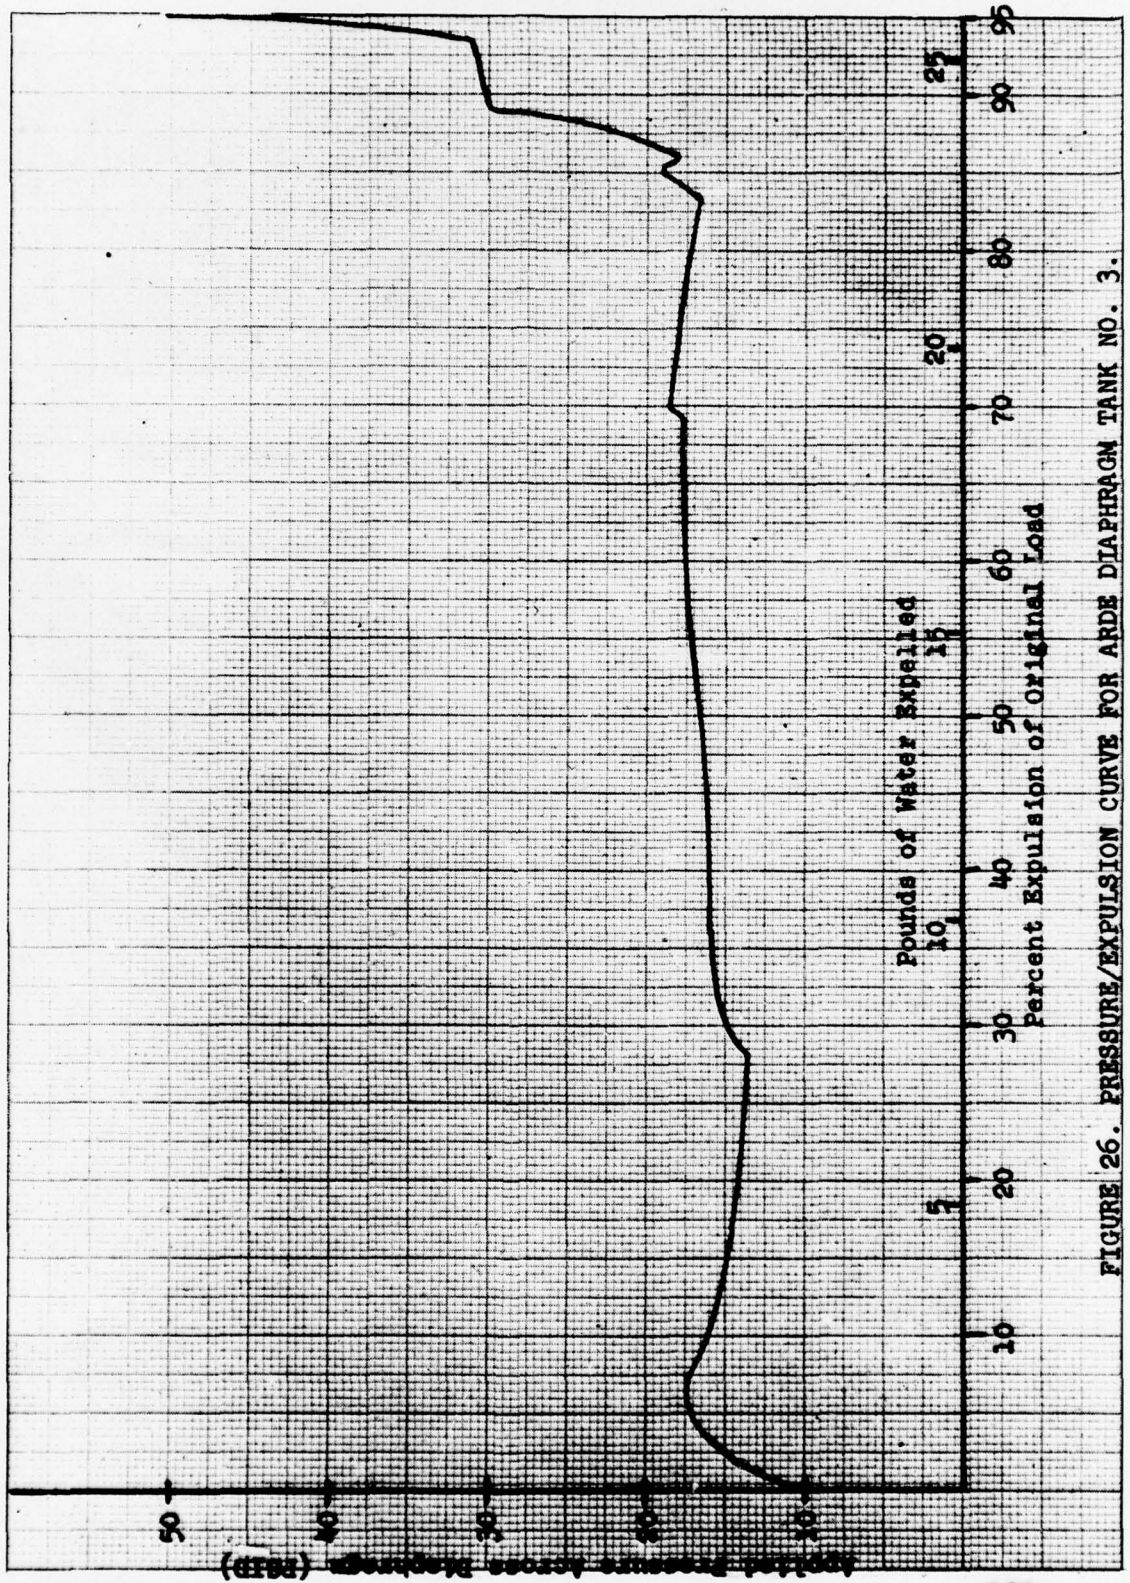
The diaphragms in both Tank No. 2 and No. 3 moved back to their "normal" position during this differential pressure leak test. This can be seen in Figure 14. With the diaphragm of Tank No. 3 now in its "normal", liquid storage position, it was possible to perform an expulsion test to determine the expulsion characteristics and efficiency of the diaphragm as a function of applied differential pressure. Therefore, Tank No. 3 was loaded with inhibited distilled water (27.12 pounds) and set up in an available expulsion test rig, that could control and monitor applied differential pressure and measure the diaphragm tank and receiver tank weight to monitor the progression of expulsion. The results of this expulsion are shown in Figure 26. It shows that no diaphragm movement occurred below 10 psid. As the pressure was raised to the 14-18 psid range, the diaphragm moved and expelled approximately 85% of the liquid. The expulsion occurred in increments as the diaphragm rolled past one or more stiffening rings in jumps. Even during this jump, the differential pressure stayed within a 2-3 psid band and was under good control.

Once the amount expelled exceeded 85% of the total liquid, the differential pressure had to be increased considerably, first to 30 psid where the last stiffening ring was passed to bring expulsion up to 93%, and finally to 50 psid where the test was stopped with 95.2% of the liquid load expelled. This is considered a good expulsion efficiency performance for a positive expulsion tank. Higher efficiencies can only be achieved with very sophisticated tank and diaphragm design. A radiograph was made of Tank No. 3 in the expelled condition and is shown in Figure 27. The

FIGURE 26. PRESSURE/EXPULSION CURVE FOR ARDE DIAPHRAGM TANK NO. 3.

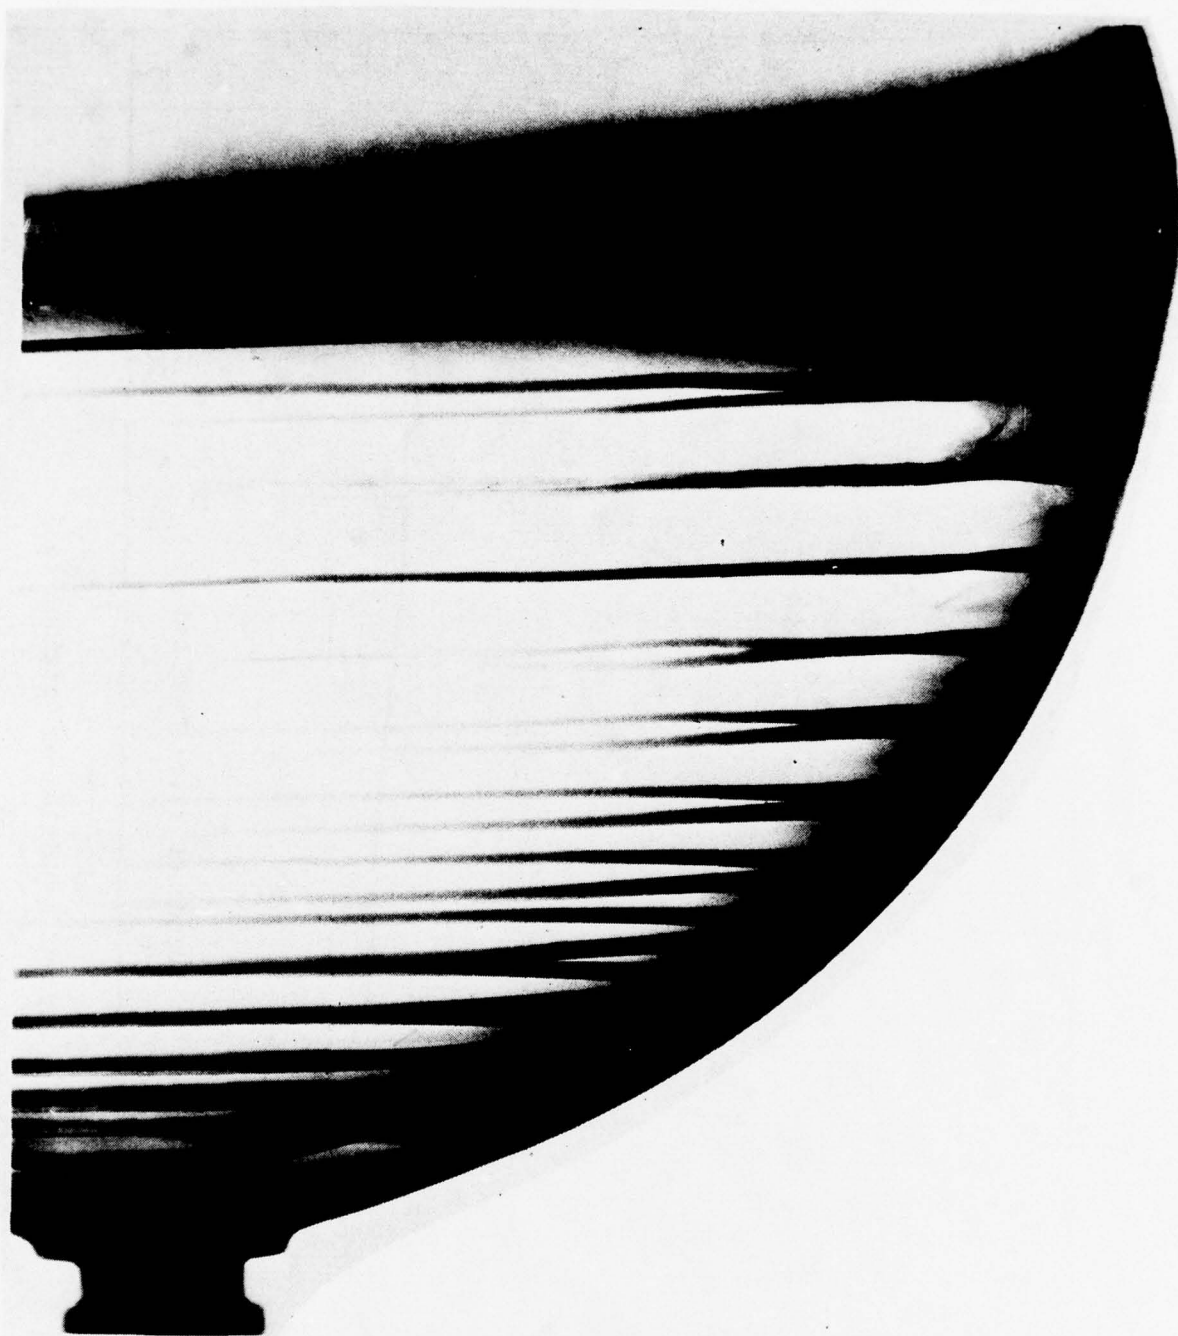
FIGURE 27. CONTACT PRINT OF RADIOGRAPH OF TANK NO. 3 AFTER COMPLETE EXPULSION AT BAT. WRINKLING AND BUCKLING OF DIAPHRAGM BETWEEN RINGS IS SEEN IN UPPER RIGHT SIDE.

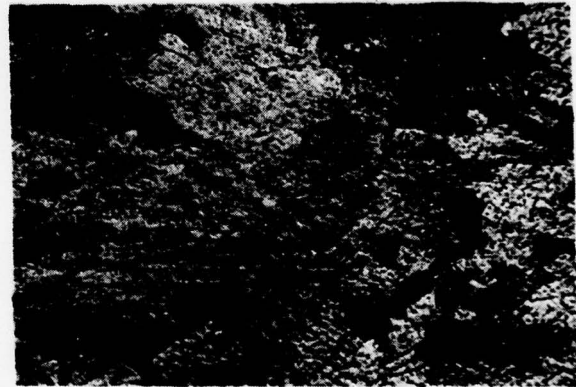
The degree of transformation occurring in the heat affected zone and in the weld structure is shown in views (c) and (d) of Figure 28. The martensitic transformation in these areas was extensive.

Dome microstructure showing transformed nature of stainless steel, structure, and lack of any directionality.

c) Edge of weld and heat affected zone showing extensive transformation through entire region.

d) Weld structure showing coarse weld grains also transformed by cryostretching.

FIGURE 28. MICROSTRUCTURE OF ARDE TANK NO. 4 IN DOME AND IN WELD JOINING DOME TO TRANSITION RING.

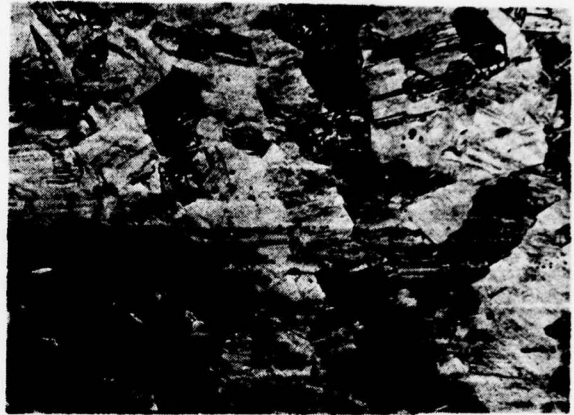
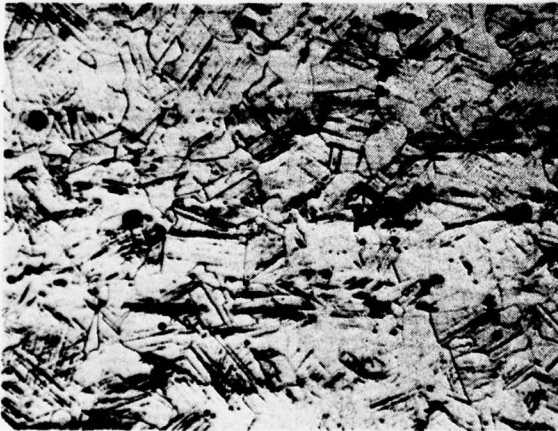
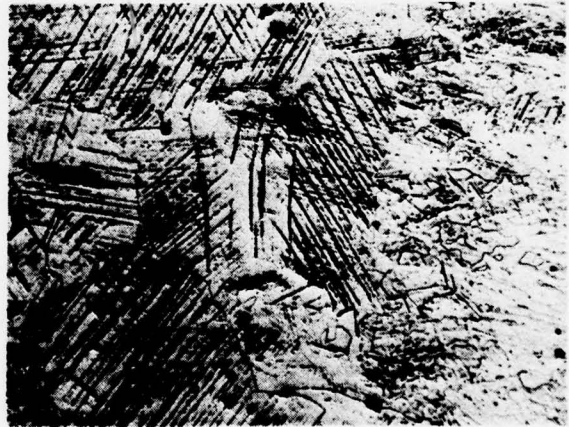
a) Structure near ring to dome weld where ring approximates dome thickness and shows structure same as dome.

b) Thicker region where transformation structure is coarser.

c) Thicker region where transformation is no longer complete.

d) Thickest portion of transition ring (at weld) where only discrete transformation has occurred.

FIGURE 29. MICROSTRUCTURE OF ARDE TANK NO. 4 IN TRANSITION RING BETWEEN DOME AND DIAPHRAGM ATTACHMENT SHOWING DECREASE IN TRANSFORMATION WITH INCREASING THICKNESS.

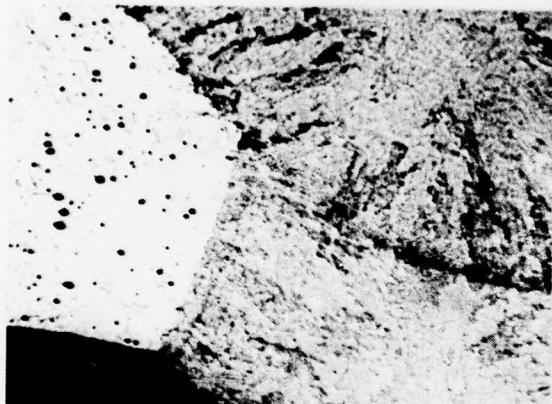
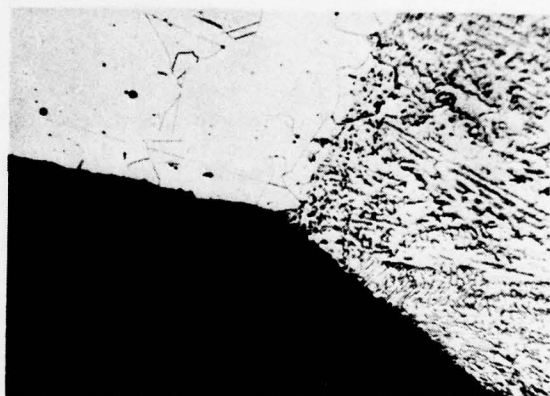
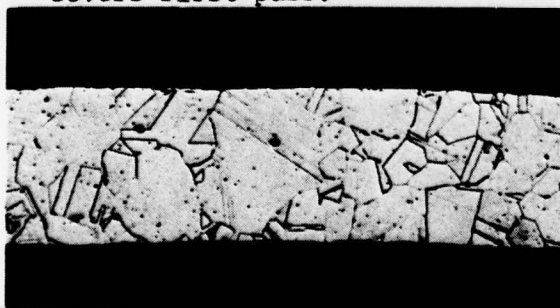
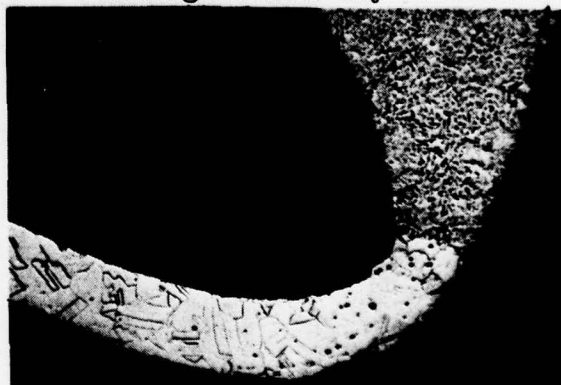
- a) Overall view of central region showing diaphragm attachment weld.

- b) Weld interface region where second pass of diaphragm attachment weld covers first pass.

- c) Closeup view of edge of weld on propellant side showing lack of any corrosion.

- d) Cross section and microstructure of diaphragm leaf showing typical stainless steel structure.

- e) Critical region at diaphragm to weld edge showing no cracks or degradation.

FIGURE 30. VIEWS OF DIAPHRAGM ATTACHMENT REGION IN ARDE TANK NO. 4 ILLUSTRATING THE SOUND WELD AND LACK OF ANY PROPELLANT INDUCED CORROSION.

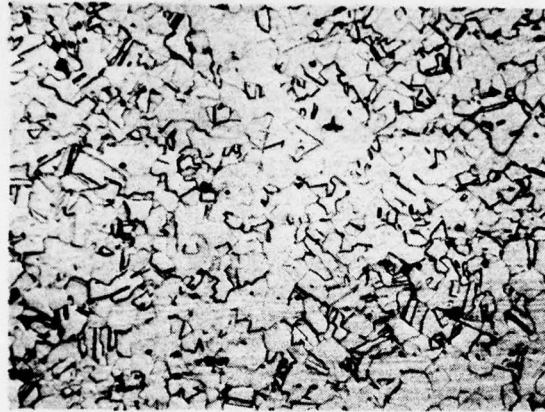
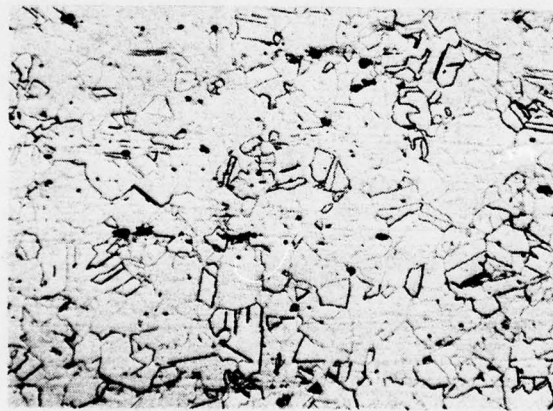
FIGURE 31. MICROSTRUCTURE OF A-286 STAINLESS STEEL SHEET USED
TO FABRICATE MARTIN TANK NO. 5.

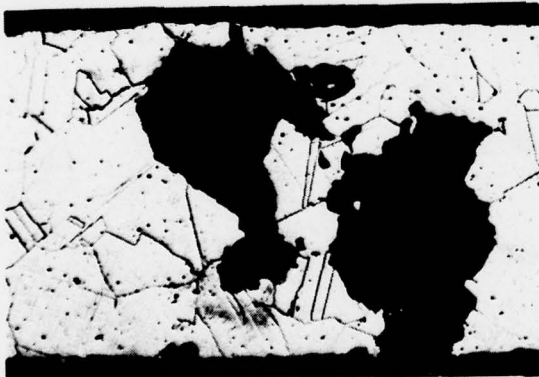
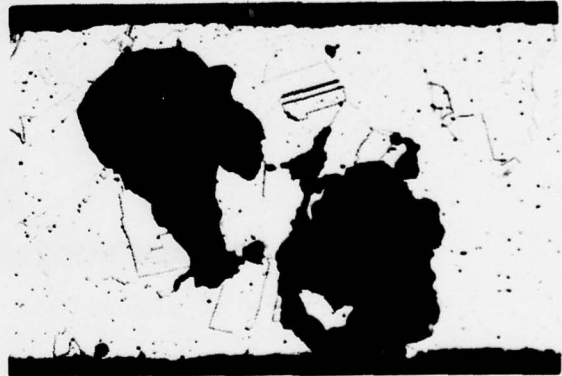
FIGURE 35. ADDITIONAL CROSS SECTION VIEWS THROUGH LEAKING DEFECT.

a) Section 0.0175 inch beyond initial site. In the 0.009 inch region between last view and this, corrosion cavity became very small. This area is associated with second pit seen in view (a) of Figure 34.

b) Section 0.0185 inch beyond initial site. Corrosion is approaching gas side surface for first time.

c) Section less than 0.001 inch beyond view (b). This is only location where penetration to gas side is seen.

d) Section 0.001 inch beyond view (c). Gas side penetration has disappeared already.

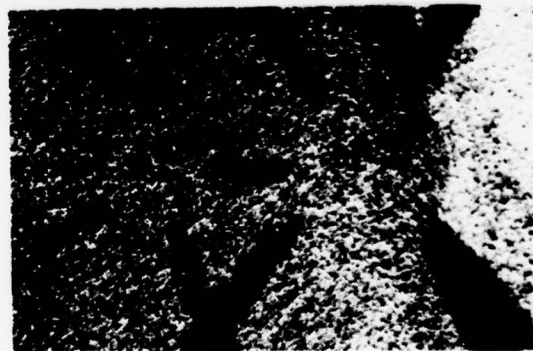
The diaphragm from Tank No. 2 was also closely examined with fluorescent dye penetrant by applying to the propellant side, allowing the dye to sit overnight and using developer on the gas side. This procedure identified at least two additional leak sites. As with the sites identified by radiographs, the propellant side showed a minor pit while the gas side showed no visible evidence of any defect, even though the areas could be well located by the faint dye indication. This area is shown, from both sides, in Figure 39.

FIGURE 39. SURFACE VIEWS OF LEAKING DEFECT FOUND BY FLUORESCENT PENETRANT SEEPING THROUGH DIAPHRAGM OF TANK NO. 2.

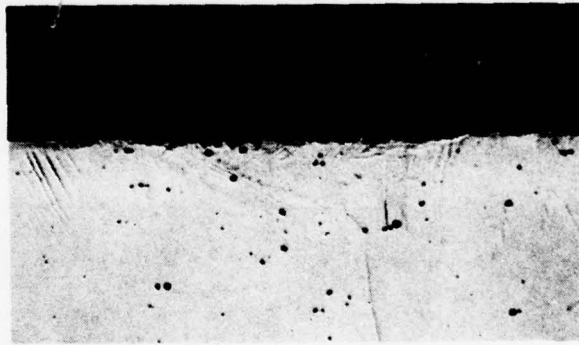
b) Region after light polishing with 600 grit paper to remove surface layer.

FIGURE 40. AREA NEAR APEX OF DIAPHRAGM IN ARDE TANK NO. 4 WHICH SHOWED A DYE PENETRANT INDICATION WHICH HAD NO SIGNIFICANT DEPTH NOR WAS A TRUE PIT.

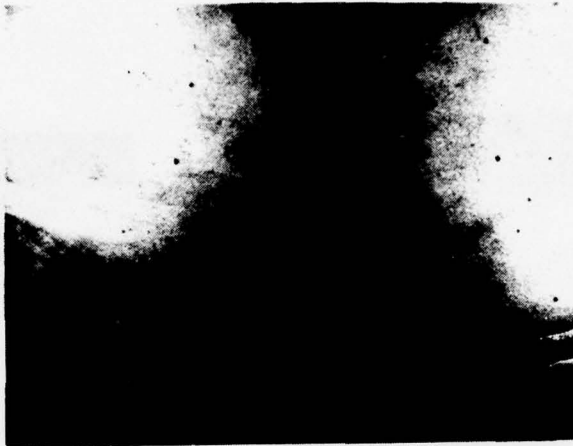
The dark spot on the shell of Arde Tank No. 1 which had been identified in the initial visual examination is shown in view (a) of Figure 41. Visible around this dark spot are numerous, very small dots which turned out to be pits. When this region was examined at higher magnification, View (b) of Figure 41, it was seen that this pitting was quite extensive, some of the pits being rather shallow, others appearing to be quite deep. The pitting on Tank No. 1 occurred over much of its exterior

- a) Overall view in area of dark spot on shell. Pits are barely visible.

FIGURE 41. VIEWS OF PITTING ON EXTERIOR SURFACE OF SHELL OF ARDE TANK NO. 1.

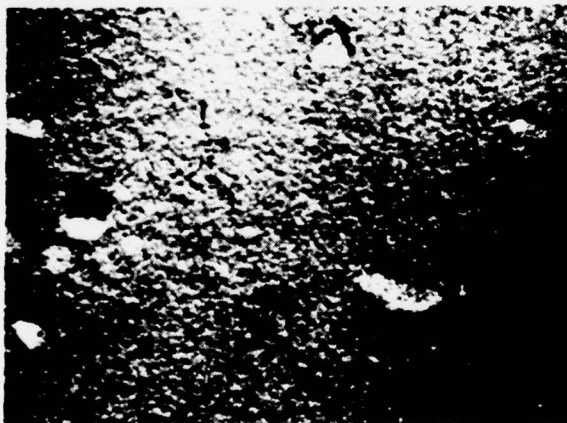
- b) Detail view showing that pits varied from very deep to shallow.

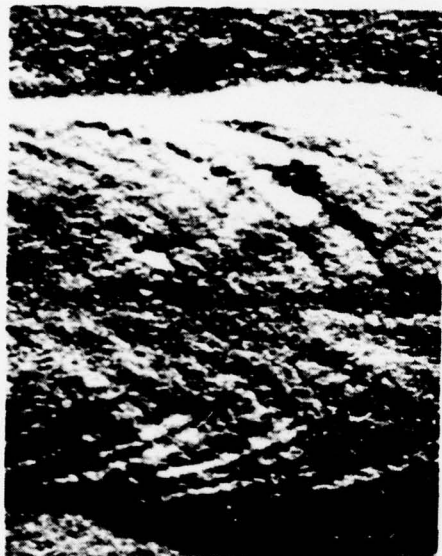
a) View of weld surface showing pits. All pits seen of weld surfaces appeared relatively shallow.

FIGURE 42. PITTING IN SHELL WELD FROM ARDE TANK NO. 1.

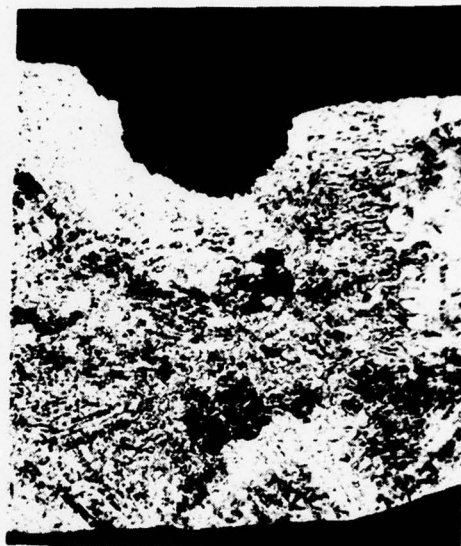
When selected pit areas from two of these tanks were sectioned and examined for depth and configuration of the pits, the results in view (b) of Figures 42 through 44 were found. In general, the pits were of a hemispherical or spherical nature, extending as deeply into the shell thickness as they did around the surface. Some areas, however, contain very deep pits, an example of which is shown in Figure 43. This particular pit in Tank No. 1 extended approximately three-quarters of the thickness of the shell and undercut the surrounding surface beyond the pit area quite extensively. When the sectioning was continued farther from the visible surface pit, it was found that the internal pit had become a large internal cavity. This internal cavity encompassed over 80% of the thickness of the shell at this point and extended over an even greater width than that. There was some evidence that the internal cavity was extending along internal inclusion bands since there is some etching out of an inclusion band in the lefthand portion of the cavity as seen in view (c) of Figure 43. Other than this extension along the inclusion stringer, there was no preferential metallographic attack in these pits. They appear to consist simply of dissolution of the stainless steel matrix in an ever increasing volume. There was no intergranular cracking or transgranular cracking as might be expected from stress corrosion. There was also no crack extension or grain boundary penetration ahead of the major cavity in any of these areas. When sectioning through a pit in a shell weld, view (b) of Figure 42, even in this instance where a rather coarse microstructure could promote intergranular cracking or inter-

b) Cross section through typical pit in weld.

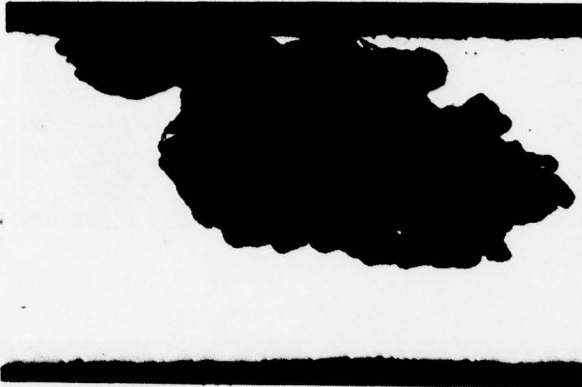
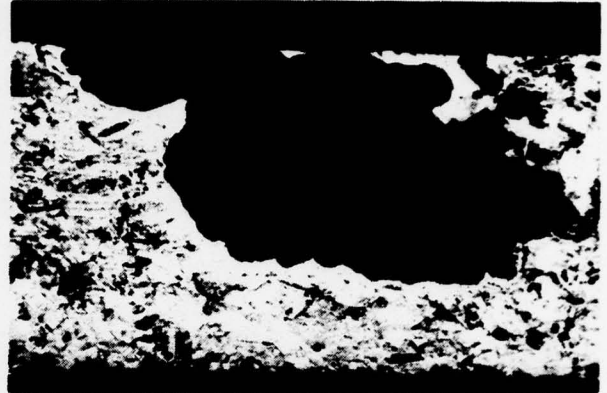
a) Unetched view showing absence of intergranular or other penetration ahead of main pit.

b) Etched view showing pit in matrix of cryostretched material.

FIGURE 43. SECTIONS THROUGH DEEP PIT FOUND NEAR DARK SPOT OF ARDE TANK NO. 1.

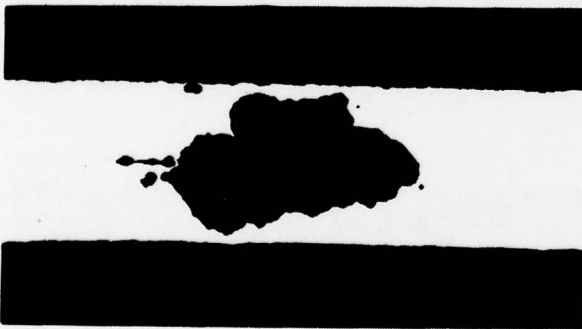
c) Views of pit after polishing 0.010" farther from above views. Pits never penetrated through to interior surface to become a leak.

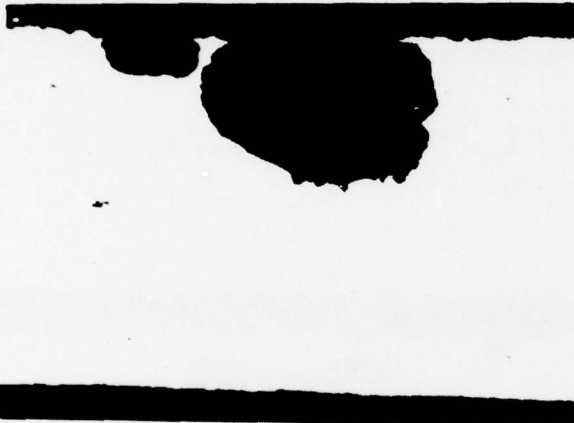
c) Section through double pit portion of region.

FIGURE 44. PITS IN SURFACE OF ARDE TANK NO. 3.

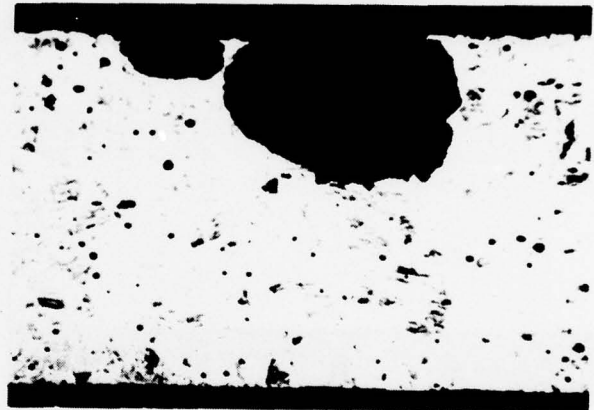
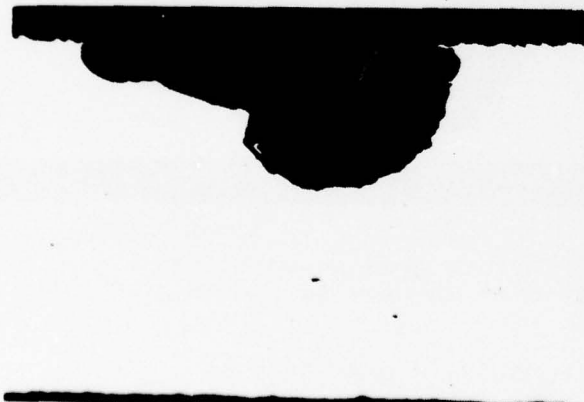
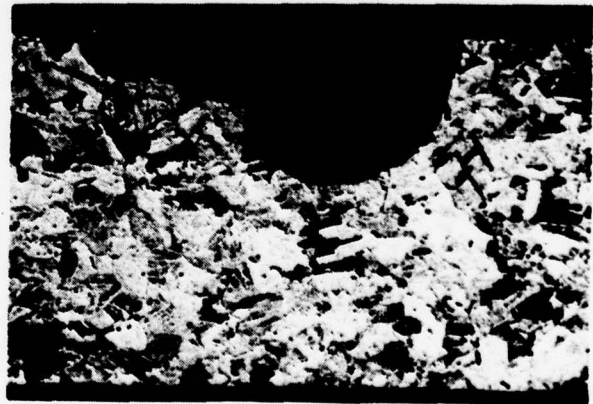
d) Section where pits have joined into single cavity.

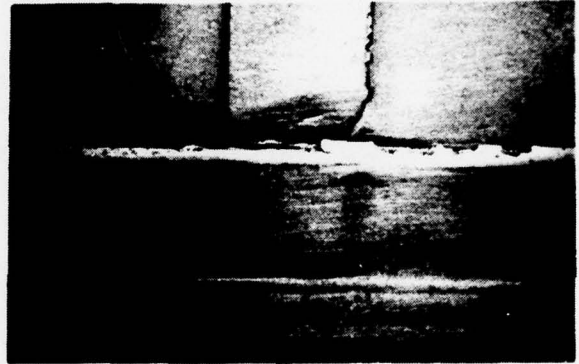
b) Lower circumferential bond joint at overlap with longitudinal cylinder joint.

FIGURE 45. VIEWS OF EXPLOSIVE BOND SURFACE APPEARANCE IN SELECTED AREAS FROM A-286 TANK NO. 5.

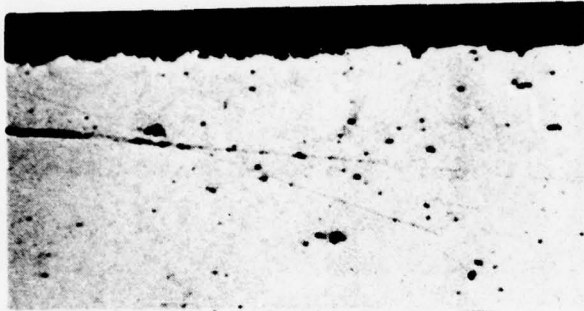
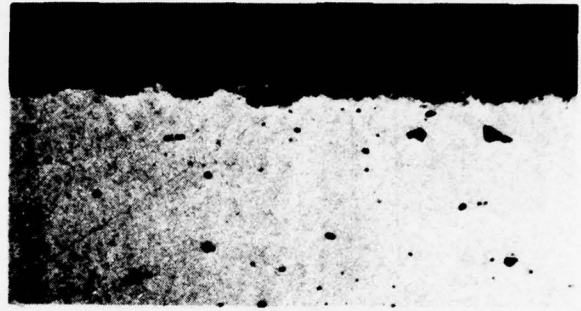
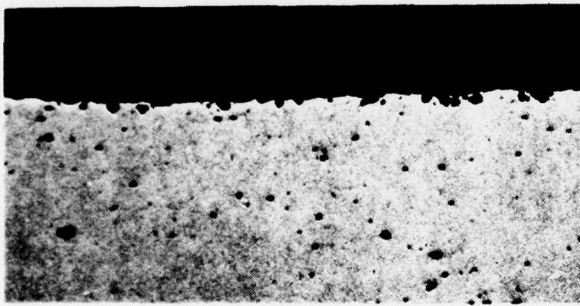
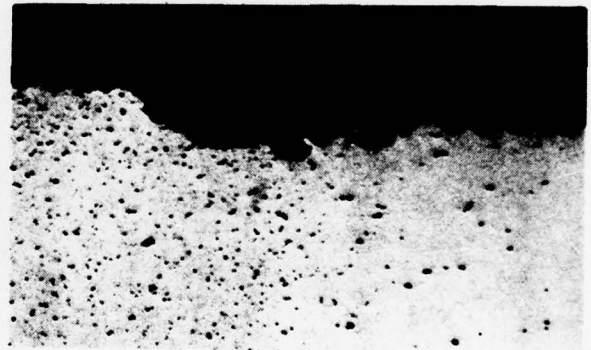
In all cases the interior surfaces of the A-286 showed a frosting or etching, which varied in degree from area to area within a tank shell. The A-286 tank identified as Tank No. 5 possessed surface staining along the bond overlaps to a somewhat greater degree than the other A-286 tanks in this program. As shown in Figure 45, staining occurred at the edge of the solid state bond, and on the surface of the overlap area of the bond. It can also be observed that the internal surface views (a) and (b), Figure 45, were sanded or ground after the bond was made. The external surface edge showed irregularities along the edge of the joint in the circumferential direction and at the area of crossover. A crossover is formed when a dome is bonded to a barrel that contains one or more longitudinal bonds. The edge irregularities were of concern since they gave the impression that localized corrosion could have taken place in this area, although at first glance one could also form the impression that they were mechanically formed, being characteristic of this type of bond. At the crossover area, view (b) of Figure 45, on the inside surface a weld patch existed which is shown at higher magnification in view (c) of Figure 45. Cross sections of the various areas are shown in Figure 46. These views at a 100X magnification show that along the edge of the bond, in

a) Near inner edge of bond overlap.

b) In central portion of bond overlap.

c) In base metal away from bond.

d) At edge of weld patch shown in Figure 45, view c.

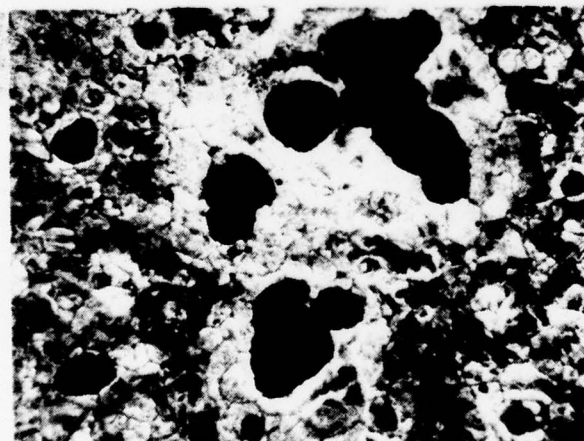
c) Detail view of surface pitting.

FIGURE 47. PITTING ON PROPELLANT SIDE OF OUTLET FITTING FROM TANK NO. 5 SHOWING IT TO BE THE RESULT OF END GRAIN ATTACK OF THE 321 STAINLESS STEEL BAR STOCK.

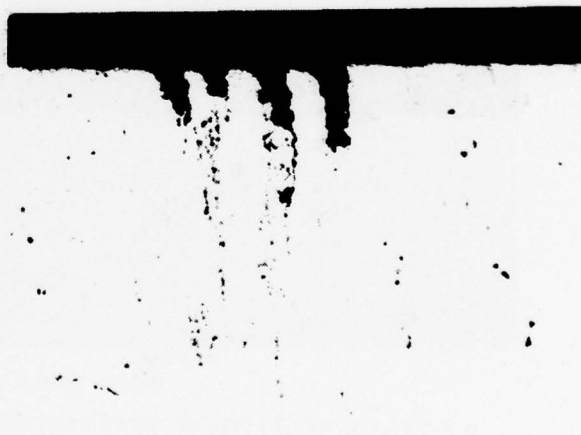
d) Cross section showing pits following intermetallic or inclusion stringers.
