CHEMICAL AND METALLURGICAL ANALYSIS OF PROPELLANT STORAGE VESSELS

FINAL REPORT - MARCH 1978 - OCTOBER 1978

BELL AEROSPACE TEXTRON
DIVISION OF TEXTRON, INC.
P. O. BOX ONE
BUFFALO, NEW YORK 14240

FEBRUARY 1979

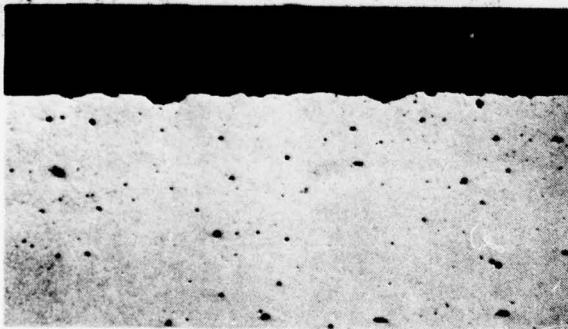
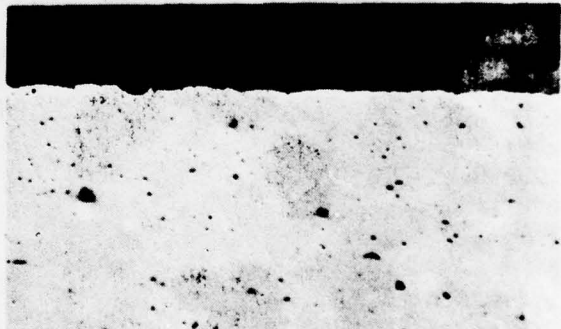
- c) Cross section at surface on waterline showing some shallow pitting. d) Cross section at surface approximately 1" from waterline showing similar pitting.

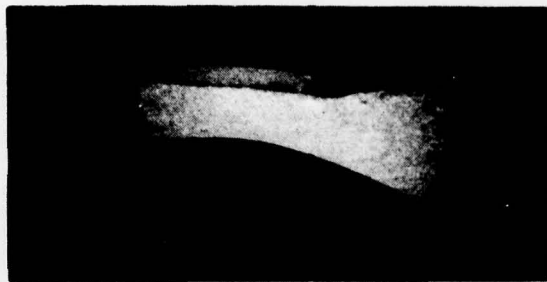
Close examination of the bonded tube near the split view (b) of Figure 49, shows that there are severe strain effects in all of the region around the maximum bulge of the tube. When the defect area of the bonded tube was sectioned (Figure 50), the defect was seen to be definitely mechanical in origin with the split occurring along a 45° shear plane adjacent to the maximum strain region in the bond. There are small secondary splits visible, views (b) and (c) of Figure 50, which are transverse fissures at inclusions. There are considerable strain effects visible at these inclusion stringers probably due to their effects as discontinuities when the explosive shock waves are passing through the material. These small fissures or splits may actually have preceded and initiated the main split. In the Martin-Denver report documenting the development of the bonding process, Reference 7, they report some difficulty with bonding of this tube and fitting because of extensive inclusions. The inclusions are discernible in view (c) of Figure 50. A cross section along the tube to fitting bond, 180° away from the split, is shown in Figure 51. The views of Figure 51 show that there were considerable inclusions in this portion of the tube also. Along the widest part of the expanded tube joint there were 45° shear strain indications in this section 180° from the split. These are shown by the arrow in view (c) of Figure 51.

- a) Overall section view showing split to be just before maximum recess in fitting.

FIGURE 50. CROSS SECTION THROUGH TORN UPPER TUBE ILLUSTRATING THE 45° SHEAR, MECHANICAL FRACTURE APPEARANCE, TANK NO. 5.

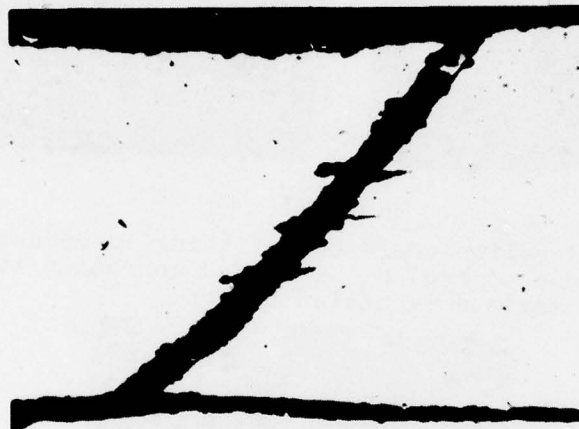
- b) Detail view of split showing lack of any corrosion. Transverse fissures are at inclusions.

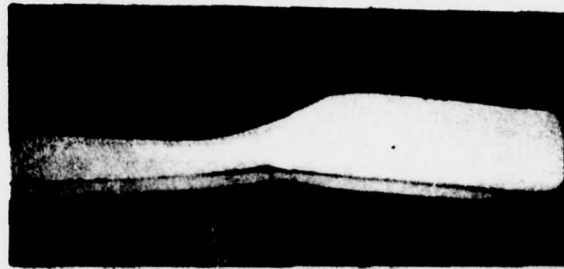
- a) Overall section view showing tube expanded into recess, but with a slight gap behind tube.

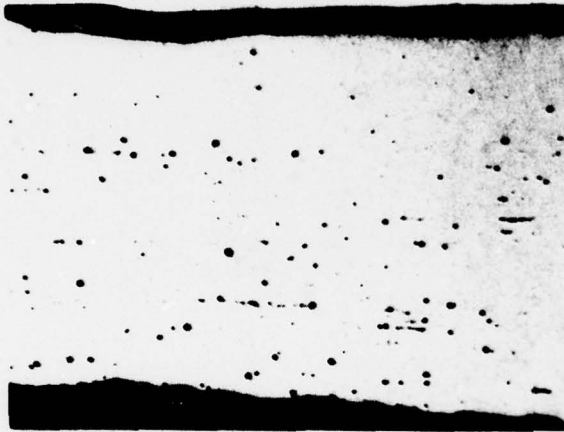
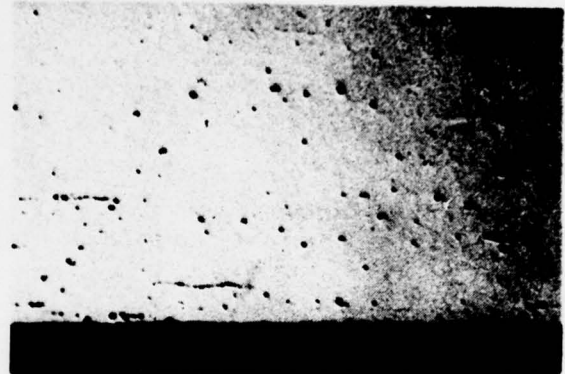
- b) Unetched views showing extensive amount of inclusions in AISI 321 stainless steel tubing.

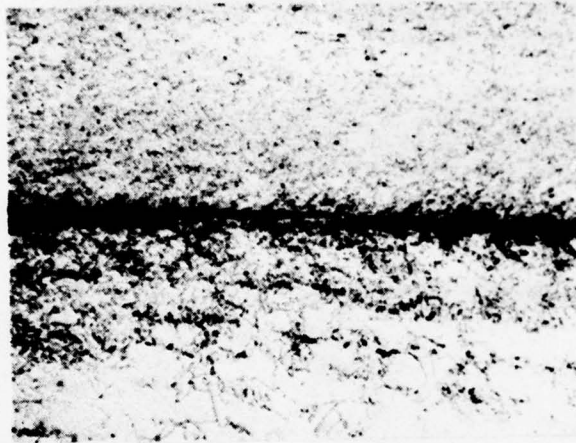
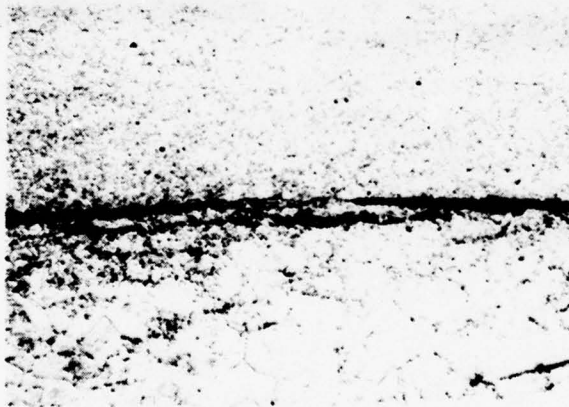
- a) Toward tank ID end. Note good, high strain and somewhat wavy bond, with no corrosion in crevice.

- b) Toward tube end with poor bond starting but no abnormal corrosion.

FIGURE 52. ENDS OF TUBE TO FITTING CREVICE AT SPLIT TUBE SHOWING LACK OF ANY CORROSION EFFECTS, TANK NO. 5.

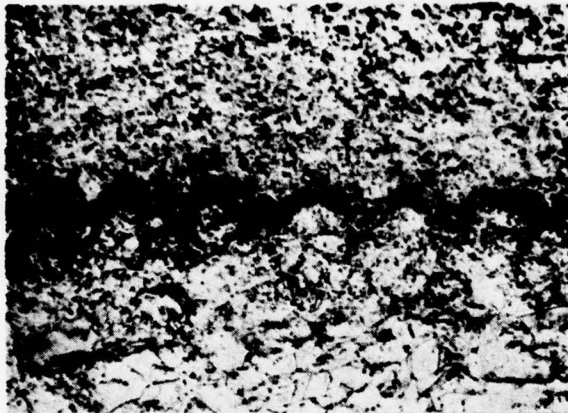
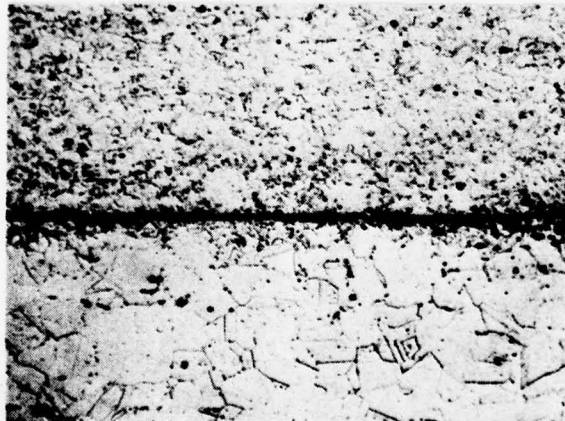
- a) Bond in region between tank ID and bulge.
Good bond with extensive strain and wave effects.

- b) Bond in region beyond bulge from tank. Poor bond
with no strain or wave effects.

FIGURE 53. EXPLOSIVE BOND STRUCTURE IN BONDED INLET/OUTLET
TUBE REGION OF TANK NO. 5.

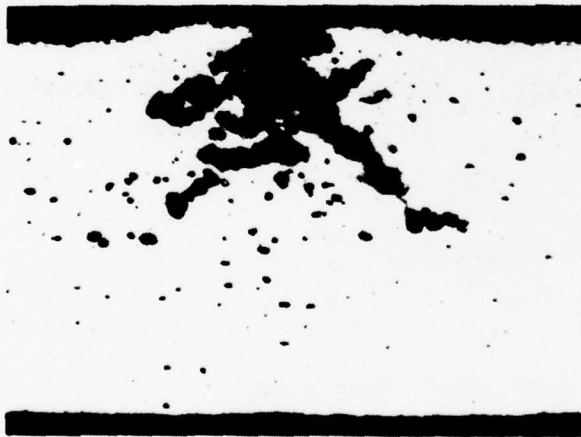
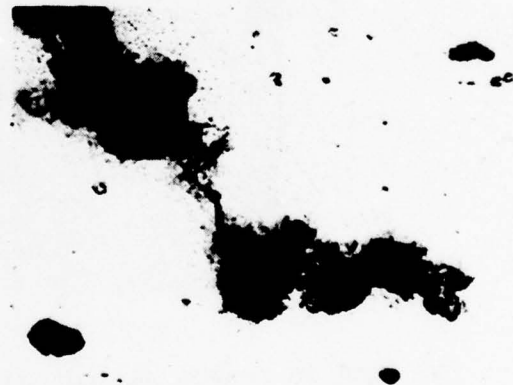
90° from the cross section shown in Figures 54 and 55 for the pit from Tank No. 5. This explains why the cavity in Tank No. 7 looks somewhat different in overall shape from that in Tank No. 5.

Review of the Martin-Denver fabrication report, Reference 7, for these tanks showed that this dome to fitting joint was particularly troublesome to achieve consistent high quality. The same joint, when applied to titanium alloy components was particularly difficult. Figure 54 of Reference 7 shows a crack in the titanium dome component at precisely the location of the high strain and pitting in these A-286 components. The reason for the particularly severe strain 1/8-inch away from the bond is seen in the joint configuration, Figure 22 of Reference 7. At this location the dome component is bent or flared to achieve the desired collision angle between the dome and fitting components. Recognizing the limited ductility of titanium, particularly compared to A-286 stainless steel, it is evident that very high strain and shock effects are imparted into the dome at this location during dome to fitting bonding. In the case of titanium tanks, this high strain was sufficient to cause immediate, mechanical failure. In the case of the A-286 stainless steel, its excellent ductility prevented immediate mechanical failure in this location but did leave the matrix highly strained and quite susceptible to rapid corrosion. On a microscopic scale, the strain and shock effects would be magnified even more around inclusions or intermetallic

Raised and pitted area shown in cross section below and in Figure 55 which follows.

- a) Etched surface of shell near bond. See view (a) of Figure 47 for overall view of this area.

- b) Cross section showing extensive pitting corrosion under raised area.

- c) Detail view of corrosion.

FIGURE 54. CROSS SECTION OF PITTED AREA NEAR DOME TO OUTLET FITTING BOND OF TANK NO. 5 INTERIOR SURFACE.

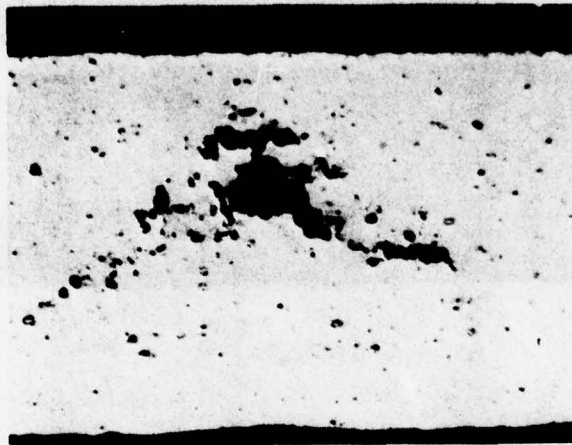
- a) Overall view showing same general pattern of attack but with no surface outlet at this point.

- b) Detail views showing corrosive attack concentrated along intermetallic or inclusion particles.

FIGURE 55. CROSS SECTION OF PITTED AREA OF FIGURE 54 AFTER POLISHING 0.020 INCH FARTHER AWAY FROM BOND, TANK NO. 5.

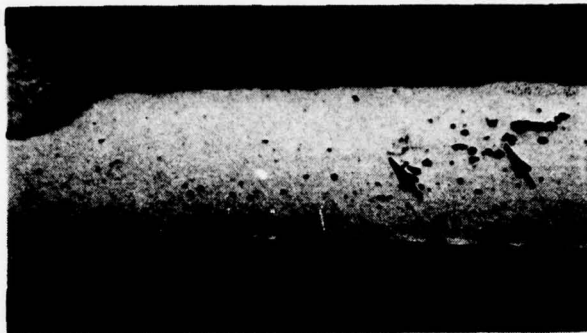
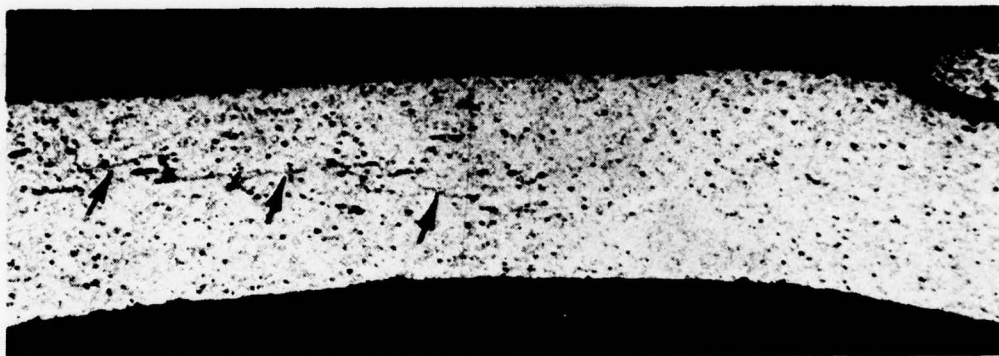
FIGURE 56. CROSS SECTIONS SHOWING INDICATION OF STRAIN AND/OR CORROSION EFFECTS APPROXIMATELY 0.1 INCH BEYOND EDGE OF BOND.

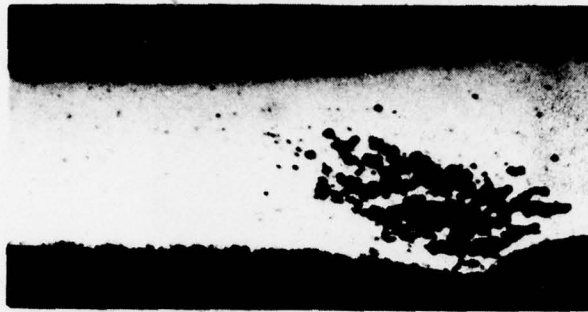
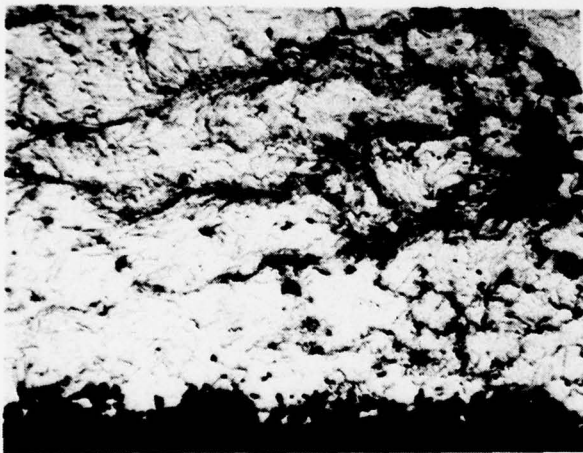
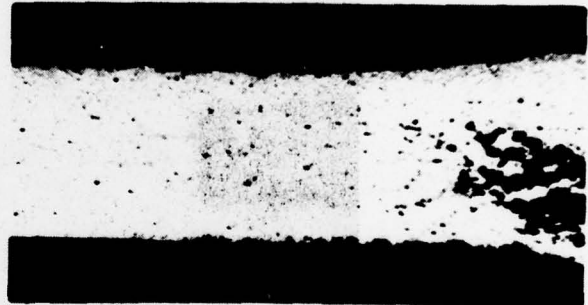
d) Detail view of pitting.

e) Strain effects in and near pitted area which promoted pitting.

FIGURE 57. VIEWS OF PITTED REGION NEAR DOME TO OUTLET FITTING
(CONTINUED) BOND IN TANK NO. 7, INTERIOR SURFACE.

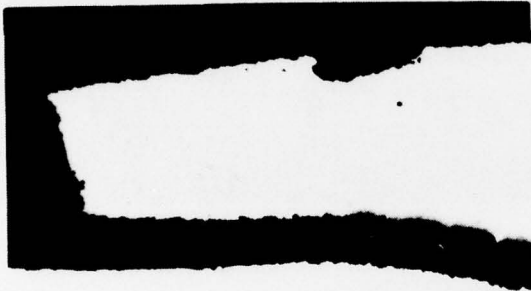
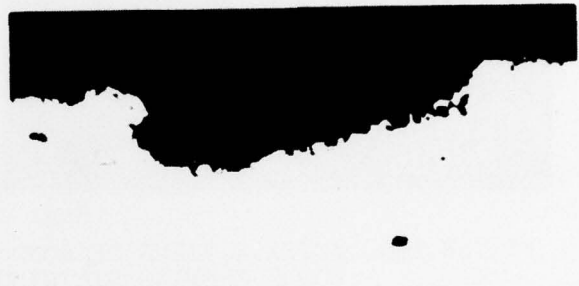
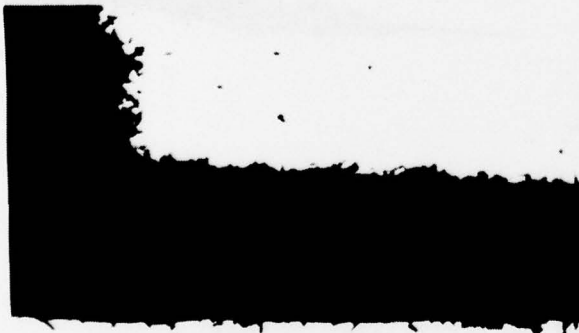
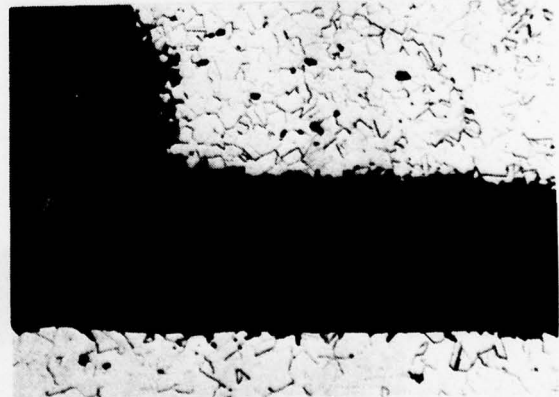
The internal surface of Tank No. 5 was studied initially since an etched groove was observed along the longitudinal solid state bond Figure 58, view (a). The configuration of the overlap plus the crevice is shown in view (b), with higher magnification photomicrographs of the type of intergranular attack shown in views (c) and (d). In the fabrication of this bond an explosive charge is placed on the inside of the tank. The shallow intergranular attack observed seems to indicate that there may have been a direct connection between the surface reaction observed, which could be attributed to the surface being disturbed by the explosive charge, thereby becoming more susceptible to the HNO_3/HF pickling solution. The degree of attack found in this Tank, No. 5, should be considered minor, being highly localized and not

a) View of inside surface of bond overlap showing etched groove.

b) Cross section showing configuration of overlap plus crevice.

c) Detail view of attack in etched groove.

d) Cross section at start of crevice showing minor grain boundary attack.

FIGURE 58. LONGITUDINAL BOND IN CYLINDER SECTION OF A-286 EXPLOSIVE BONDED TANK NO. 5 SHOWING MINOR ETCHING OR CORROSION ATTACK. METALLURGICAL LABORATORY MET NO. 78-79011

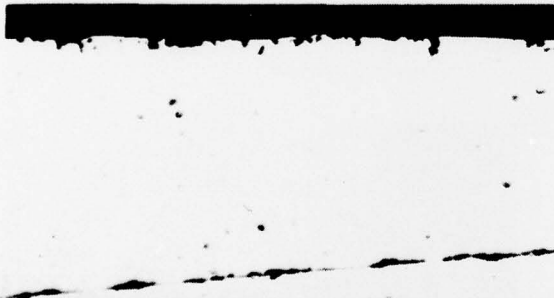
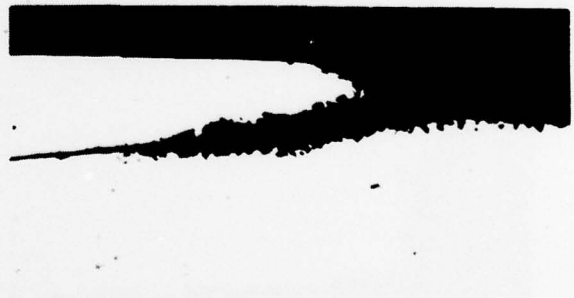
Staining was observed in the bond overlap region on the interior surface of Tank No. 6. This staining of the surface occurred in the girth area of the tank where the cylinder is joined to the dome. In making this joint the explosive is on the outside surface, therefore, in contrast to Tank No. 5, the corrosion of this A-286 surface is not the result of a disturbed surface being attacked but is the result of direct attack, which may also be the case for Tank No. 5. Once again, the attack is very shallow in nature and highly localized allowing for the postulation that this type of staining and corrosion is the result of a pickling process performed on the tanks prior to storage. Figure 59 shows surface views of the bond overlap region on the interior surface of Tank No. 6. The degree of attack is presented in the cross sectional views of Figure 60 and is very shallow in depth.

a) Over bond.

b) At interior bond edge.

FIGURE 60. CROSS SECTION VIEWS SHOWING MINOR ETCHING OR CORROSION ATTACK OF THE SURFACE LAYERS, TANK NO. 6.

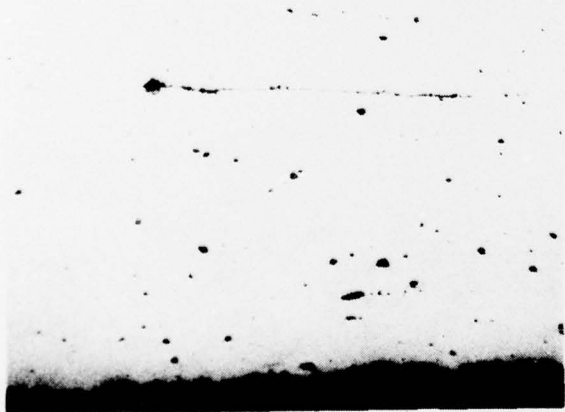
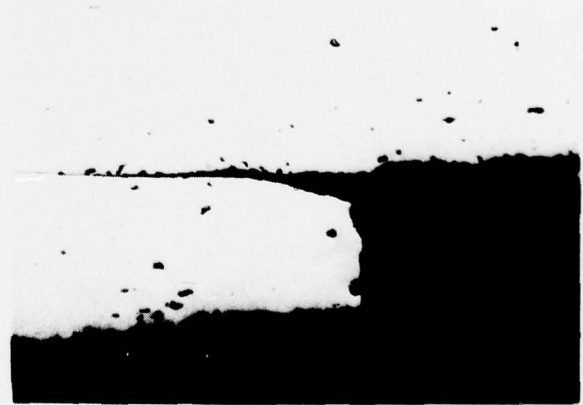
a) Overall view of end of puddle.

b) Detail views of surface attack and buildup of deposits.

c) Section views showing slight attack in bond and along surface.

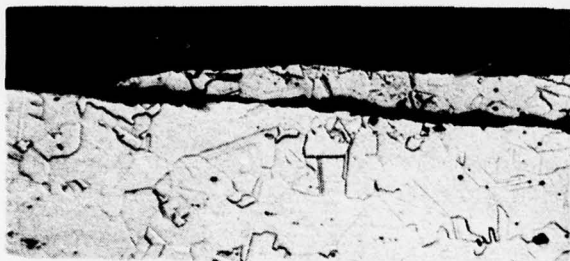
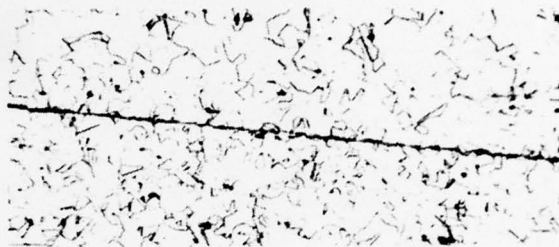
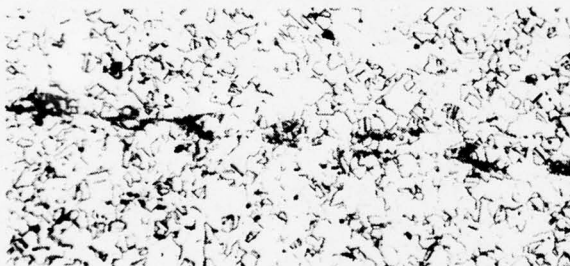
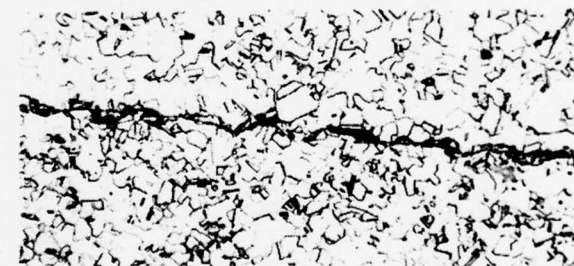
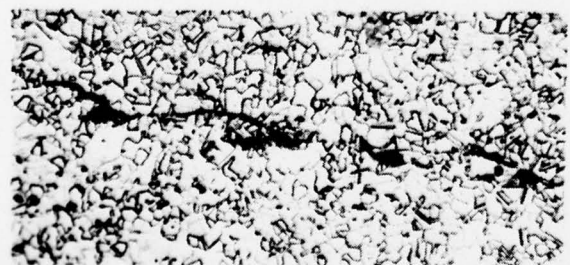
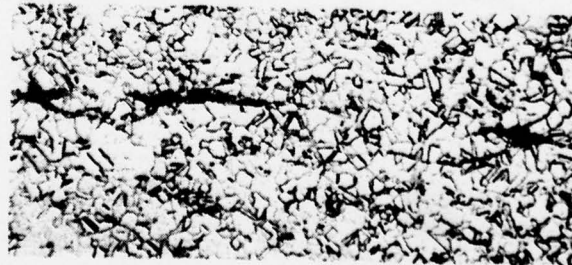
(1) Longitudinal Cylinder Joint. The longitudinal cylinder bond which joins the edges of the rolled sheet to form the central cylinder portion of the tank is the first major bond formed in the processing of the tank. The joint is made by positioning the overlapping edges of the rolled sheet in a massive external mandrel, applying the explosive strip to the interior of the bond surface and then detonating that explosive. Examples of the metallographic appearance of the bond from two different tanks are shown in Figures 65 and 66. A low magnification cross section of this bond is shown in view (a) of Figure 65 and shows the characteristics of this scarf joint in which the edges of the overlapping sheets are ground flush after the bonding so that the joint has a smooth appearance. This was particularly necessary because this joint is made before the circumferential cylinder to dome joints and this bond is required to fit smoothly along the interface of the succeeding cylinder to dome bond. The most obvious characteristic of this bond, as seen in view (a), is the straight bond or actual lack of bonding at the outer and inner edges of the scarf-type of joint. There is a slight separation between the overlapping surfaces at the inner and outer periphery of the bond. As has already been discussed with other bonds in previous detail metallurgical analyses, these unbonded and slightly separated regions provide cavities which can trap liquids during processing or service and form pockets of slight corrosion. The lack of bonding extends inward approximately 10% of the bond length both from the exterior and interior surfaces. However, this lack of bonding for almost

20% of the bond interface did not degrade the tensile properties across this joint as has previously been discussed in Section V.C. The lack of bonding also did not cause any leakage problems through this joint. The central region of the bond is quite leak-tight and structurally sound and provides sufficient strength to insure that failure does not occur in the bond when a tensile test is performed across these joints. As will be discussed below, however, this lack of bonding, forming a notch at each edge of the bond could be expected to be detrimental to fatigue or other cyclic service performance. The bond interface itself showed several distinctly different regions. The central portion of the bond shown in views (d), (e) and (f) of Figure 65 and (b), (c) and (d) of Figure 66 represent areas where very good bonding was produced by the characteristic jetting and wave formation in the explosive bond. The details of the formation of these waves during the jetting action are covered in the Discussion Section, which follows. The primary observation to be made in this region is that excellent intimate contact and metallurgical bonding has occurred over at least a portion of each wave in this region. One portion of each wave formation also contains a pocket of molten and then refrozen material which formed during the intense plastic deformation of the bonding process. Within some of these melted zones, pores or cavities have formed. Successive polishing stages through these bonds showed that none of the pores or cavities as seen in these views extended for any significant depth along the bond, but rather appeared to be roughly spherical and therefore had

maximum dimensions no greater than the 0.002-0.005" dimensions shown in these views. The excellent bonding and grain growth which occurred in the other portions of each individual wave are quite obvious in examination of these views. Towards each end of the bond in the region approaching the unbonded and slightly separated zones there was a length of interface with no apparent wave action or a very slight ripple to the surface. Along these regions the two components were in intimate contact with no cavities or molten zones created, but without the intense jetting action. The surface oxides, films and other contaminants were not removed and hence a true metallurgical bond was not formed. Examples of these regions are seen in view (c) of Figure 65 and view (a) of Figure 66. These regions are probably sufficiently bonded to aid in providing mechanical strength during constant load service or a tensile test. However, these regions could be expected to be quite susceptible to rapid failure during cyclic service or fatigue stress.

a) Overall view of cylinder bond showing location of views presented below. Letters in above section refer to view numbers below. Mag: 4X

b) Joint interface at exterior showing lack of bond and tight crevice.

c) Interface region showing tight contact but no true bonding.

d) Bond area where there is intermittent melted material.

e) Area where melted material is almost continuous.

f) Area where wave action is pronounced.

g) Melted material contains pores.

FIGURE 65. DETAIL VIEWS OF EXPLOSIVE BOND STRUCTURE OF TANK NO. 5 IN THE LONGITUDINAL CYLINDER JOINT.

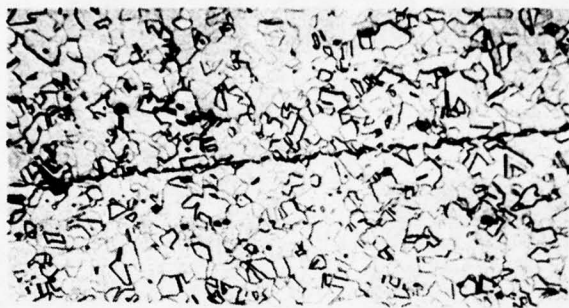
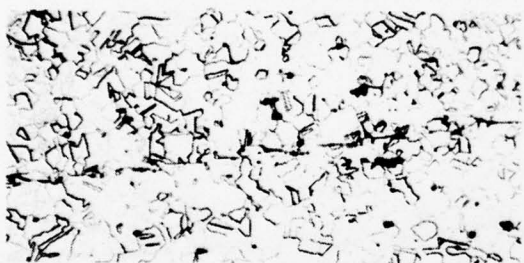
Overall view of joint is same as view (a) of Figure 65.

- a) Interface region showing tight contact but no bond. Location indicated by "c" in Figure 65, view (a).

- b) Area with intermittent good bond and then melted material. Location indicated by "d" in Figure 65, view (a).

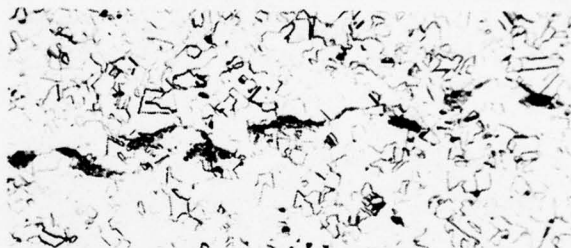
- c) Wave action visible in melted material. Location indicated by "e" in Figure 65, view (a).

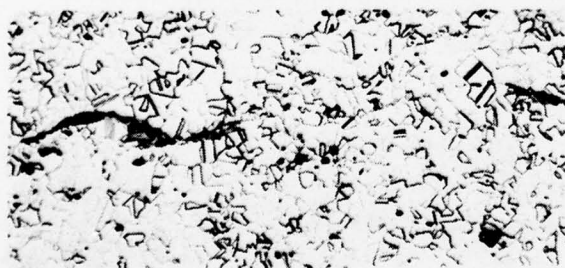
- d) Between melted material good bonding is seen. Location indicated by "f" in Figure 65, view (a).

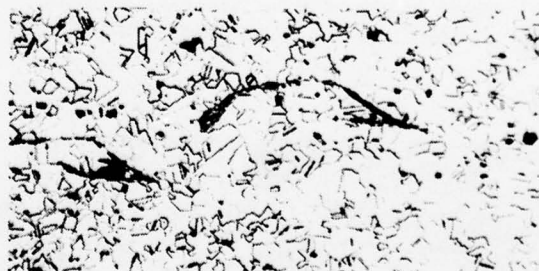
- e) Extensive melted material with pores and cavities. Location indicated by "g" in Figure 65, view (a).

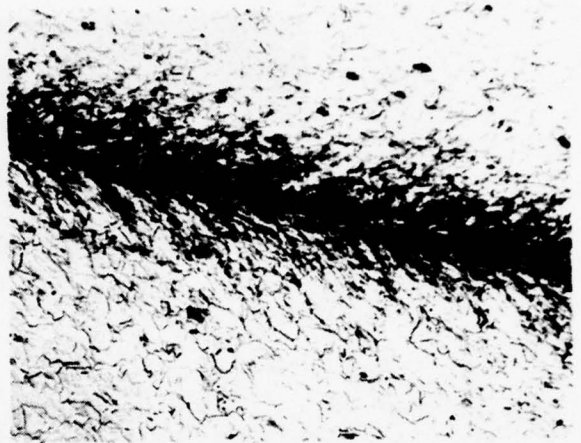
No. 5 and No. 7 are presented in Figures 67 and 68. Again, a low magnification view in each figure provides an overall illustration of the joint shape and configuration. It can be noted that the outer surface of the joint after bonding is left in the as-bonded condition with a rather rough and irregular protrusion of the dome component. Even at low magnification the configuration of the joint is quite obvious with a central region having a pronounced wave effect, whereas towards each surface the bond becomes relatively flat with unbonded regions or even slight cavities formed. Metallographic examination of the bond region as seen in Figures 67 and 68 showed this bond to be somewhat different in appearance from that previously described for the longitudinal cylinder joint. In this particular bond there was evidence of intense strain effects in the mating surfaces on each side of the joint producing a pronounced feathery band on either side of the joint. Close inspection along the interface line within this heavily strained band shows occasional regions, that had obviously melted during the bonding process and formed either slight gas pores or other cavities during this bonding process. At no point did the wave action in the bonding appear to produce the crest or overlapping wave effects seen in the previous bond. Instead, the wavy portion of this bond contained a smooth sinusoidal wave shape. It can be noted that the proportion of wavy bond compared to the essentially flat and straight bond portion of the joint is much less in these dome cylinder joints. However, again, there is no evidence of any leak paths from interior to exterior and no loss

a) Overall view illustrating shape and overlap configuration of joint.

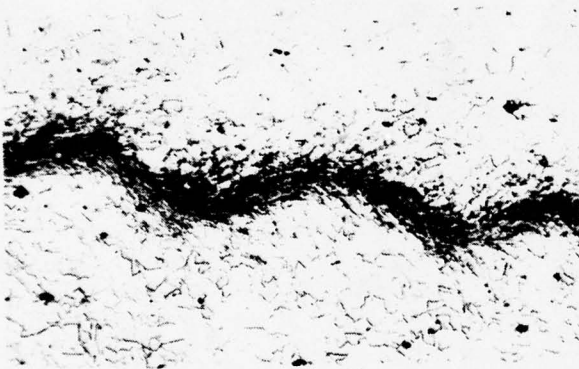
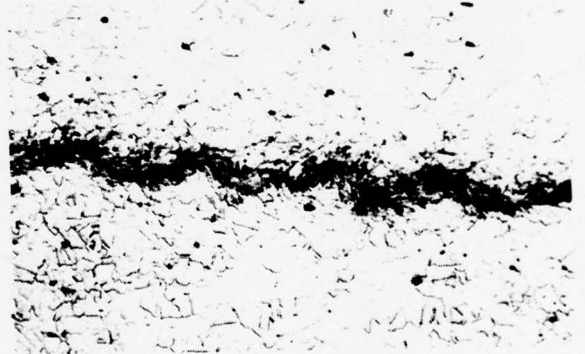
b) Bond near outer surface.

c) Bond in interior showing varying amounts of wave action.

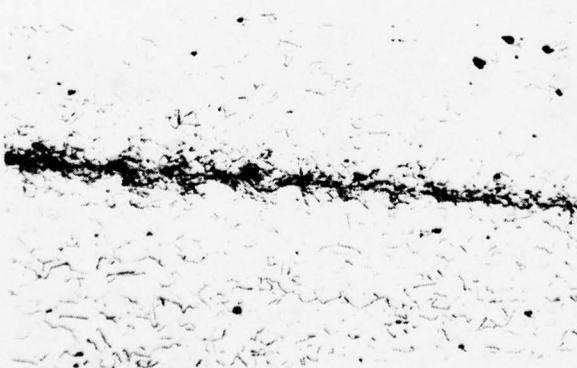
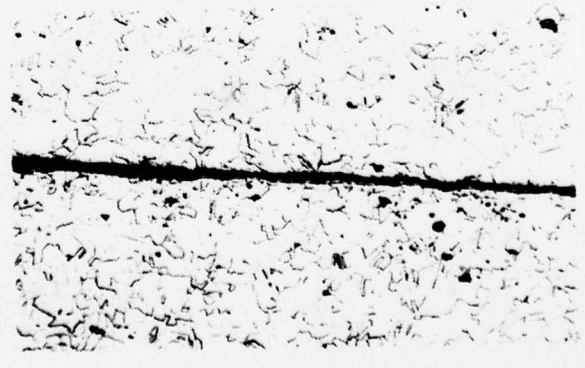
d) Bond when approaching ID showing tailoff of wave.

d) Bond near ID showing little bonding.

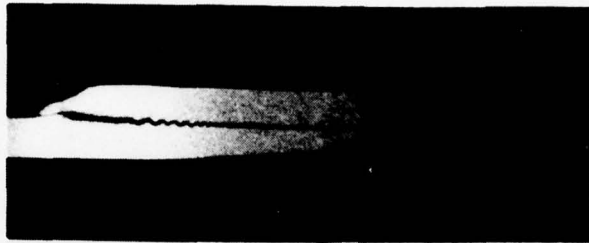
in structural integrity as measured by ultimate tensile strength, when tests were performed across these bonds. There are substantial lengths of flat bond region showing a layer of foreign or oxide material along the interface not removed by the jetting action. The presence of the visible intense strain patterns on either side of this joint and their absence from the longitudinal cylinder bond is not well understood, but as will be discussed in the Analysis Section which follows, probably indicate slight differences in the collision velocity and collision angle formed when the two components come together during the explosive bonding process. In view (c) of Figure 68, a set of short cracks are visible in the molten zone within each wave. These cracks in no case extend more than 0.005" in any direction. However, they do illustrate a potentially degrading feature of this bonding process in that molten material is formed during this process and it is no longer a truly solid state bond as generally described. Whenever a molten zone is formed, there is the possibility for "hot-short" cracking or other freezing effects, which can cause defects and anomalies similar to that found in fusion welding. Again, this feature will be discussed below in the Analysis Section.

a) Overall view illustrating joint shape and showing location of detail views. Mag: 4X

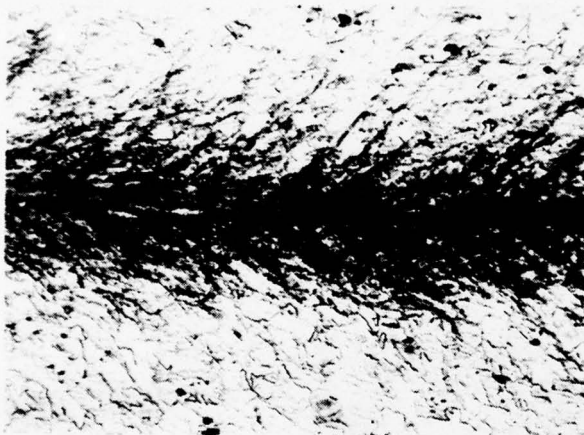
b) Bond near exterior the starting area with extensive strain but before wave action has started.

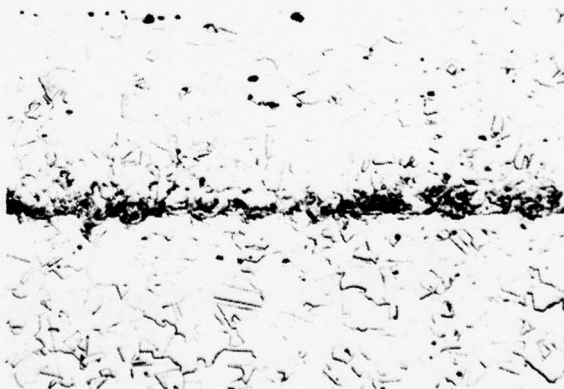
e) Interface near interior with only intermittent bonding.

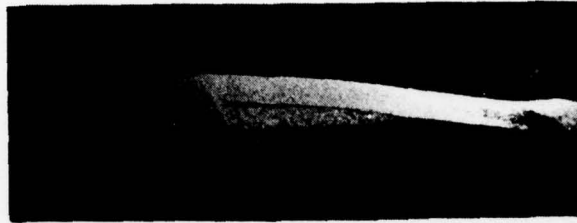
tapered faying surface, whereas, the dome is left with constant thickness but with the shell bent upwards to achieve the desired collision angle. As seen in view (a) of Figure 69, the cross section of this joint achieves the desired scarf interface surface by the machining of the outlet fitting. The dome segment itself remains with a somewhat irregular overlapping configuration. The extensive corrosion seen in the righthand corner of view (a) of Figure 69 has already been discussed as part of Detail Examination No. 5 in this section. The metallographic appearance of this bond interface is shown in views (b) and (c) of Figure 69 for Tank No. 7. As with the dome to cylinder joint there is only a short length of wavy bond with the bulk of the bond interface being essentially flat and often showing slight cavities or unbonded areas.

a) Overall view illustrating joint shape and showing location of detail views. Mag: 4X

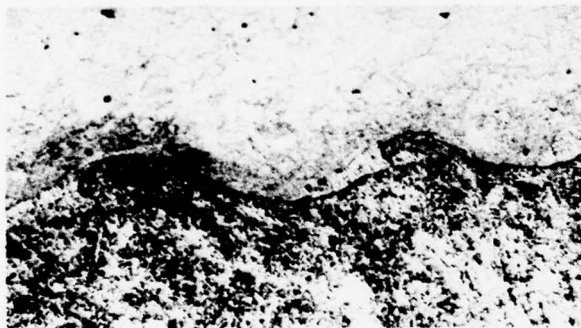
In metallographic appearance the wavy bond portion of this joint is slightly different from both of the previous joints discussed. Although a definite wave action is noted in view (b) of Figure 69, there is very little obvious strain markings showing as was the case with the cylinder to dome bond, nor is there the intermittent, excellent bonding shown by the longitudinal cylinder bond. Instead there is an almost continuous layer of material between the two components with occasional regions in the overlapping portion of the waves, where there is an obvious molten zone. The other portions of the wave, however, do not show high quality metallurgical bonding between the components. These components, one being machined 321 stainless steel bar stock and

b) Wavy area near exterior. Very little strain indications and considerable melted material seen in interface.

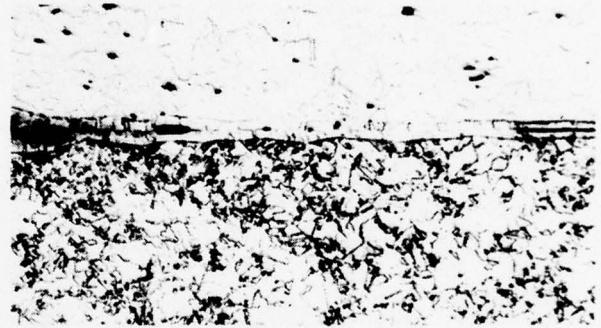
the other explosively formed A-286 stainless steel sheet metal do have slightly different microstructure appearances. However, it is still evident that there was only intimate contact and not the removal of surface oxides and films as had been the case in the previous two bonds. Therefore, even in this wavy bond region the metallurgical quality of the dome to fitting bond must be considered poor. When the flat portions of this bond are examined, view (c) of Figure 69, the bond quality is seen to be even worse. There are occasional pores or cavities along the bond line itself and an almost continuous film of oxide or foreign material that was not removed in the desirable jetting or wave action of the bonding process. The metallographic section shown in this Figure 69 was from Tank No. 7. It should be noted that in the metallographic section from Tank No. 6 which had previously been discussed in "Detail Metallurgical Analysis No. 6", which preceded this section, the bond for this outlet fitting to dome joint was even poorer with a considerable length of the interface completely separated and bonding only over a very short length of the interface. Thus, it is apparent that the bonding parameters used for this joint gave a poor and intermittent bond, one which was capable of sealing and avoiding any leak paths, but not one in which the large proportion of the interface was bonded nor one which would be satisfactory from a structural standpoint.

c) Central region of joint showing no wave or strain effects and occasional porosity.

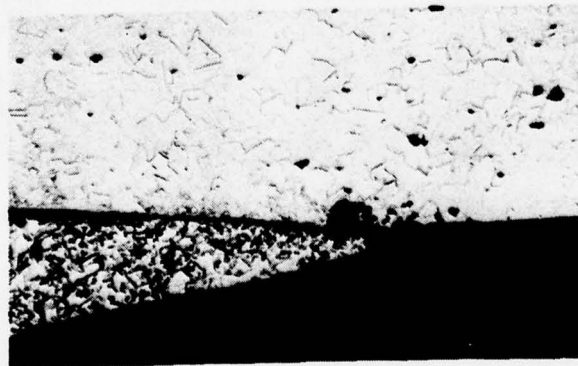
d) Interior edge of joint showing slight bonding with corrosion.

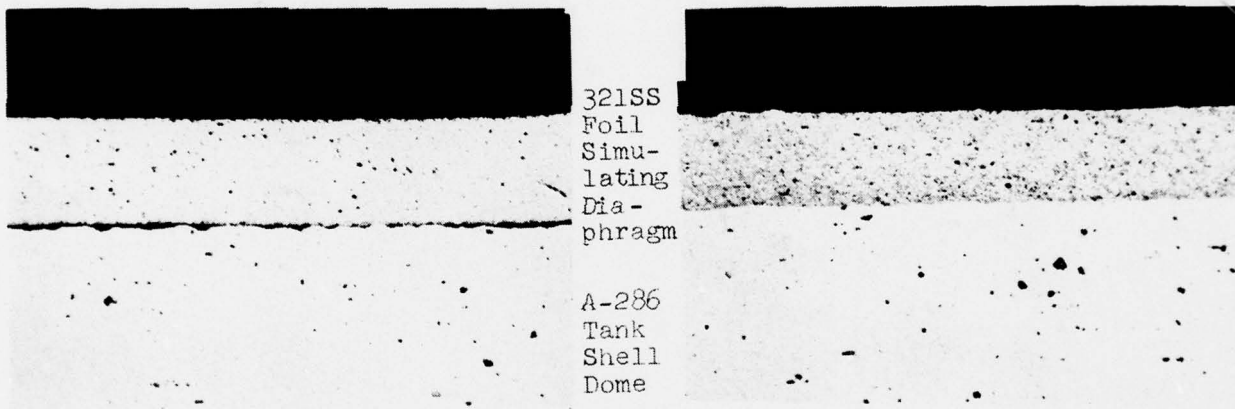
b) Section near foil end of explosive joint showing essentially no bonding.
