**INTERIM FIELD PROCEDURE FOR BOMB
DAMAGE REPAIR -USING CRUSHED ^{Line}STONE FOR
CRATER REPAIRS AND SILIKAL[®] FOR SPALL REPAIRS**

MICHAEL T. McNERNEY
ENGINEERING DIVISION,
RAPID RUNWAY REPAIR SECTION

APRIL 1979

INTERIM REPORT
JUNE 1978 - MARCH 1979

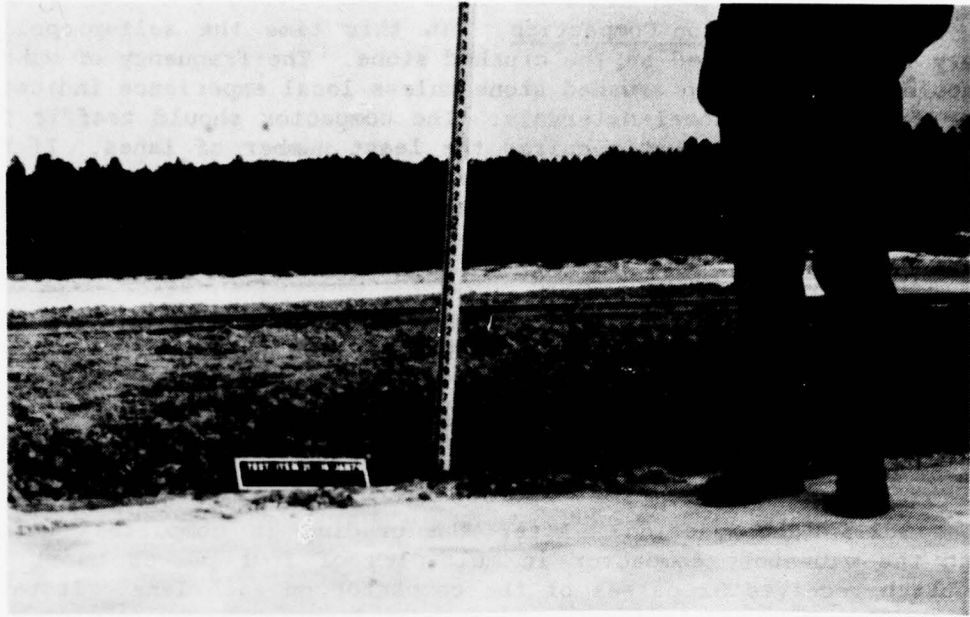
Figure 1
Crater Over-filled with Six Inches of Uncompacted Crushed Stone

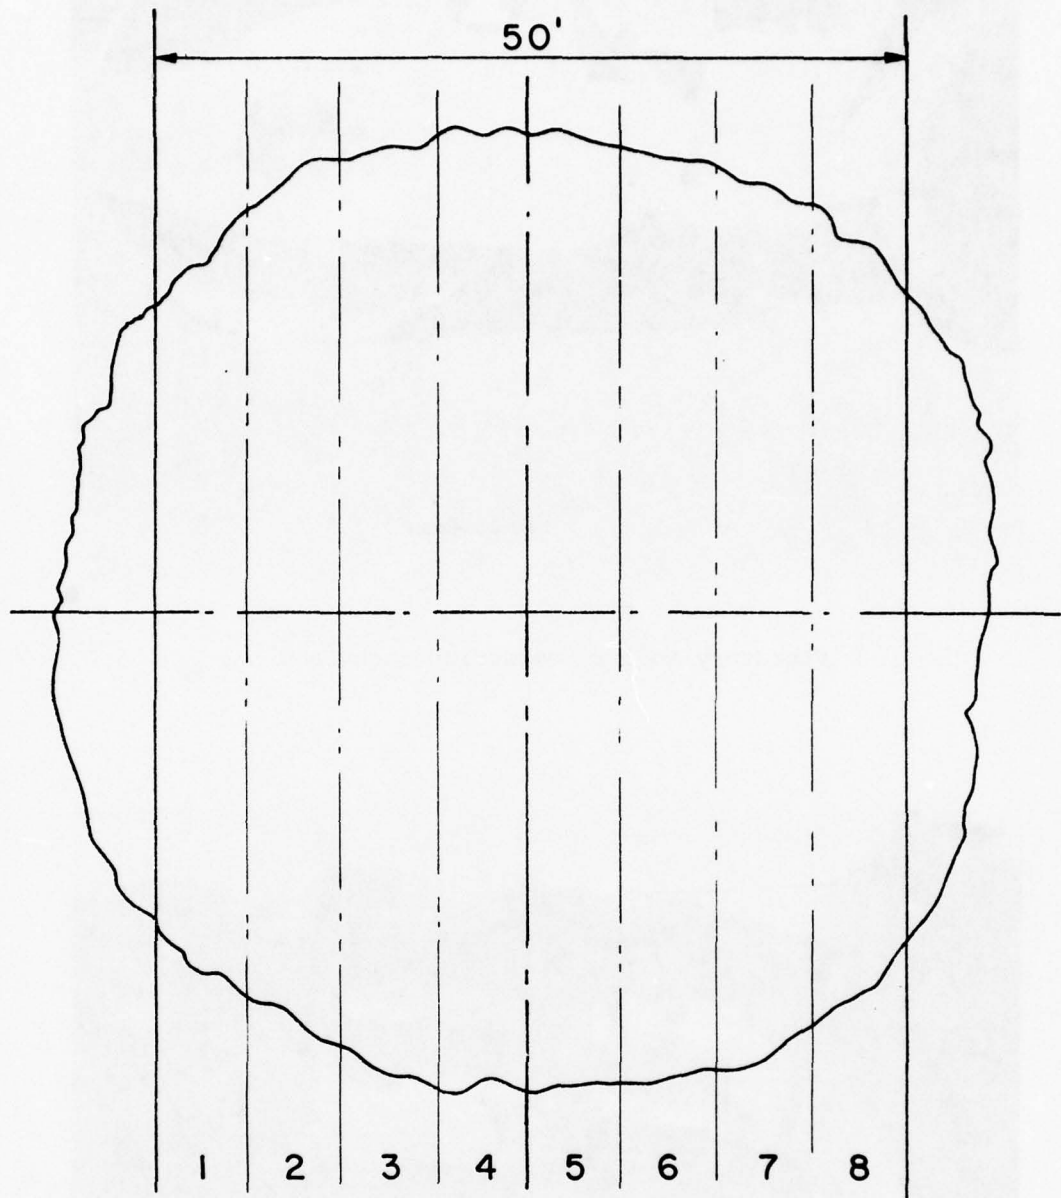
Figure 3. Compacting Lanes for Typical
750-Pound Bomb Crater

3.2.3 Vibration Compaction. At this time the self-propelled vibratory roller is placed on the crushed stone. The frequency of vibration should be 1500 vpm on crushed stone unless local experience indicates a better frequency on local materials. The compactor should traffic the repair in the direction that requires the least number of lanes. If the repair exceeds 50 ft in diameter, compact only the portion within the emergency launch strip using the minimum number of lanes (Figure 3). Compact the repair four passes at a time on each lane, then move to the next lane (Figure 4).

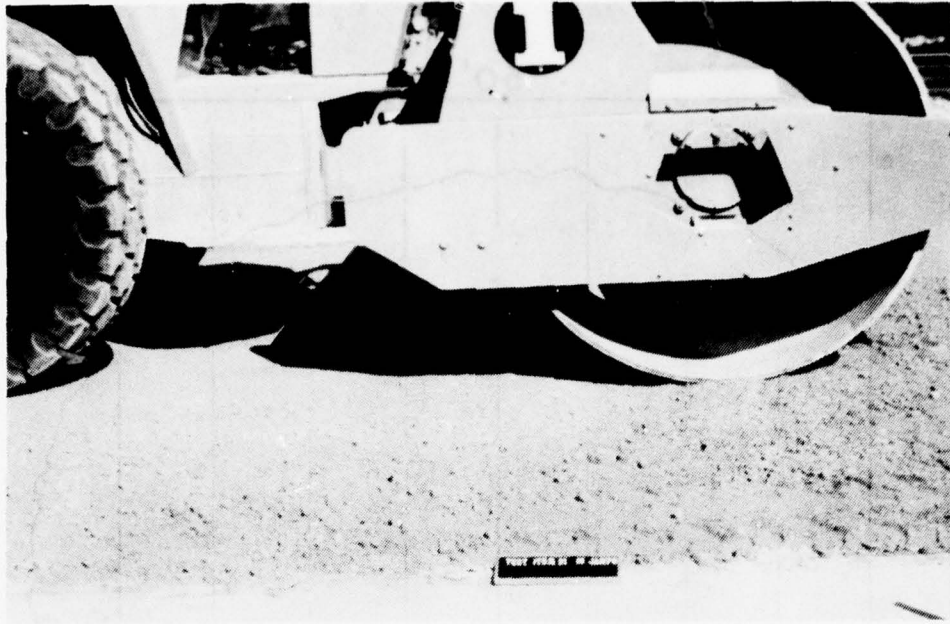
Figure 4
Vibratory Roller Compacting Each Lane

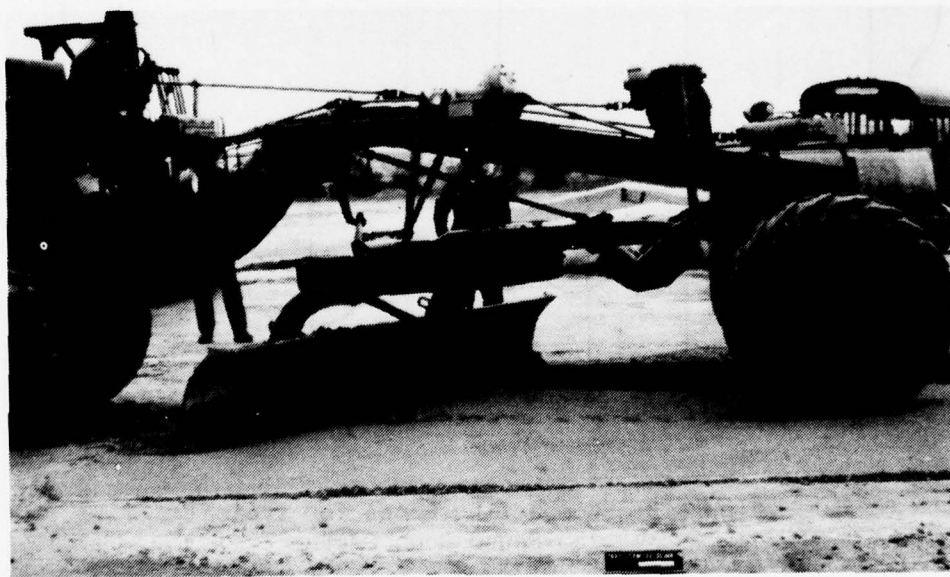
Figure 5
Grader Operator Grades the Patch After Four Coverages of the
Vibratory Roller

3.2.4 Grading. After four passes of the compactor have been applied to each lane the patch should be releveled to approximately one and one-half inches above the concrete. The easiest way to do this is to use an experienced grader operator to grade the patch (Figure 5). An experienced operator can do this in a single pass per lane with only a minimum of hand work with shovels required.

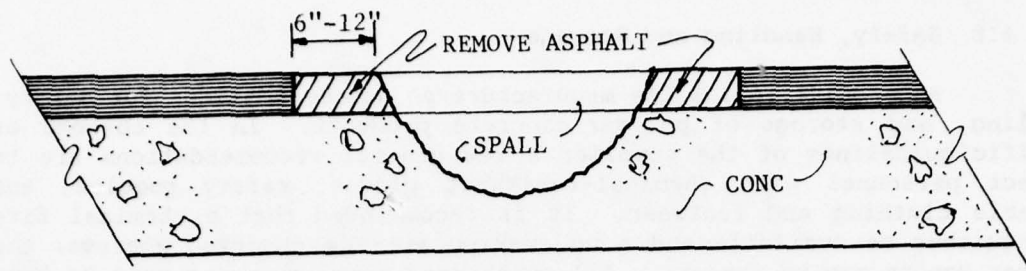
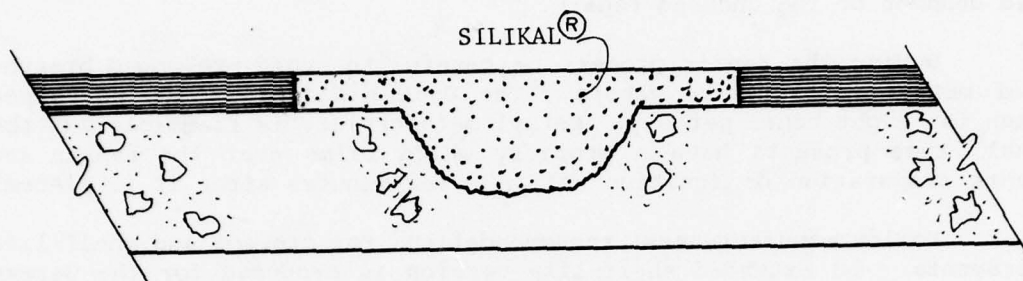
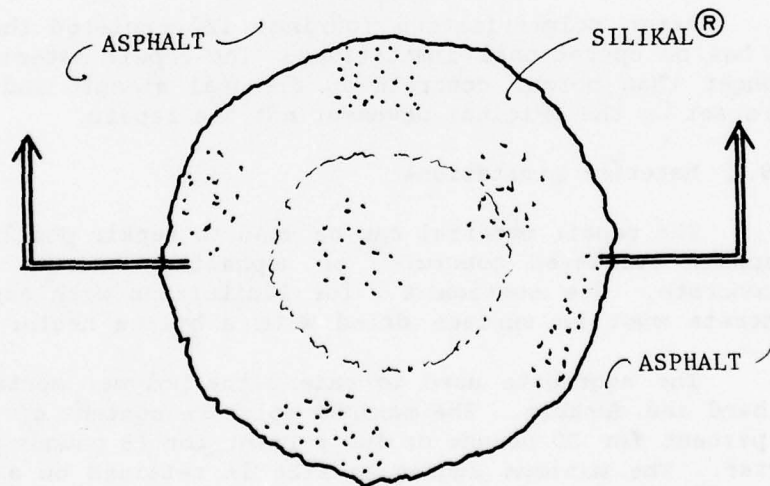
Figure 17 Proper Spall Preparation for Asphalt Overlaid Concrete

SECTION BEFORE REPAIR

SECTION AFTER REPAIR

PLAN VIEW AFTER REPAIR

The best procedure is to minimize the contact between asphalt and MMA by removing as much asphalt as possible. The spall should be prepared in accordance with Figure 17. The concrete should be sandblasted to remove asphalt if permanent repairs are made. For emergency repairs the tack coat can be removed from the concrete surface by scarifying the surface with a jackhammer. Precautions should also be taken to avoid spills of MMA or Silikal[®] liquid on the asphalt.
