# LAKE WYNONAH DAM

## PHASE I INSPECTION REPORT NATIONAL DAM INSPECTION PROGRAM

JULY 1978

LAKE WYNONAH DAM  
SCHUYLKILL COUNTY, PENNSYLVANIA  
NATIONAL I.D. NO. PA 00702

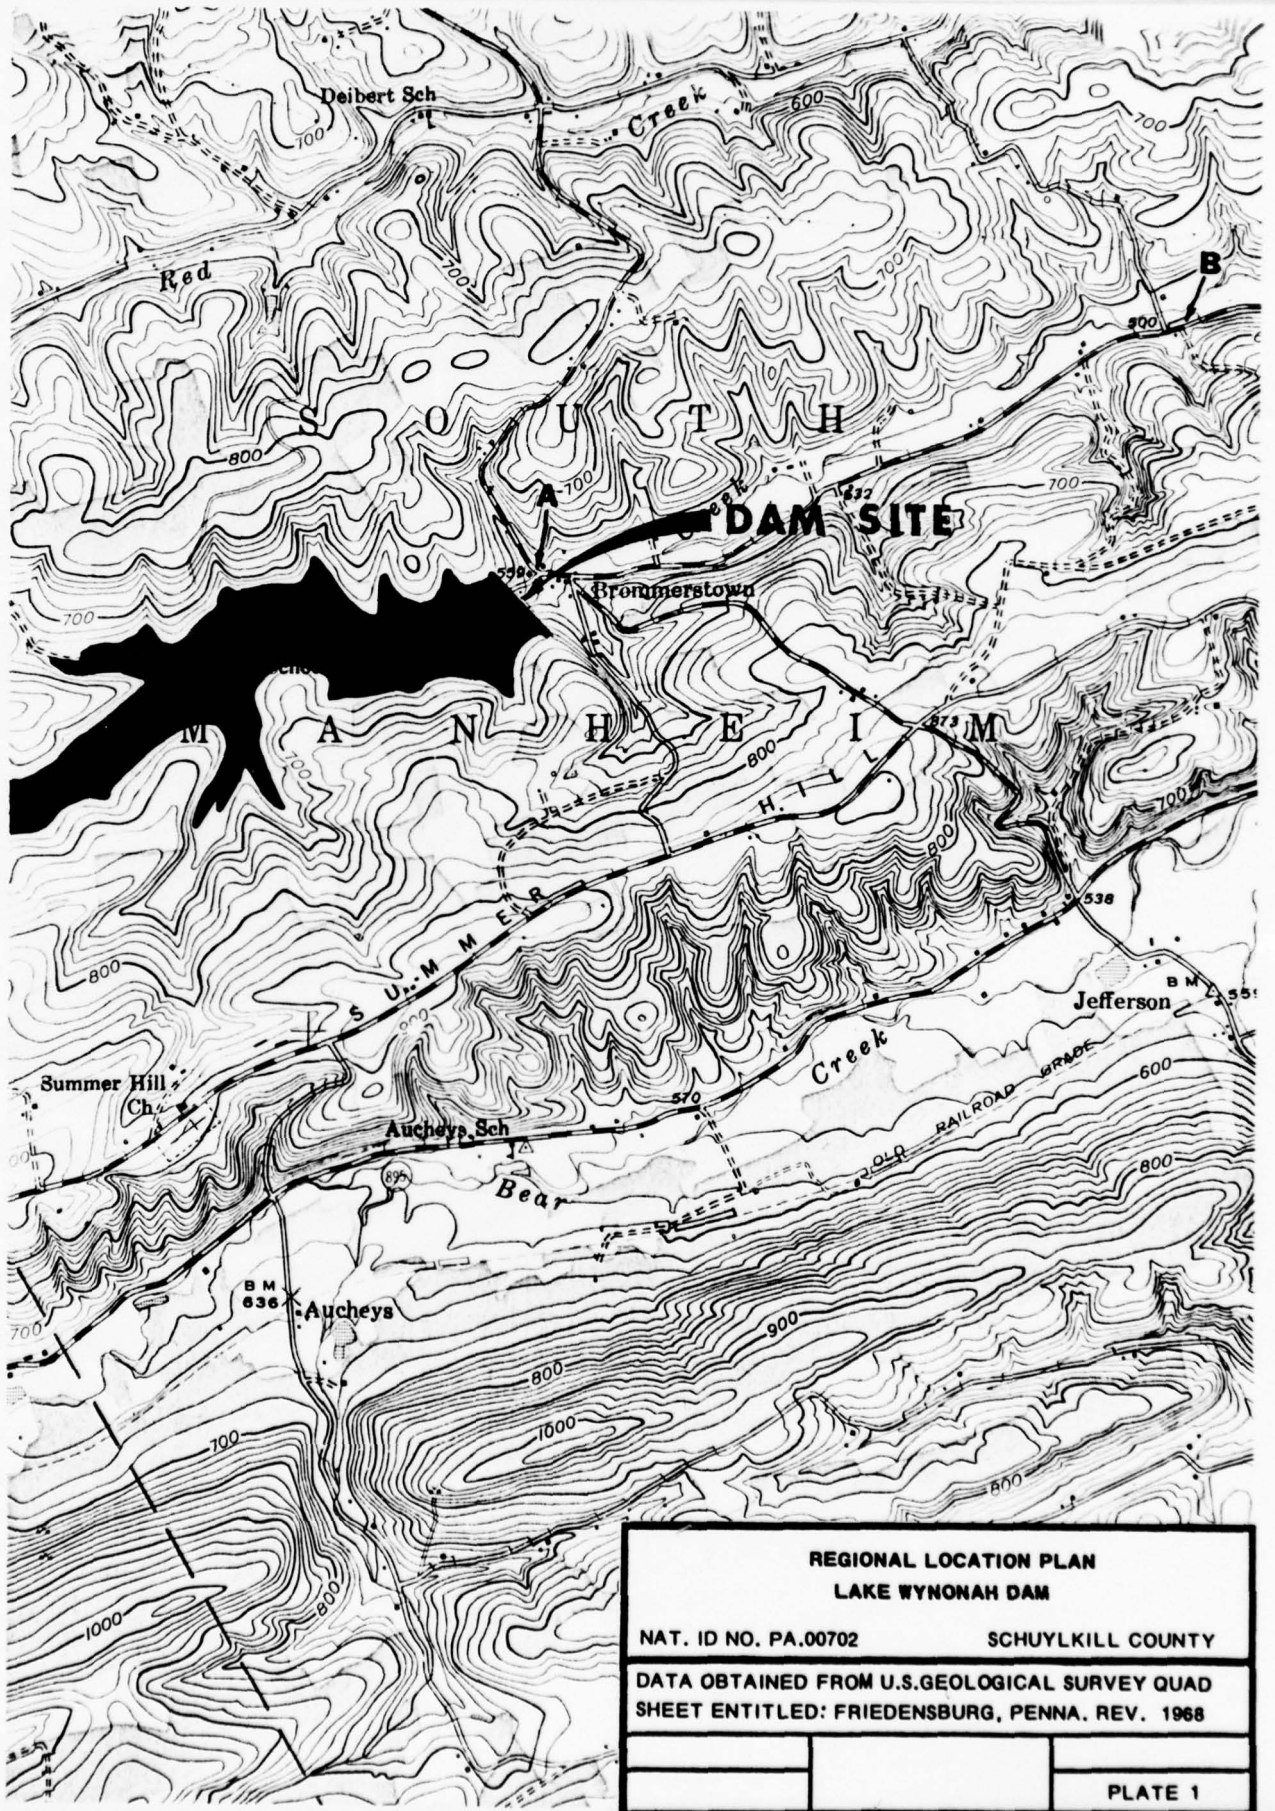
<b>REGIONAL LOCATION PLAN LAKE WYNONAH DAM</b>	
NAT. ID NO. PA.00702	SCHUYLKILL COUNTY
DATA OBTAINED FROM U.S.GEOLOGICAL SURVEY QUAD SHEET ENTITLED: FRIEDENSBURG, PENNA. REV. 1968	
PLATE 1

d. Hazard Classification. A "High" hazard classification is assigned consistent with the potential for extensive property damage and loss of life 1.5 miles downstream along Plum Creek (between points A and B as shown on Plate 1, Appendix E).

There are 13 additional homes with several attendant structures in the flood plain of the discharge channel between points A and B as shown in Plate 1. During periods of high flow some of these homes would be damaged and all would suffer at least some damage if the dam failed. Thus, a "High" hazard classification is assigned to this dam.

VISUAL EXAMINATION OF	OBSERVATIONS	REMARKS OR RECOMMENDATIONS
CONDITION (OBSTRUCTIONS, DEBRIS, ETC.)	<p>Heavy growth including trees were observed along the channel and occasionally within the 200 foot wide flood plain. The downstream channel passes through a 30 foot by 4.75 foot bridge opening under Schuykill Mountain Road 300 feet downstream from the toe of the dam. In the next 1.5 miles downstream, there are several (6-10) private bridges, a 28 foot by 4 foot highway bridge is 1.5 miles downstream. It is expected that the private bridges will be damaged and highway bridges will be overtopped during heavy flows.</p>	
SLOPES	<p>The valley gradient is approximately 0.8 percent. The channel side slopes vary from 5:1 to 1.5:1. The bottom is stony (coarse gravel).</p>	
APPROXIMATE NO. OF HOMES AND POPULATION	<p>Immediately downstream of the dam are three homes and a sewage treatment plant (serving Lake Wymonah property owners) which would be subject to flooding during high flows and damaged if the dam failed. There are 13 more homes with several attendant farm buildings adjacent to the channel in the next 1.5 miles downstream. It is estimated that less than 100 people reside in the flood plain between points A and B shown on Plate 1.</p>

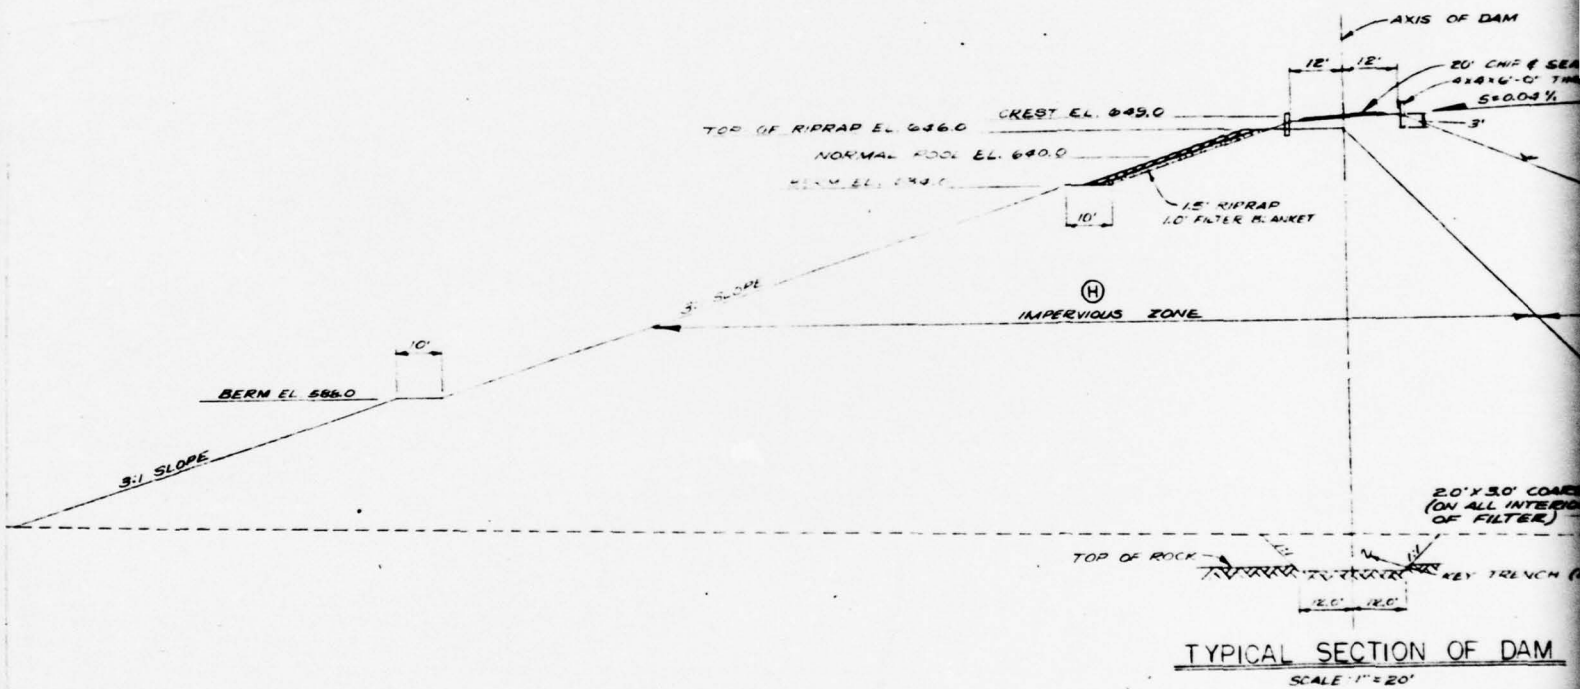
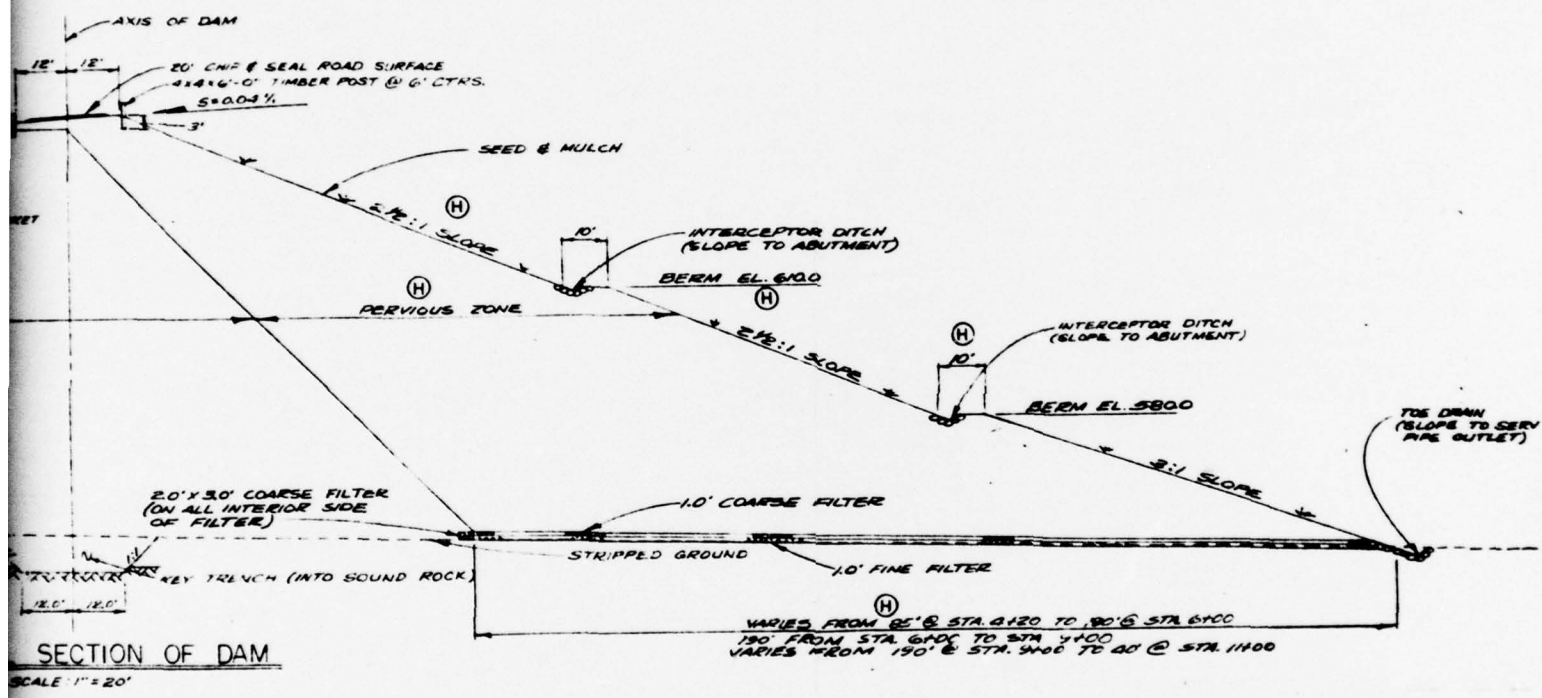
<b>TYPICAL EMBANKMENT SECTION</b>		
<b>LAKE WYNONAH DAM</b>		
NAT. ID NO. PA.00702		SCHUYLKILL COUNTY
DATA OBTAINED FROM AMERICAN REALTY SERVICE CORPORATION, ENGINEERING, MEMPHIS, TENN. DWG. NO. 7970-D-2, SHEET 2 OF 15, DATED SEPT., 1970		
		PLATE 3

The original design consisted of a homogeneous embankment with a chimney drain. However, by May, 1971, a zoned embankment was adopted based on the recommendations of G. K. Jewell and Associates. Plate 3, Appendix E, shows the final design and as-built section of the embankment.
