MAUCH CHUNK LAKE DAM

PHASE I INSPECTION REPORT
NATIONAL DAM INSPECTION PROGRAM

SEPTEMBER 1978

MAUCH CHUNK LAKE DAM
CARBON COUNTY, PENNSYLVANIA
NATIONAL I.D. NO. PA 00605

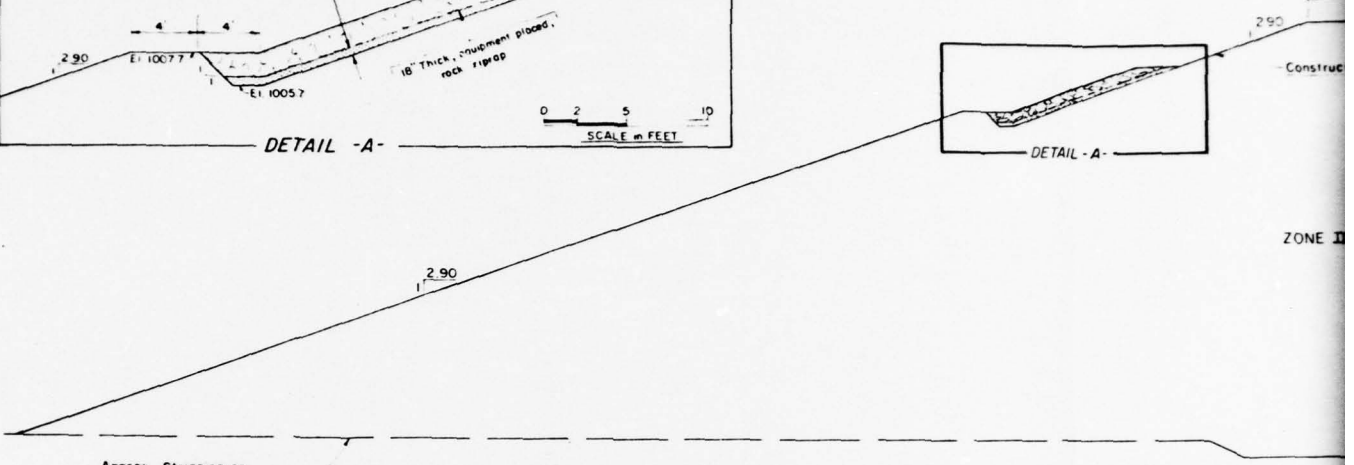
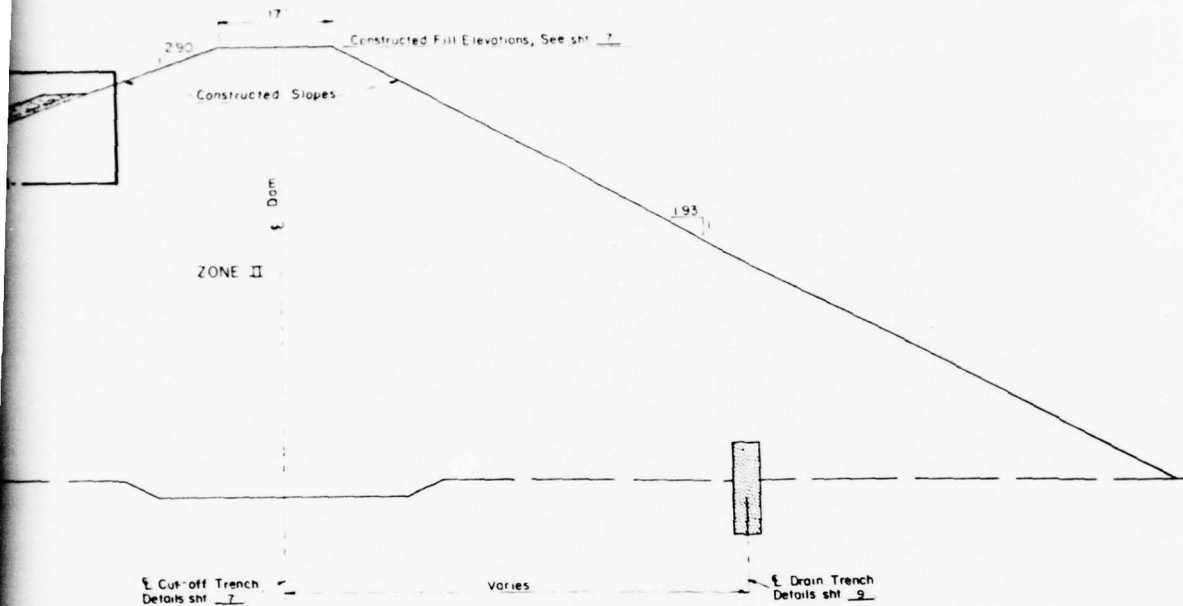
TYPICAL SECTION OF EMBANKMENT	
MAUCH CHUNK LAKE DAM	
NAT. ID NO. PA.00605	CARBON COUNTY
DATA OBTAINED FROM U.S. DEPT. OF AGRICULTURE, SOIL CONSERVATION SERVICE, DRAWING NO. PA-462-P, SHEET NO. 4 OF 27, DATED MARCH, 1967	
PLATE 3

The dam is a rolled earth embankment containing a cutoff trench and drainage trench. The drainage trench has a rectangular cross-section and is located downstream of the centerline. Plates 3 and 4 show the location of this trench. The purpose of the trench is to control embankment seepage. The water is discharged through two 6-inch diameter pipes into the impact basin at the downstream toe. The dam also contains a cutoff trench located under the centerline and a triple line grout curtain between Stations 9 + 50 and 13 + 70. Details of the grout curtain are shown on Plate 10 of Appendix E. The split spacing, stage grouting method was utilized where the upstream and downstream holes were drilled and grouted first. Holes were staggered 5 feet on center, and occasionally, the grout hole spacing was reduced to 2-1/2 feet on center.
