PASSAIC RIVER BASIN
CANOE BROOK, ESSEX COUNTY
NEW JERSEY

CANOE BROOK RESERVOIR NO. 2 DAM NJ 00526

PHASE 1 INSPECTION REPORT NATIONAL DAM SAFETY PROGRAM

79 05 14 210
April, 1979

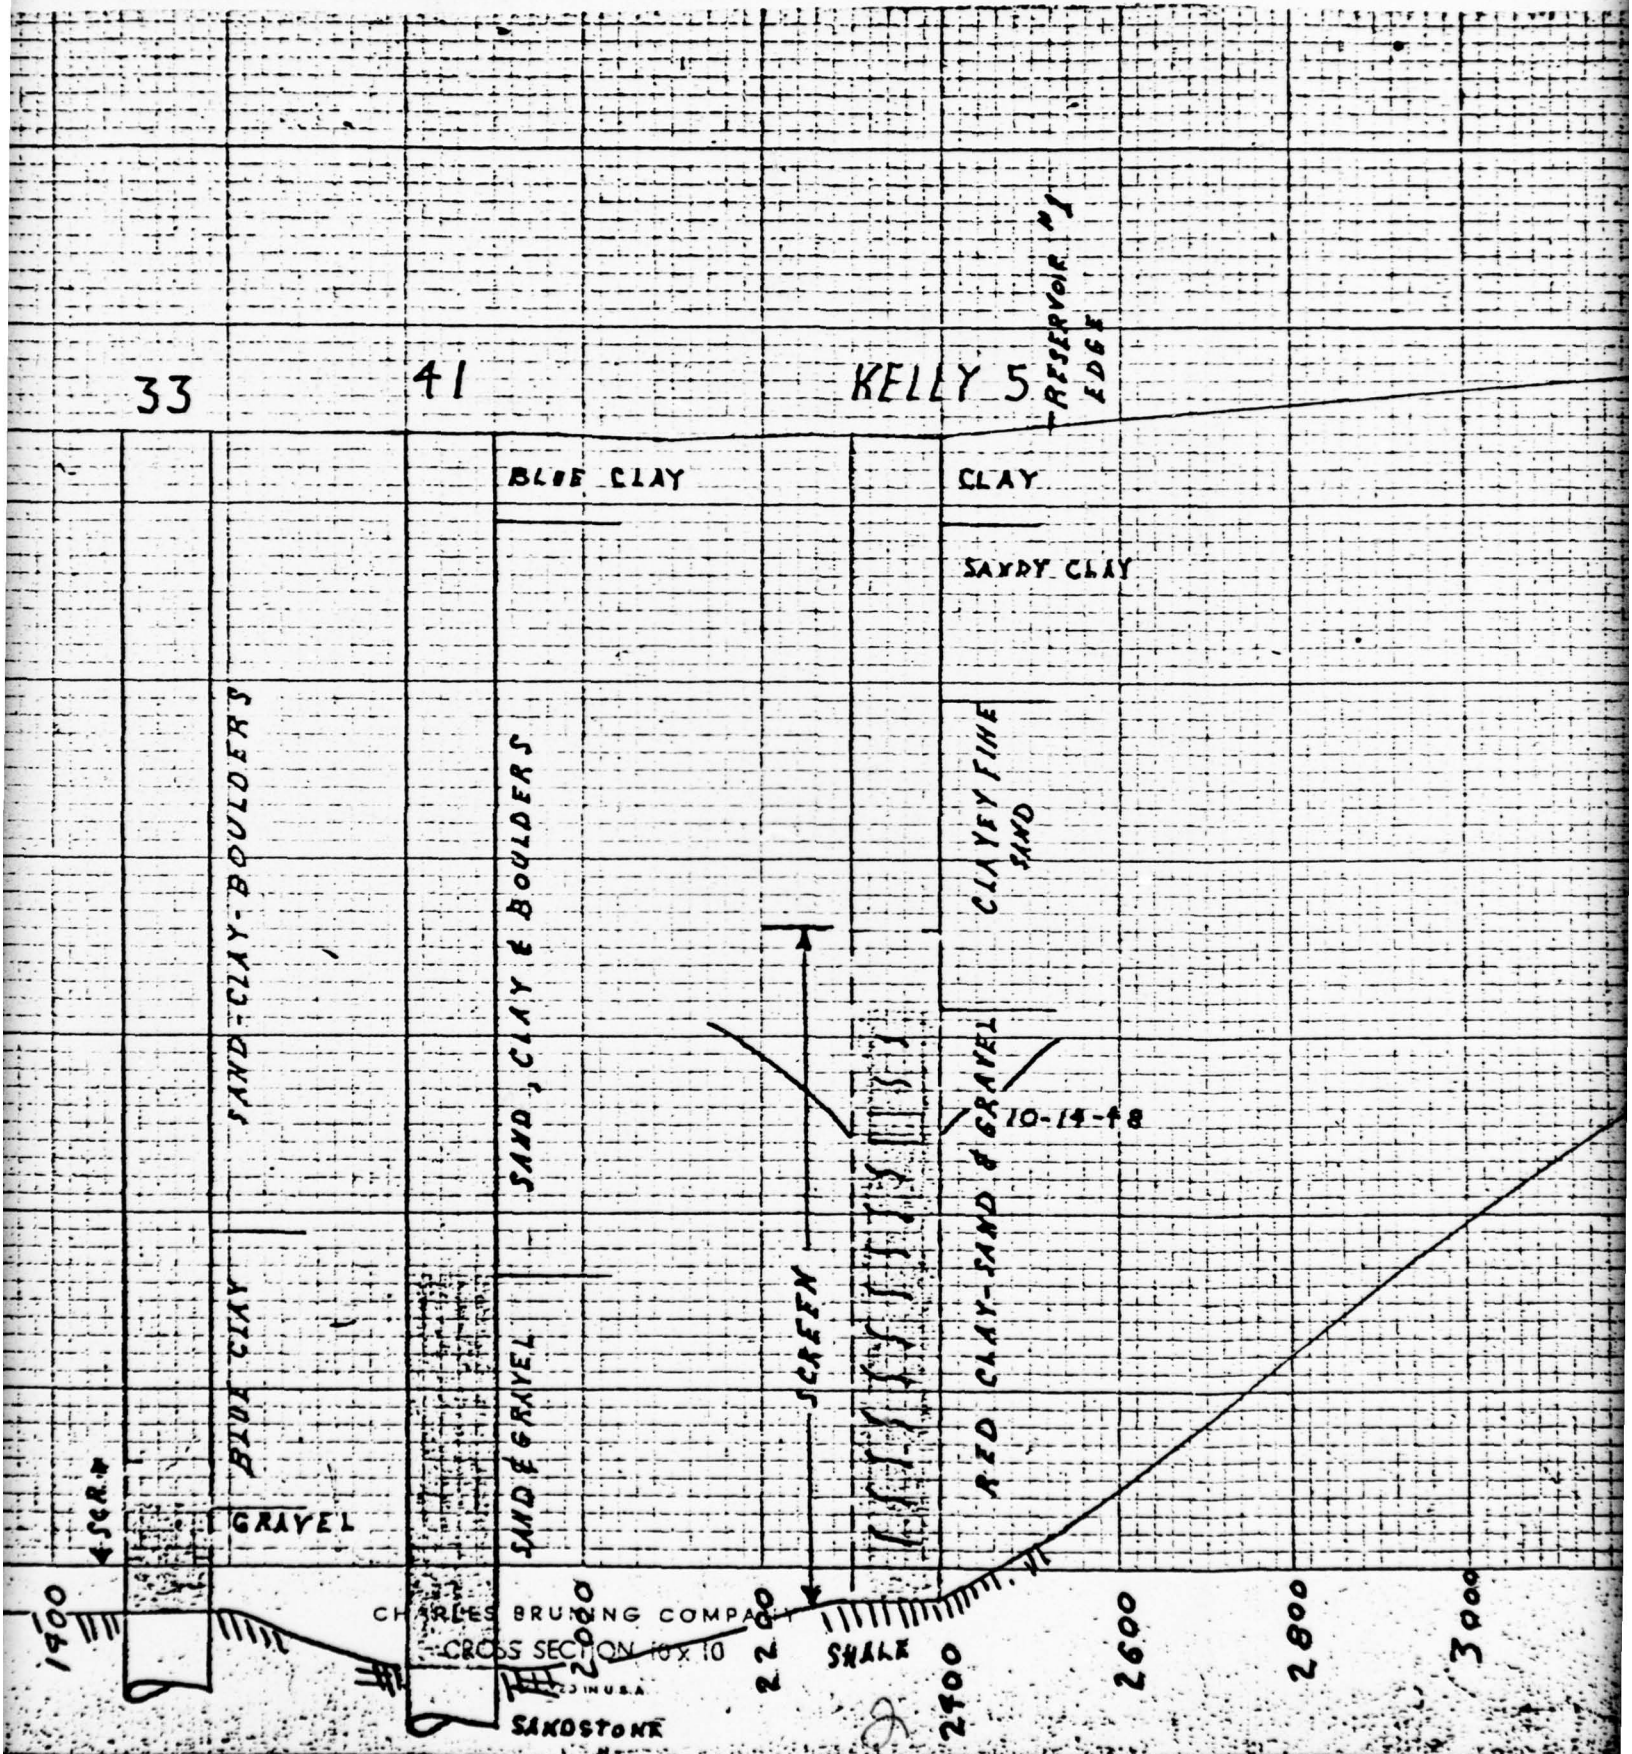
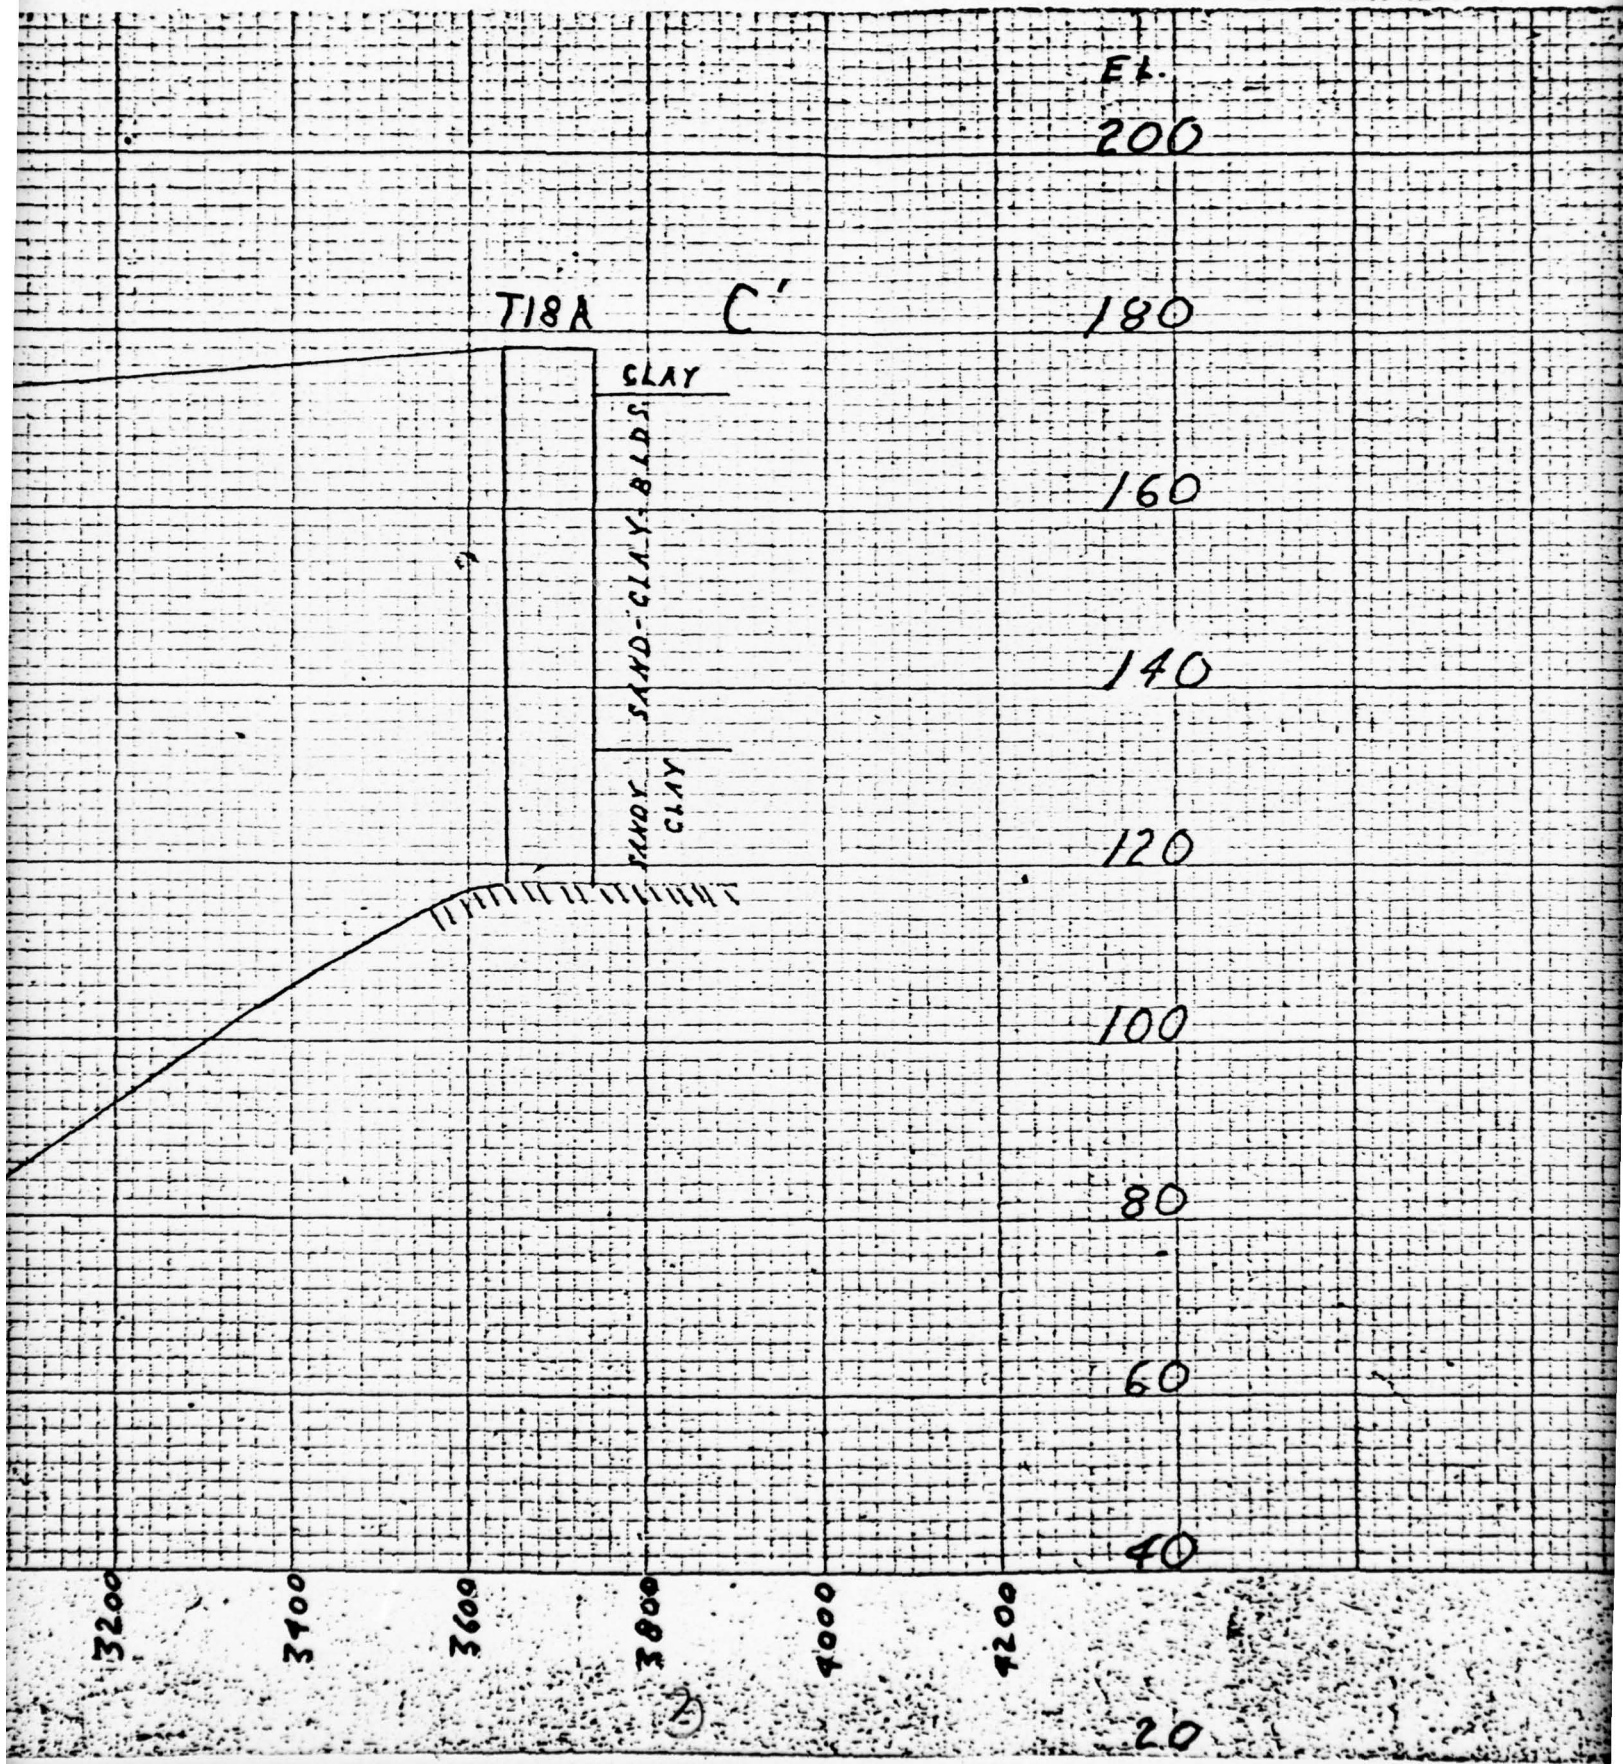
FIG. 6 - SEE FIG. 5

CANOE BROOK WELLS

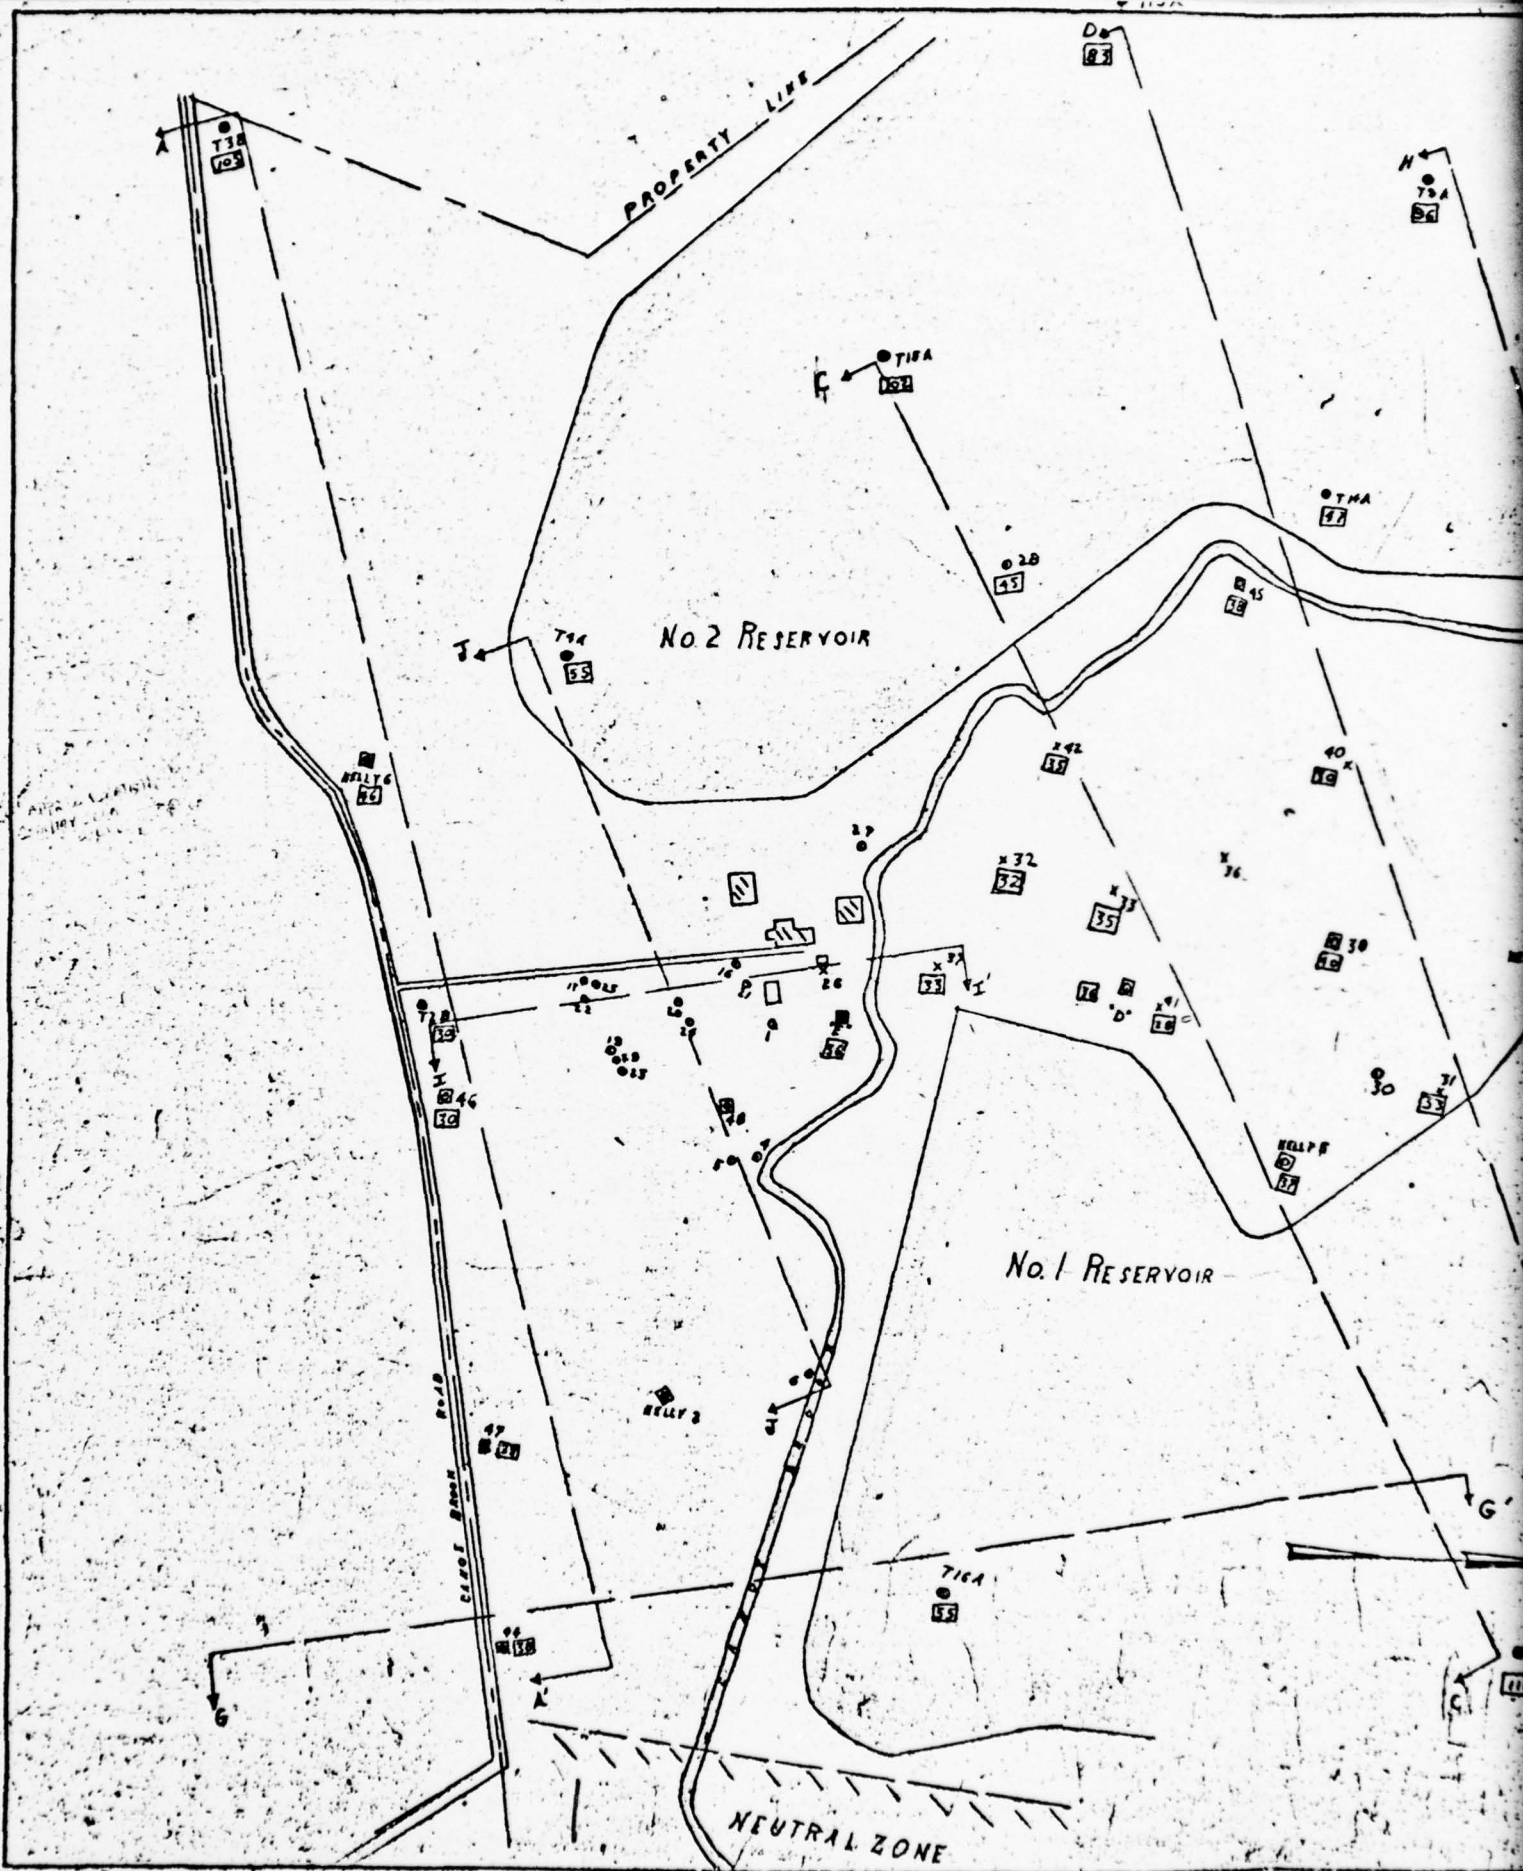
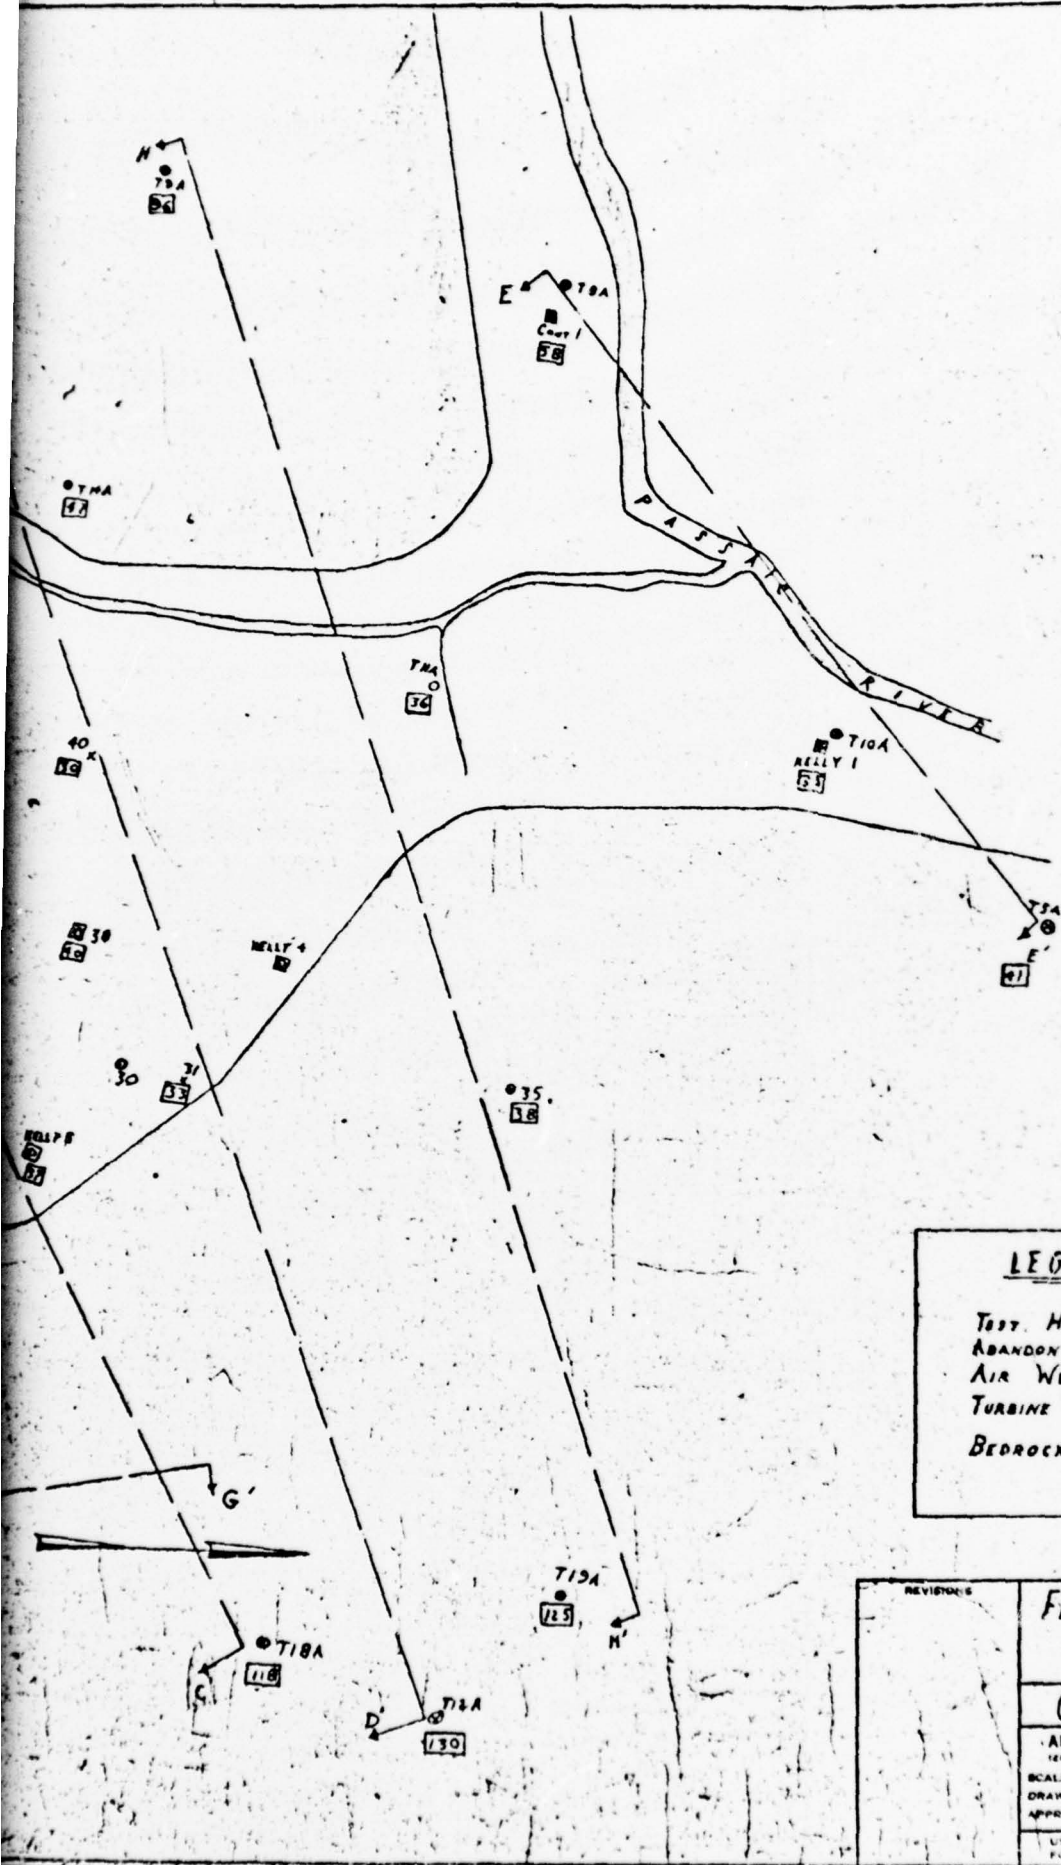
REVISIONS	<p>FIG. 5 WELLS AT THE CANOE BROOK STATION - SEE FIG. 6 FOR CROSS SECTIONS</p> <p>COMMONWEALTH WATER CO.</p> <p>AMERICAN WATER WORKS SERVICE COMPANY, INC. 121 SOUTH BRIDGE STREET PHILADELPHIA 7, PA.</p> <p>SCALE 1"=200' USE DIMENSIONS ONLY</p> <p>DRAWN BY RAR DATE 7-1-55 CHECKED BY</p> <p>APPROVED PROJECT P-89 INSP BY</p> <p>USE APPROVED DRAWINGS ONLY FOR CONSTRUCTION PURPOSES</p>	
	<p>69-845</p>
