IRONWORKS DAM

PHASE I INSPECTION REPORT NATIONAL DAM INSPECTION PROGRAM

IRONWORKS DAM
BUCKS COUNTY, PENNSYLVANIA
NATIONAL I.D. NO. PA 00789

PHASE I INSPECTION REPORT
NATIONAL DAM INSPECTION PROGRAM
IRONWORKS DAM
NATIONAL ID #PA 00789
DER NO. 9-137

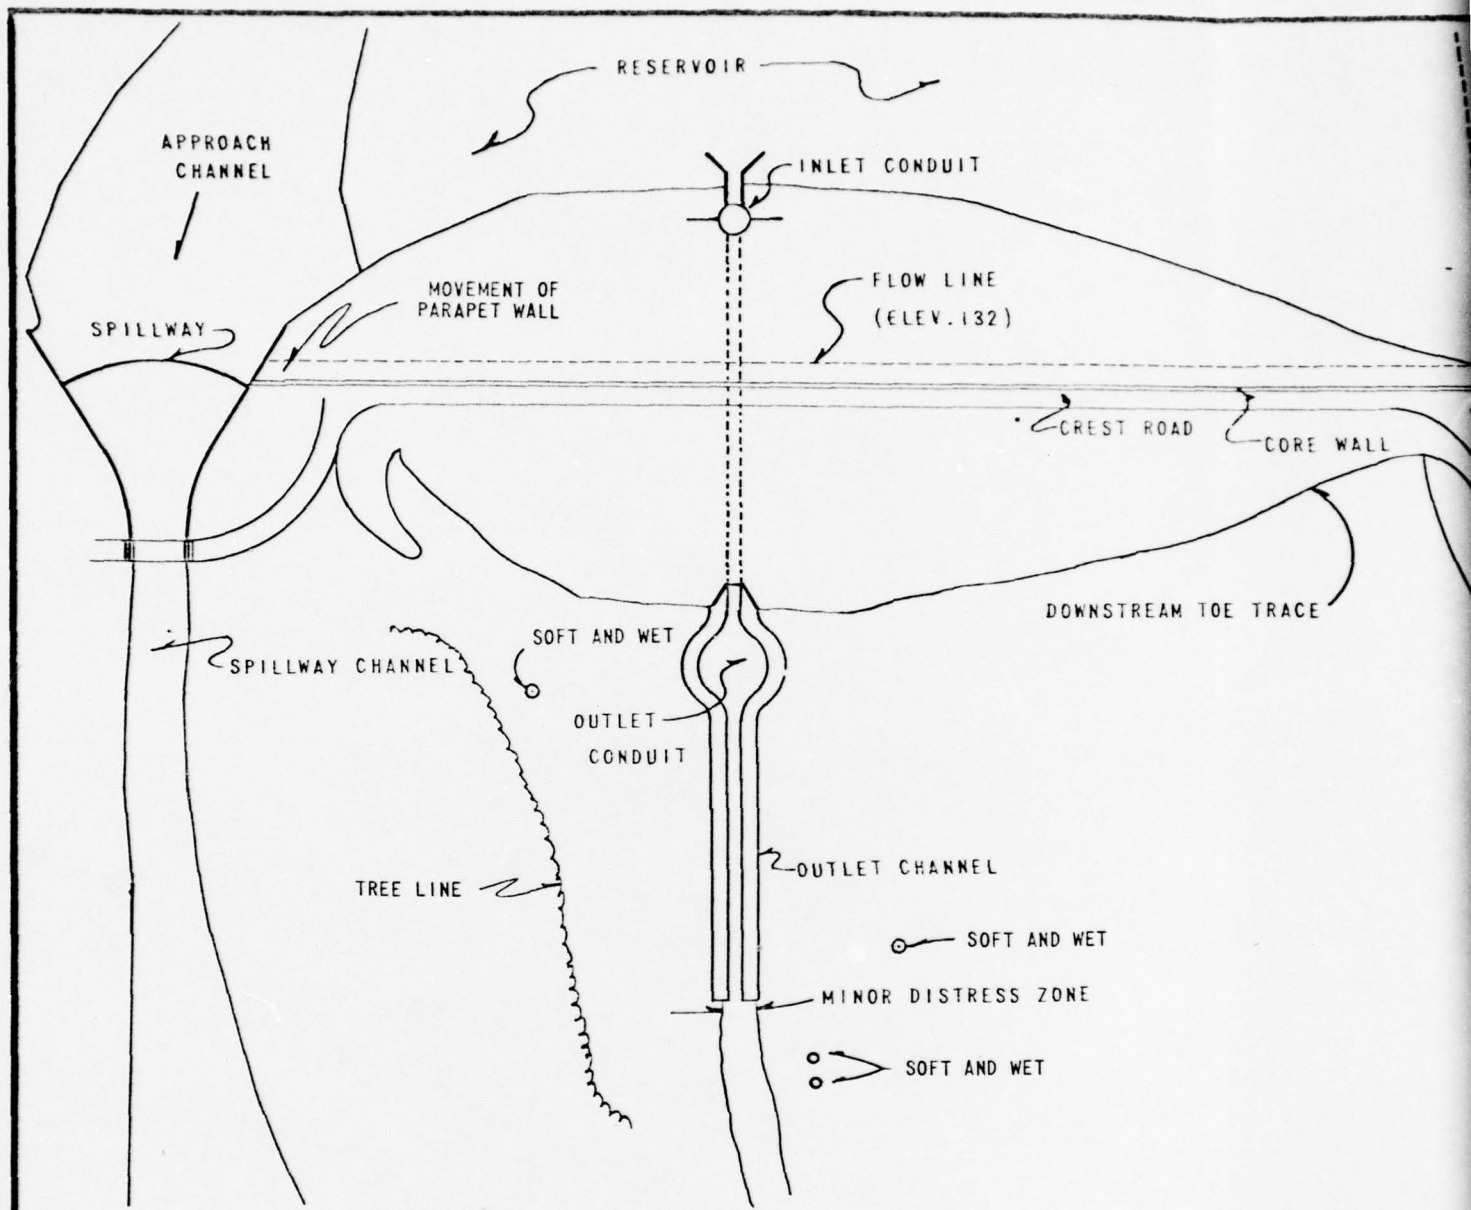
VISUAL EXAMINATION OF	OBSERVATIONS	REMARKS OR RECOMMENDATIONS
JUNCTION OF EMBANKMENT AND ABUTMENT, SPILLWAY AND DAM	<i>Nothing unusual observed.</i>	
ANY NOTICEABLE SEEPAGE	<i>None on the embankment but seepage was observed beyond the downstream toe on both sides of the outlet discharge channel. These seeps are located as shown on sheet 5a. Water was not flowing from the seeps but the areas were soft and wet.</i>	
STAFF GAGE AND RECORDER	<i>None.</i>	
DRAINS	<i>None observed.</i>
