GAI CONSULTANTS INC MONROEVILLE PA
NATIONAL DAM INSPECTION PROGRAM. HUTCHINSON RESERVOIR DAM NUMBE--ETC(U)
JAN 79

National Dam Inspection Program.
Hutchinson Reservoir Dam Number 1
(NDI-PA-214), Ohio River Basin, Redstone
Creek, Fayette County, Pennsylvania.
Phase I Inspection Report.

The visual inspection, operational history and hydrologic/hydraulic analysis indicate the facility is in poor condition. Apparent rotation of the outlet riser structure, unevenness of the upstream face and a sinkhole in the crest suggest possible internal piping problems which are possibly active under normal or high pool conditions. Records of past performance show numerous problems related to seepage both under and through the embankment during its 91 year life span.

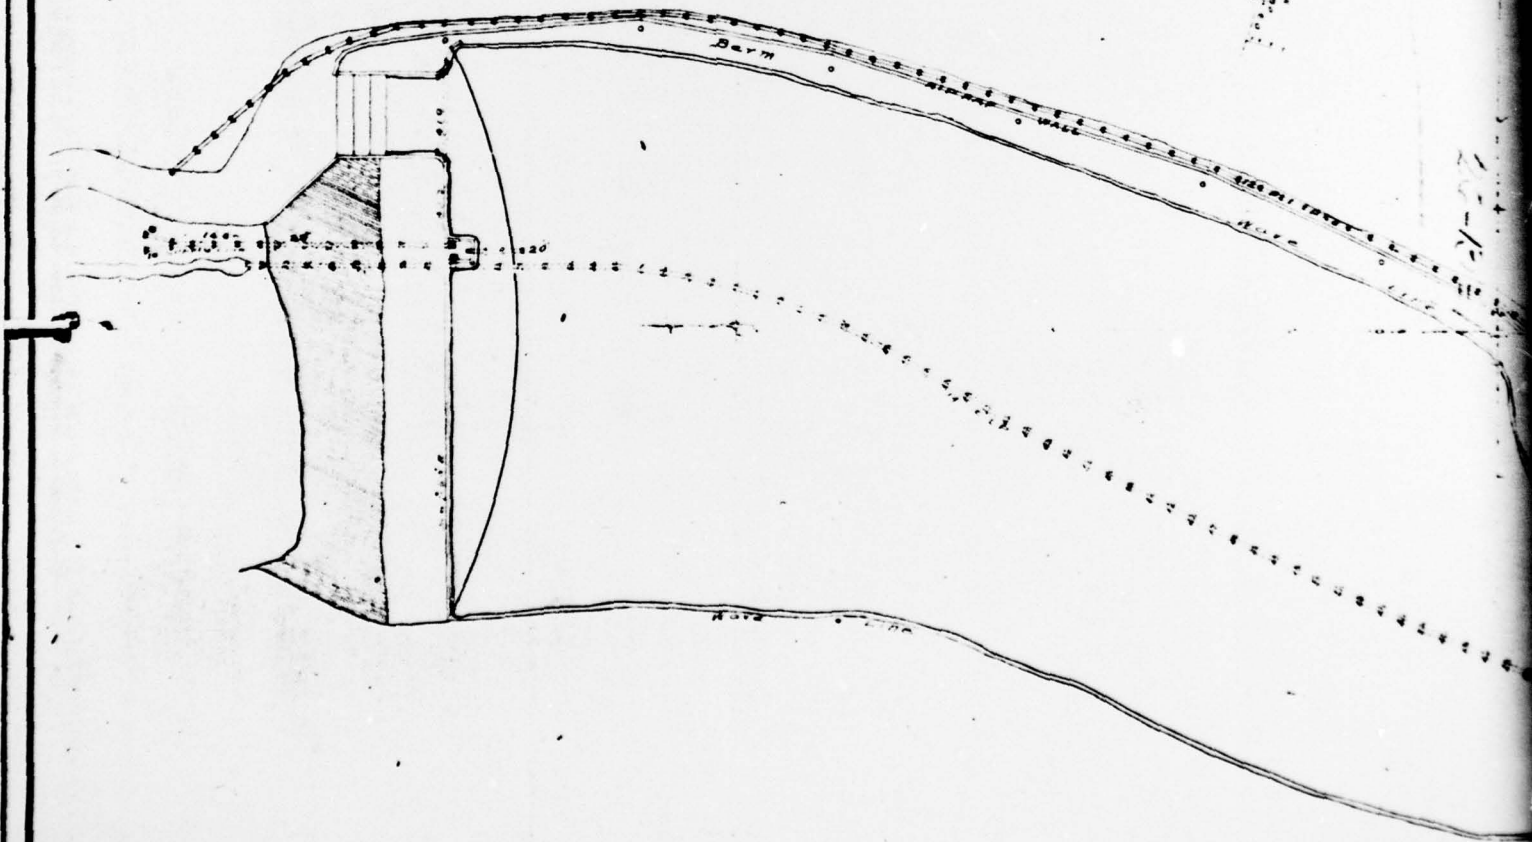
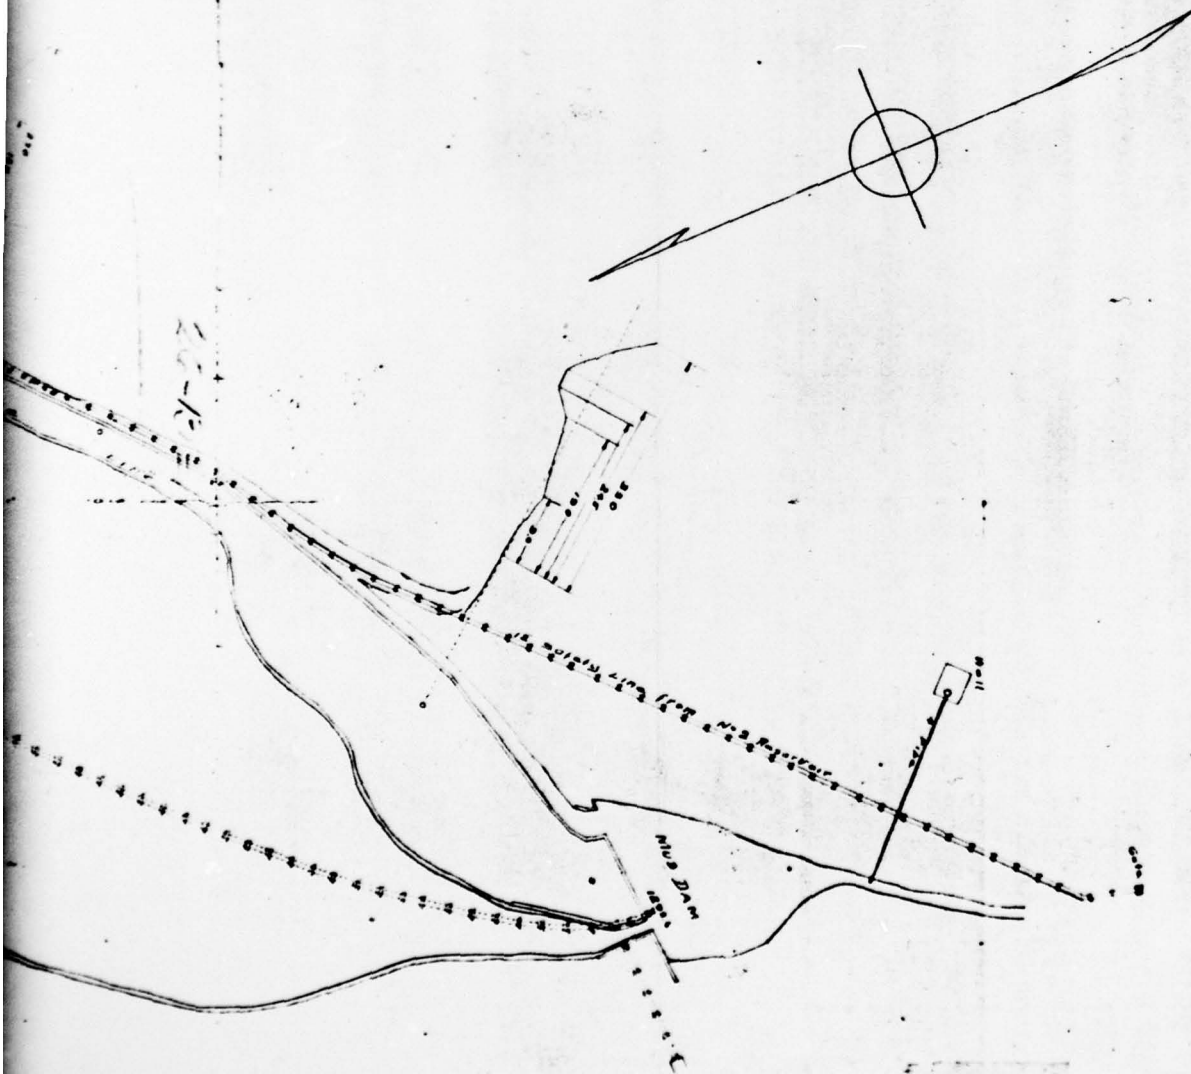
FIGURE 2

In the fall of 1930, the clay puddle core wall between the vault (see Figure 2) and the spillway was opened to a depth of 20 feet in an effort to stop seepage through the embankment near the left side of the spillway channel.

Impervious Core - Drawings indicate that the dam is provided with a 2-foot thick clay puddle core wall confined with one-inch thick oak plank. The puddle extends 14 feet below the original ground surface along the centerline section to the top of the dam (see Figure 2).
