Thorn Run Dam, NDI Number PA-271.
Ohio River Basin, Thorn Creek, Butler County,
Pennsylvania. Phase I Inspection Report.

PHASE I REPORT
National Dam Inspection Program

Thorn Run Dam

31 August 1978 and 5 September 1978

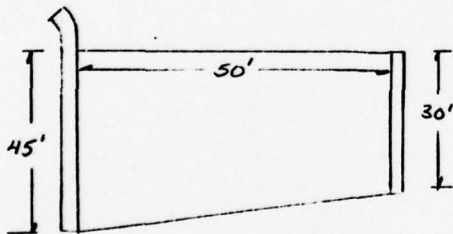
SUBJECT DAM SAFETY INSPECTION
THORN RUN DAM
BY DLB DATE 9-8-78 PROJ. NO. 78-501-271
CHKD. BY EJMI DATE 9-15-78 SHEET NO. 4 OF 9

ASSUME ANY MINOR EMBANKMENT SETTLEMENTS TO BE RESTORED TO PROPER GRADE (MAXIMUM MEASURED SETTLEMENT EQUALS APPROXIMATELY ONE FOOT)

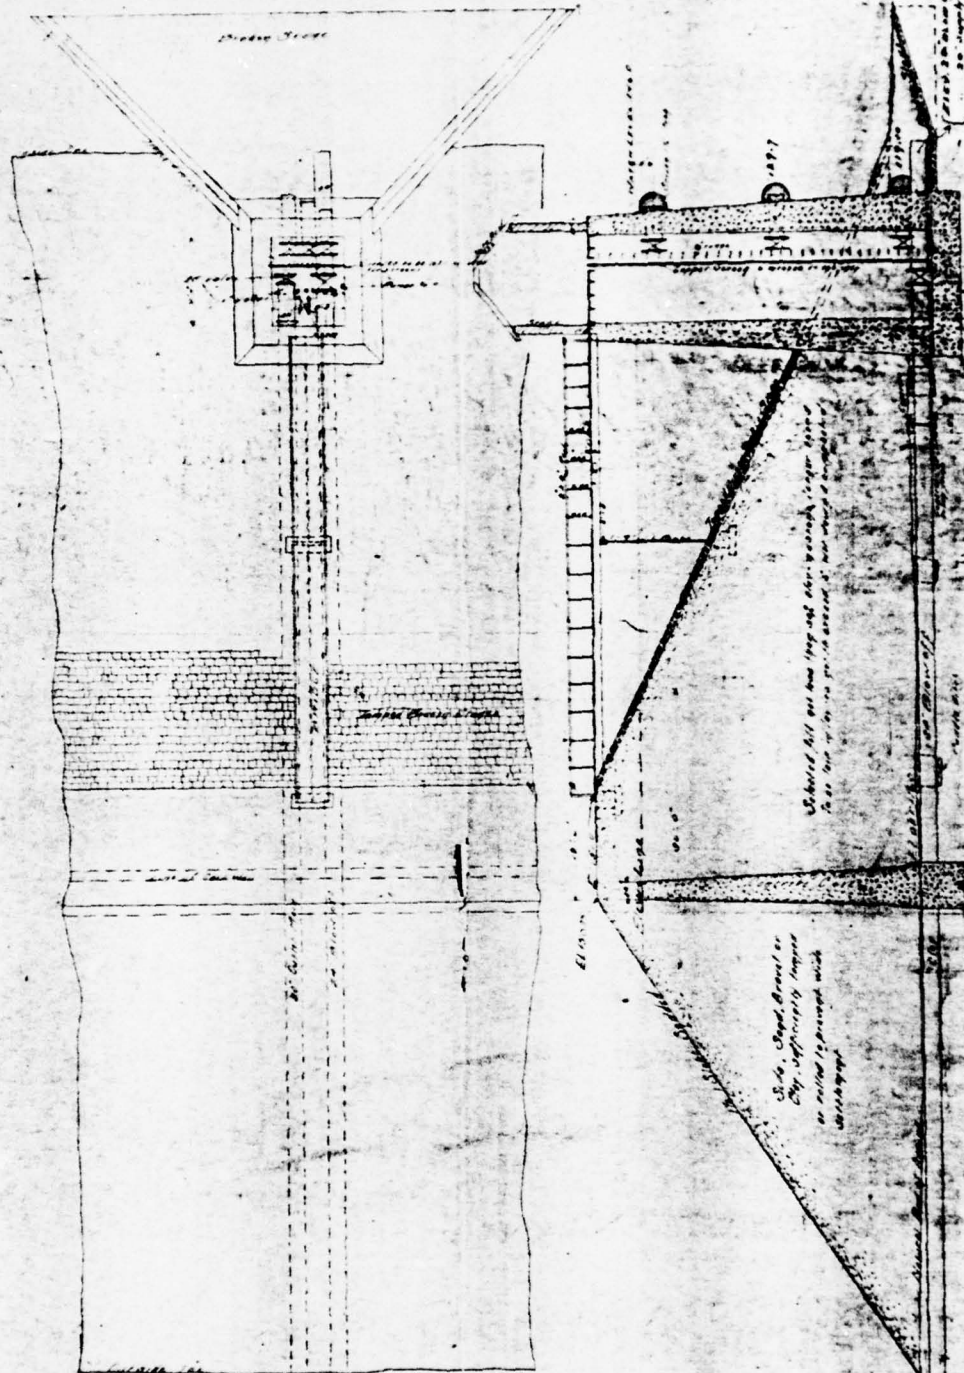
FIGURE 2

Figure 2 shows a booster station structure located at the base of the downstream toe. This masonry structure housed pumping equipment used to supplement the pumping capabilities of the water supply system located at the treatment plant. The booster station was not part of the original design. It was constructed in 1940, many years after the project had been completed and remained in operation until the system was modified and is presently non-functional.

Although the spillway has reportedly not discharged in recent weeks, a significant pool of water is visible at its discharge end. According to the available drawings (see Figure 2), the discharge end of the spillway is designed such that a small pool is normally impounded in this area, apparently to act as a stilling basin. However, the amount of water observed at the time of inspection appeared to be excessive (see Photograph 10). Less than 20 feet beyond the pool a definite flow was observed indicating that some seepage was emanating from the pool area. A small seep (less than 5 GPM) was located directly behind and below the old booster station approximately level with the stream surface. Upon further examination of this seep, gas bubbles were observed issuing from below the water level. Upon re-examining the pool area at the end of the spillway, gas bubbles were also observed from several different areas within this pool (see Figure 1). The nature or origin of the gas could not be readily ascertained.

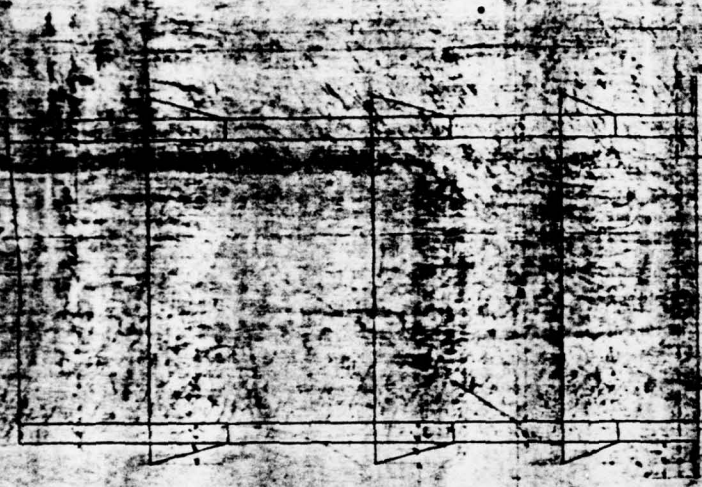
FIGURE 3

Zoning - Figure 3 indicates the embankment to be comprised of two zones separated by a concrete core wall located several feet downstream of the embankment centerline. The upstream zone is apparently composed of selected fill of not less than 30 percent clay. The drawings indicate the downstream zone is composed of a more pervious material; that is, a mixture of sods, sand, gravel and clay.

b) Outlet Conduit. The outlet works shown on Figure 3 has since been modified and is no longer an accurate representation of the system. The original design called for a 24-inch diameter cast-iron blowoff pipe and a 20-inch diameter cast-iron service main. The lines were to be laid near the center of the embankment, surrounded with clay and constructed with concrete piers surrounding each joint (see Figure 3). When the system was modified (date of which is not known) the 24-inch diameter blowoff pipe was extended to the treatment plant and now also serves as a supply line. Blowoff and drawdown capabilities are provided by a 12-inch pipe connected to the 24-inch diameter supply line and valved at the downstream toe. In addition, the flow in the 20- and 24-inch diameter supply line can be regulated at the treatment plant downstream.
