² LAKE ONEIDA DAM
NDI No. PA - 272

⁴ PHASE I INSPECTION REPORT

⁶ NATIONAL DAM INSPECTION PROGRAM .

¹¹ SEPTEMBER 1978

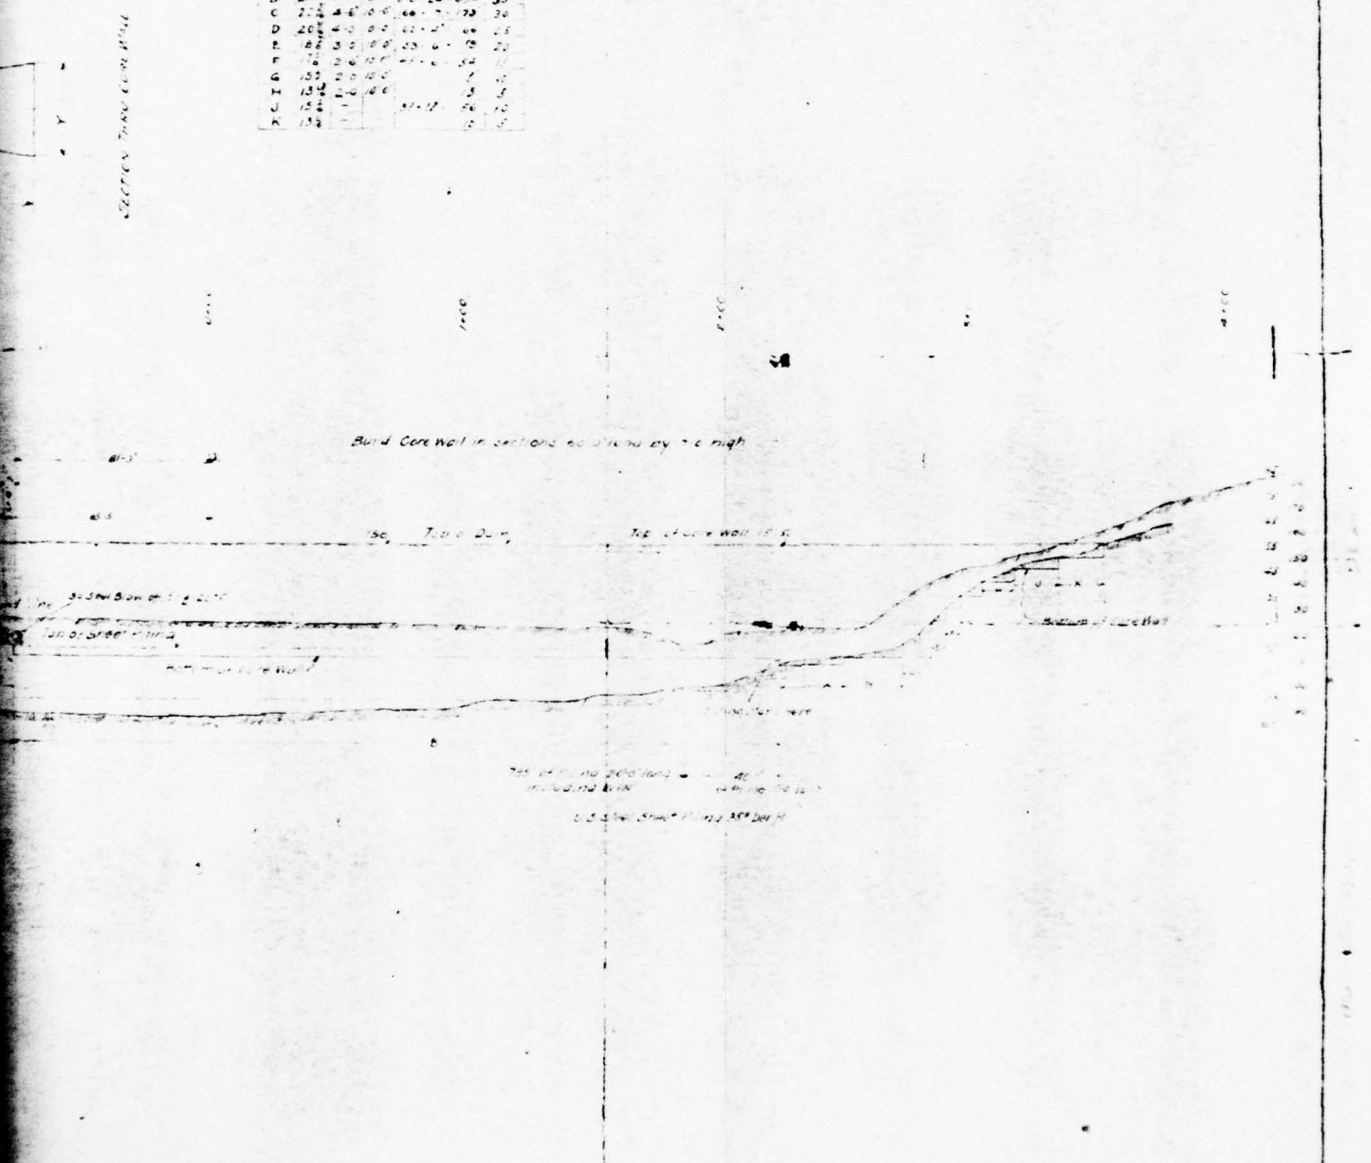
FIGURE 8
 BUTLER PA.
 LAKE ONEIDA DAM
 CORE WALL AND SHEET PILING

1. Embankment. Contract drawings, specifications, and inspection reports (all available in PennDER files) indicate the embankment is a rolled earthfill structure containing a reinforced concrete corewall underlain by interlocking steel sheetpiling. Contract drawings and the visual inspection indicate that the upstream and downstream faces are sloped at 2H:1V. Drawings and specifications indicate that four 18- x 18-inch stonefilled drainage laterals were constructed from the corewall to the downstream toe. Field inspection indicates that these drains may be directed into drain tile that discharges into the natural stream channel. Contract drawings indicate that the steel piling extends about 20 feet below the base of the corewall, probably penetrating the clay strata indicated by the geologic cross section. (See Figure 7).
