UPPER KITTANNING DAM

NDI I.D. NO: 530

PHASE I INSPECTION REPORT

Upper Kittanning Dam, NDI ID Number 530,  
Susquehanna River Basin, Burgoon Run,  
Blair County, Pennsylvania. Phase I.  
Inspection Program.

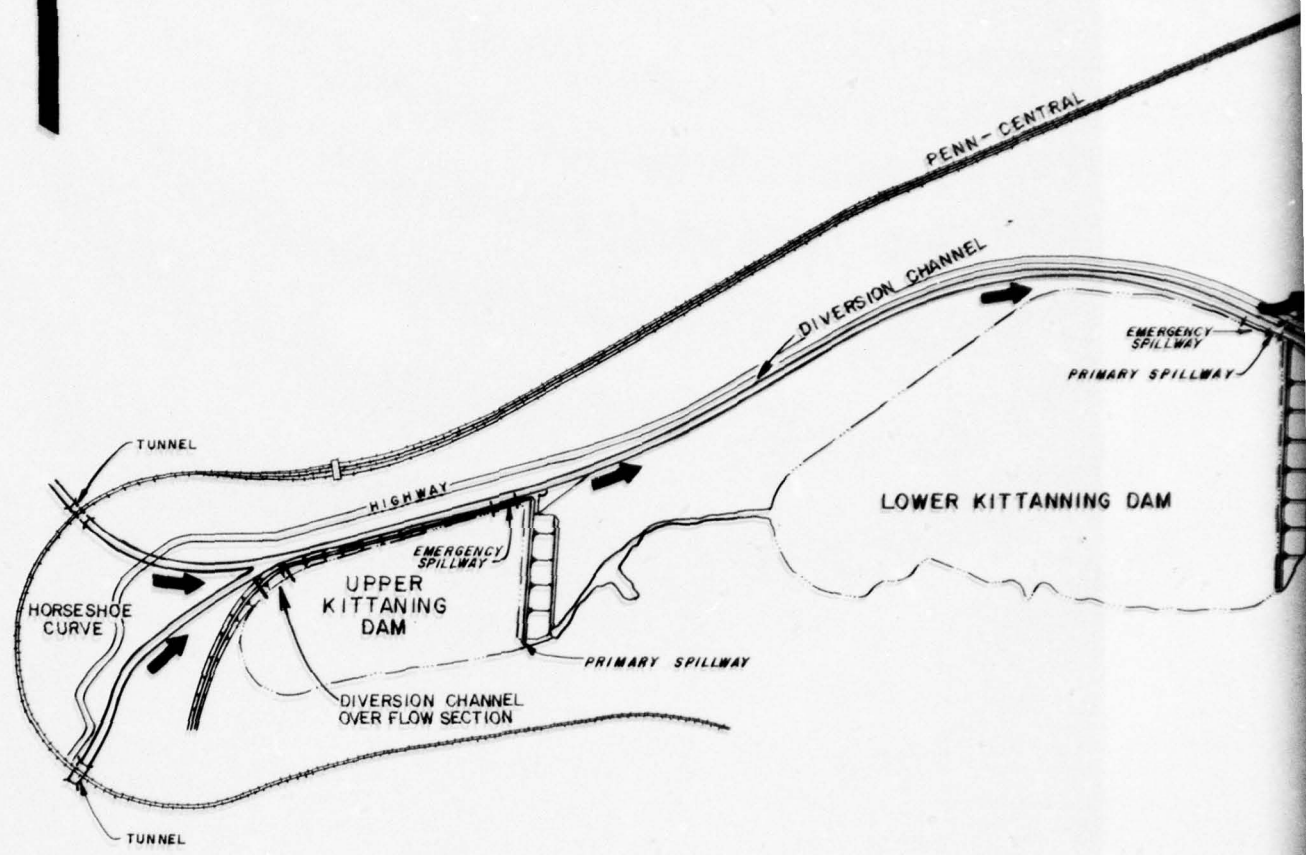
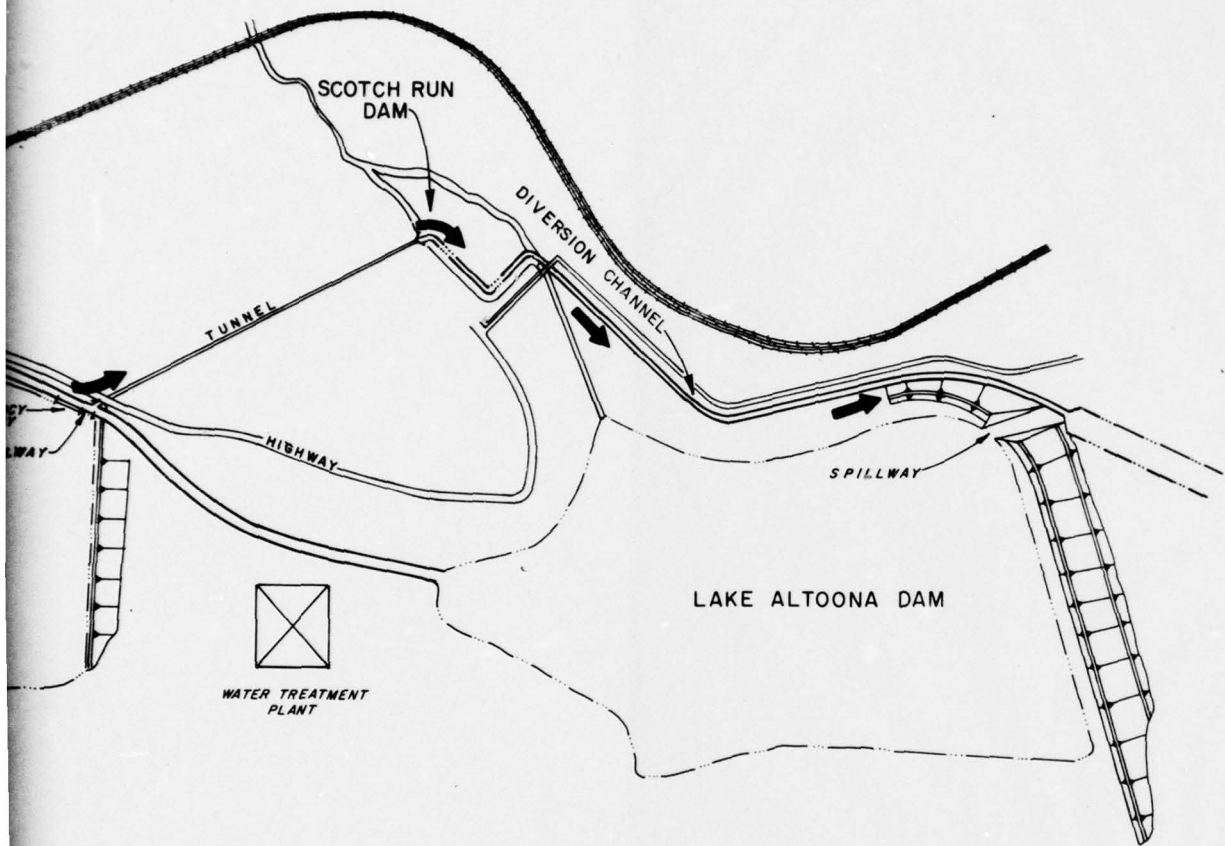
PLATE 2  
 UPPER KITTANNING DAM  
 DIVERSION CHANNEL PLAN  
**D'APPOLONIA**

The runoff from the Burgoon Run watershed is diverted by a channel bypassing the reservoir (Plate 2). The controlled inflow into the reservoir is discharged through the primary spillway and flows into the Lower Dam reservoir, which is located about 1000 feet downstream.

Under normal flow conditions, runoff from the watershed bypasses the reservoir. However, with increasing flow in the diversion channel, the reservoir would start to receive uncontrolled inflow through the diversion channel overflow section (Plate 2). This overflow section is located on the dike which separates the diversion channel and the reservoir. It is a 98-foot-long broad-crested section with its crest at a level about four feet four inches above the bottom of the diversion channel. Therefore, in the event of flow depths over four feet four inches in the diversion channel, the reservoir would receive uncontrolled inflow.

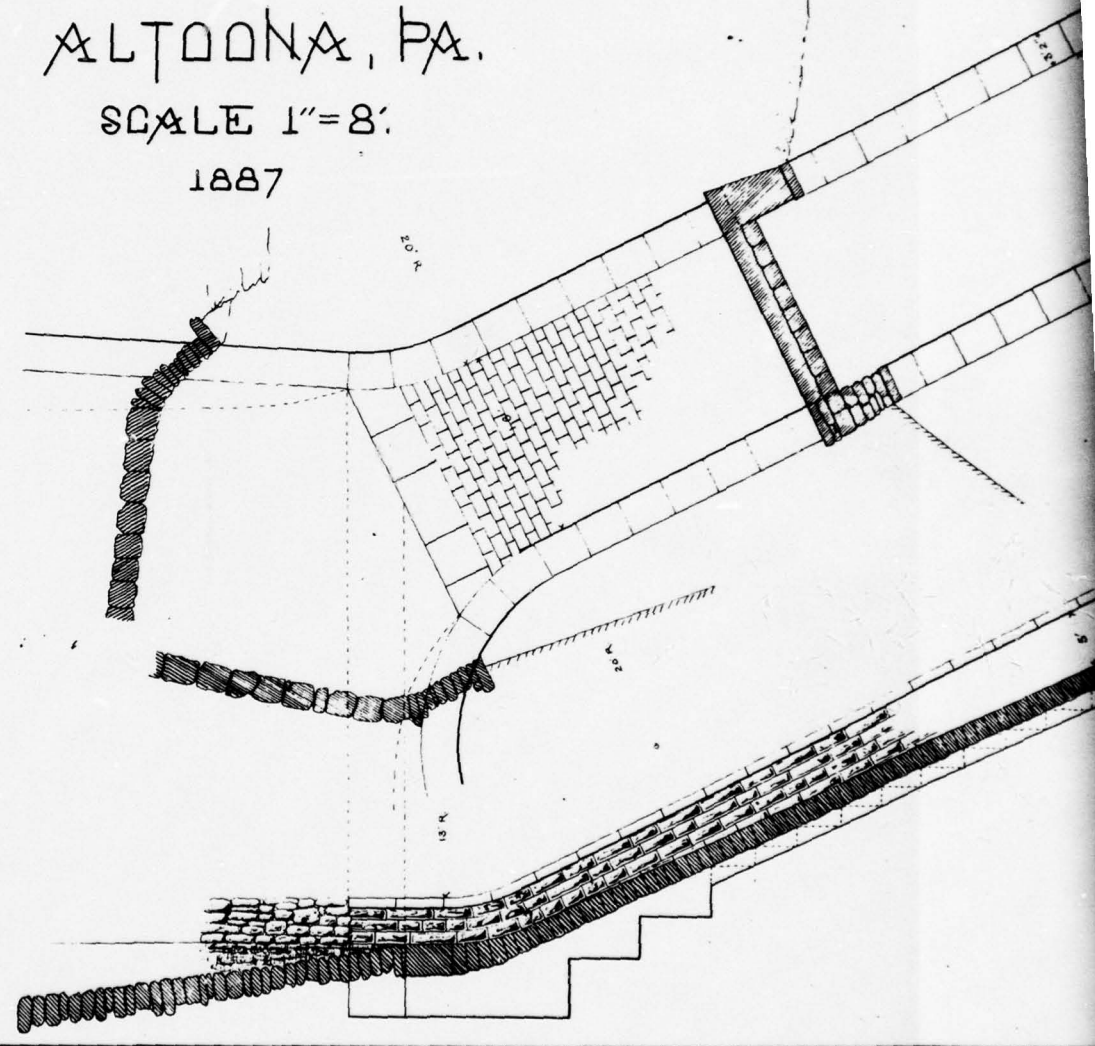
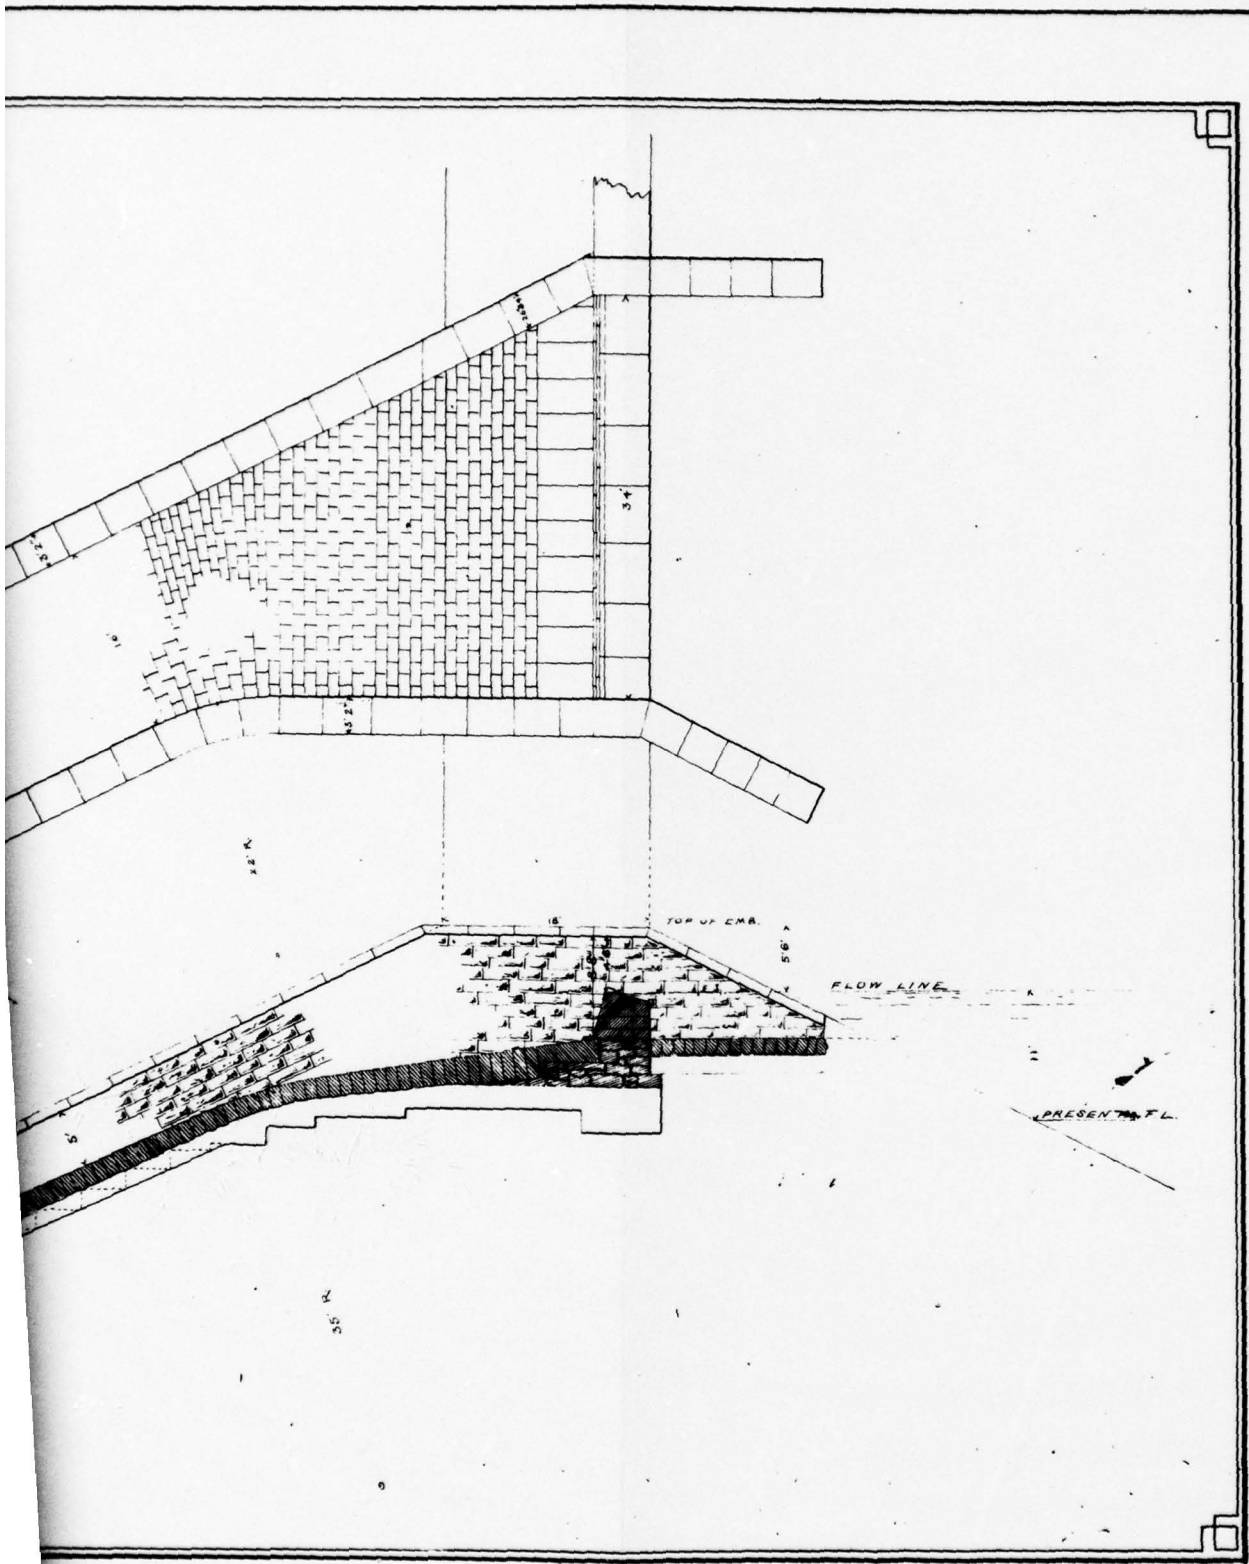
PLATE 3  
**D'APPOLONIA**

g. Design and Construction History. Available documents do not indicate the construction date of the dam. A spillway plan found in the city records, dated 1887 (Plate 3), shows a proposed enlargement of the dam. A plaque on the wall of the valve house indicates that the valve house was erected in 1888 and Mr. C. W. Knight was the responsible engineer.

2.2 Construction. Very limited information is available on the construction of the dam. Reference to a "present flow line" in a drawing dated 1887 (Plate 3) suggests that the dam was built prior to 1887. A drawing dated 1889 (Plate 5) also refers to an "old stone filling" and to an "old spillway." This drawing also indicates that the dam was enlarged in 1889.

d. Post-Construction Changes. As discussed in Section 2.2, the dam was enlarged in 1894. Plates 3 and 5 illustrate this post-construction change.

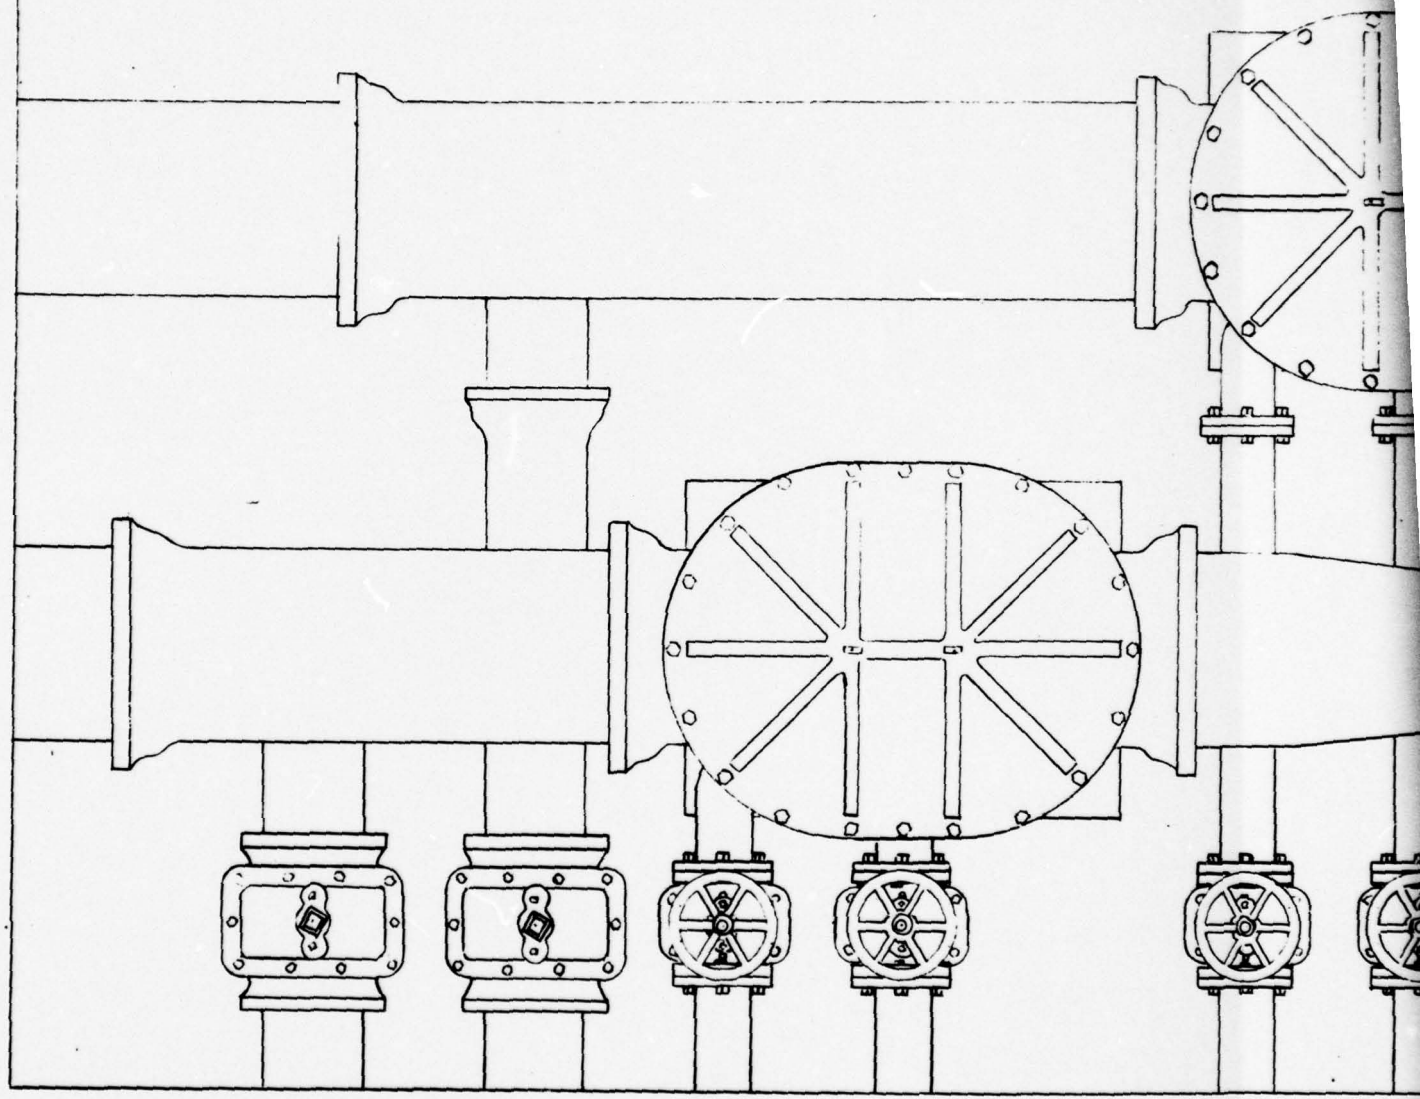
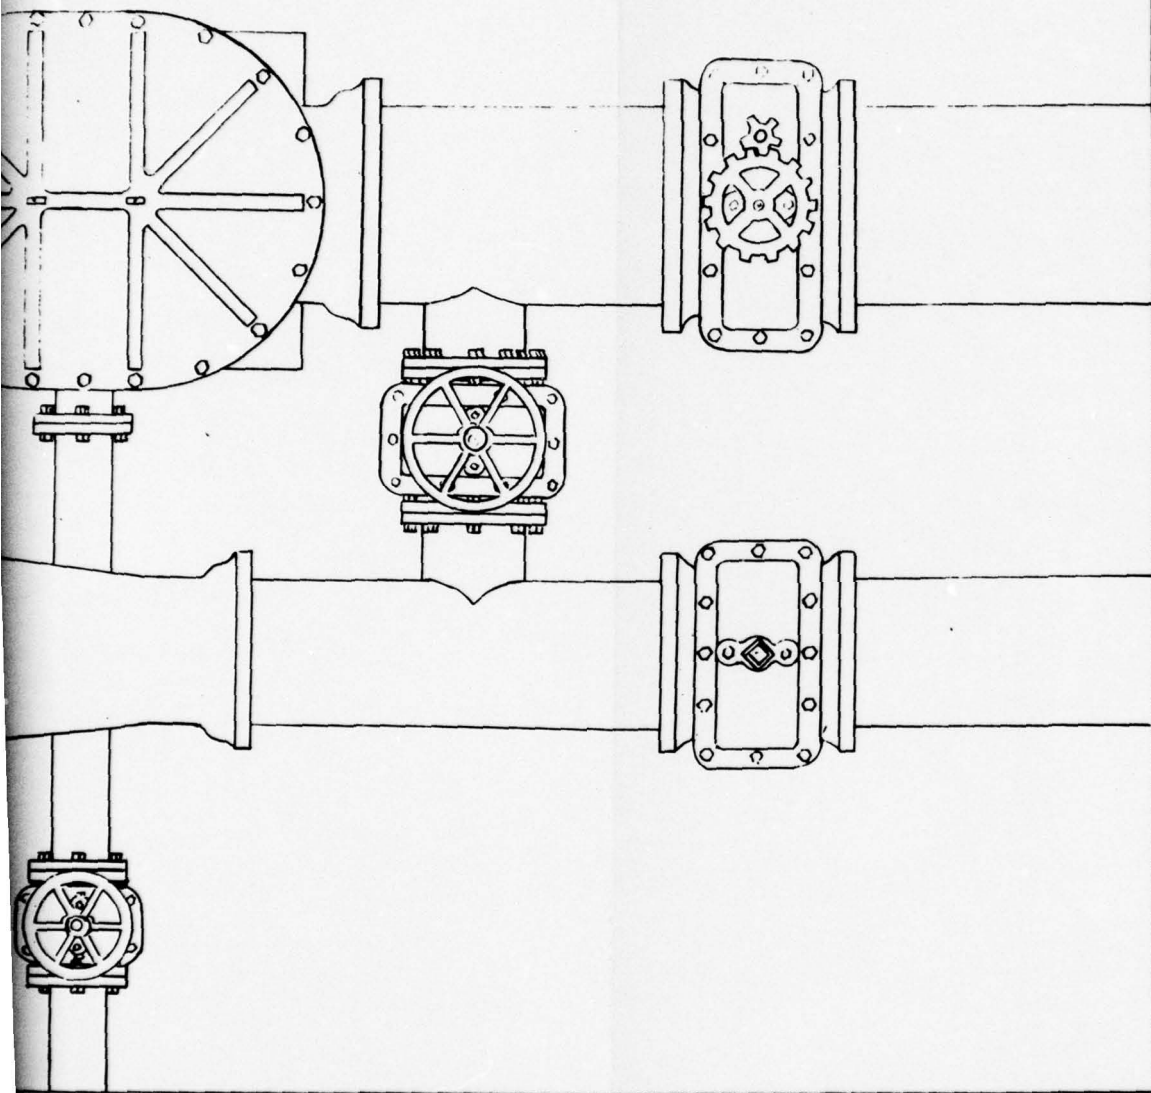
PLATE 6  
**D'APPOLONIA**

(3) Appurtenant Structures. Very limited information is available on the design of the outlet works. Plate 6 shows the arrangement of the blow-off valves in the valve house. No information is available on the configuration of the pipes through the embankment.

4.3 Maintenance of Operating Facilities. City maintenance personnel reported that the upstream controls on the supply and blow-off pipe are not operational. The blow-off valves located at the downstream valve house were operated and observed to be operable. Visual observations indicate that the operating equipment is in poor condition. The condition of the downstream valve on the 24-inch lake blow-off line shown in Plate 6 is unknown, along with the location of its discharge point.

It is recommended that the owner immediately perform the necessary maintenance to the upstream controls located at the intake tower to make them operational.

It is recommended that the owner take necessary steps to evaluate the structural integrity of the pipes through the embankment.
