LAKE ALTOONA DAM

NDI I.D. NO: 532

PHASE I INSPECTION REPORT

LAKE ALTOONA DAM
NDI I.D. NO. 532
AUGUST 9, 1978

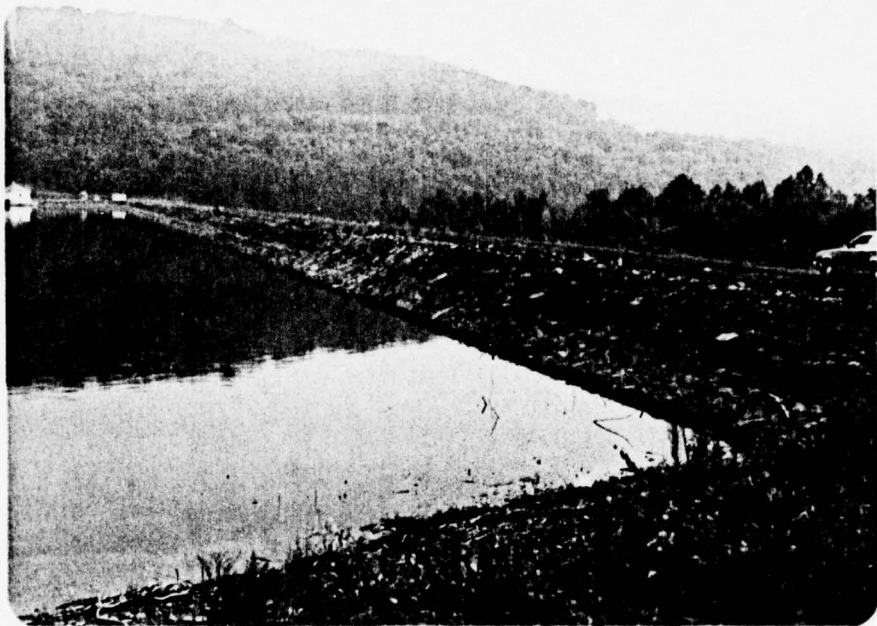
Upstream Face

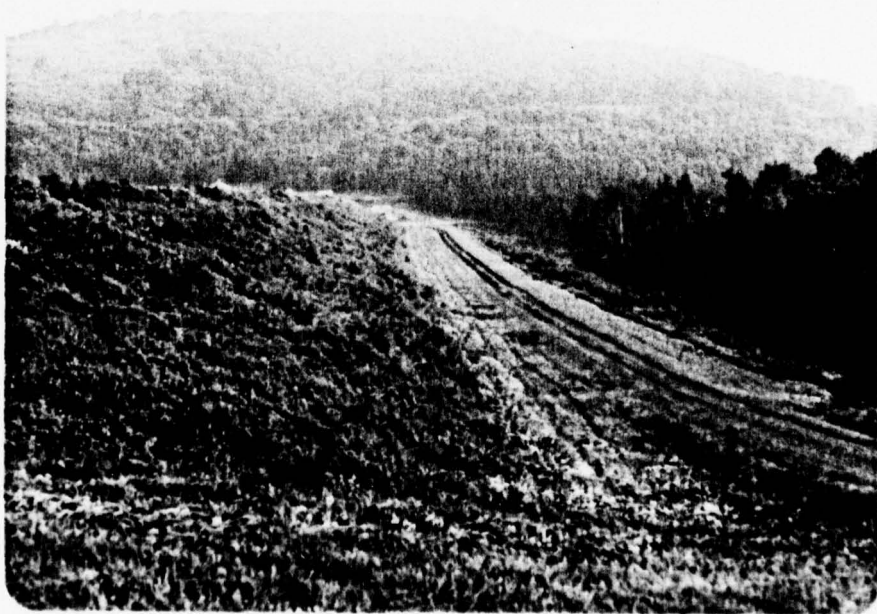
Downstream Face

4.2 Maintenance of the Dam. The general condition of the dam is considered to be satisfactory. Periodic removal of the brush from the downstream face of the dam and the area below the toe is required.

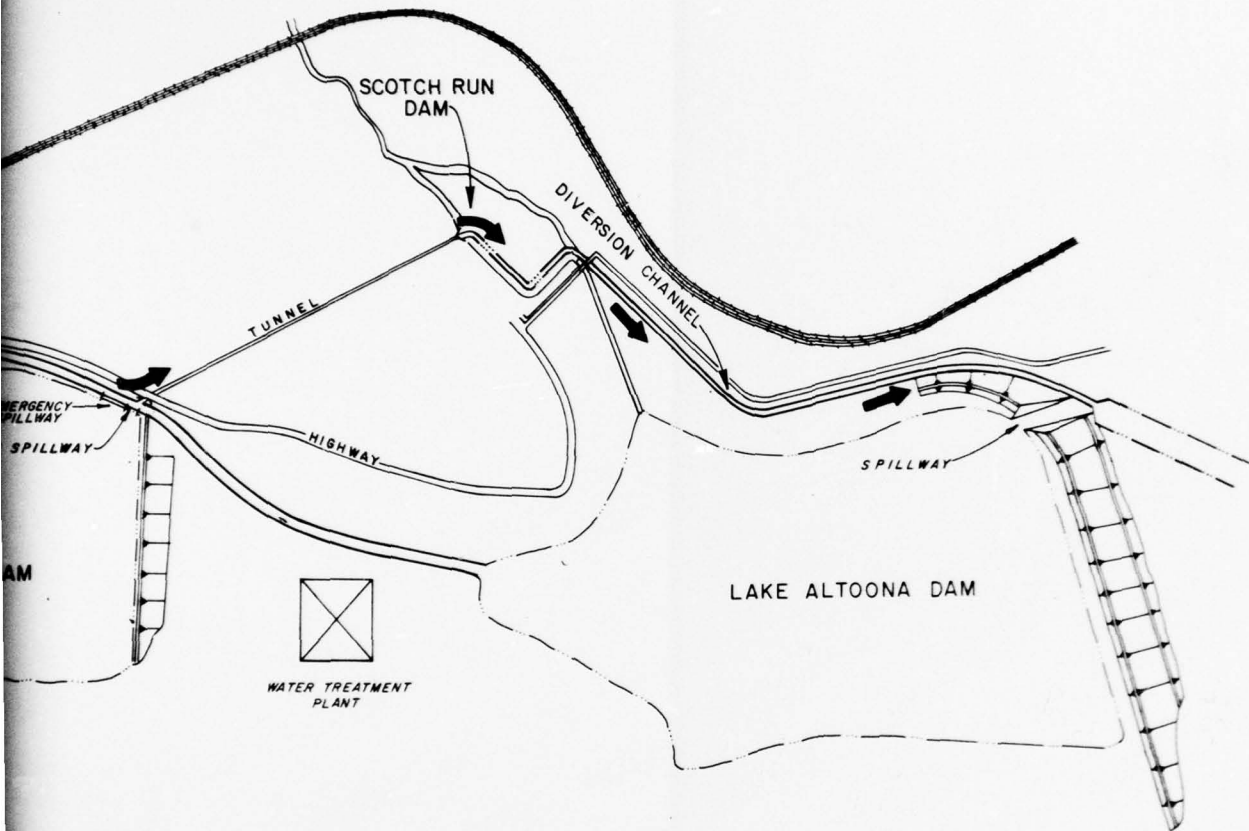
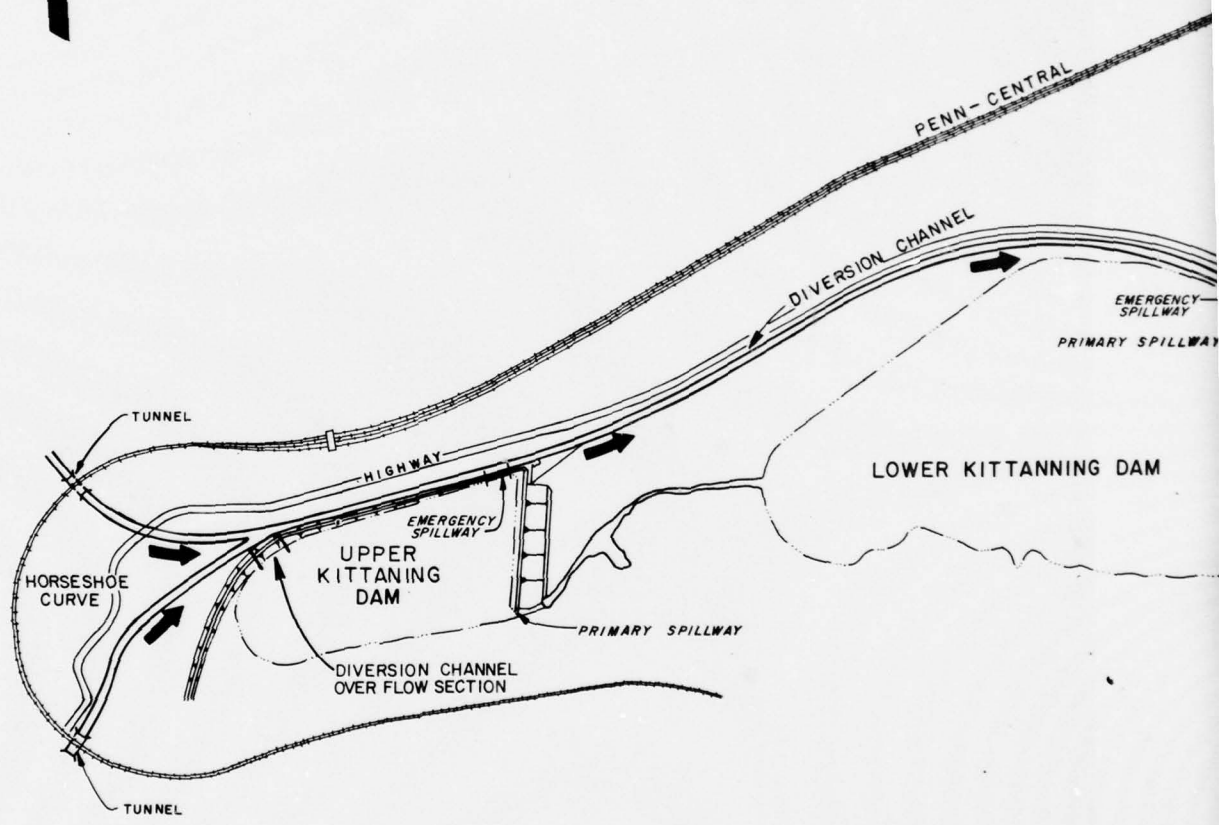
PLATE 2
 LAKE ALTOONA DAM
 DIVERSION CHANNEL PLAN
D'APPOLONIA

The normal runoff from the Burgoon Run watershed is diverted through a channel bypassing the reservoir (Plate 2). The excess flow into the reservoir is discharged over the spillway into the diversion channel which terminates at a plunge pool at the toe of the dam.

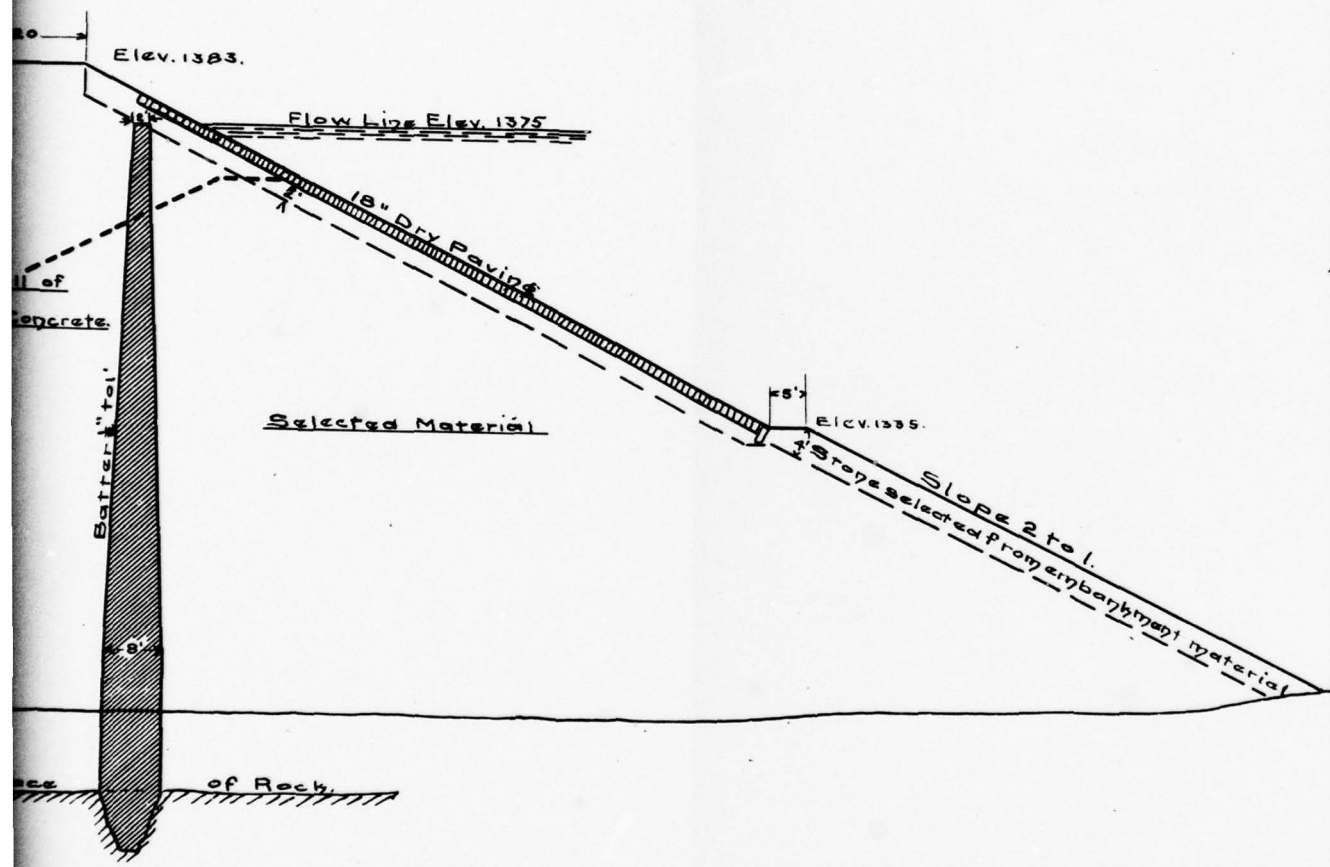
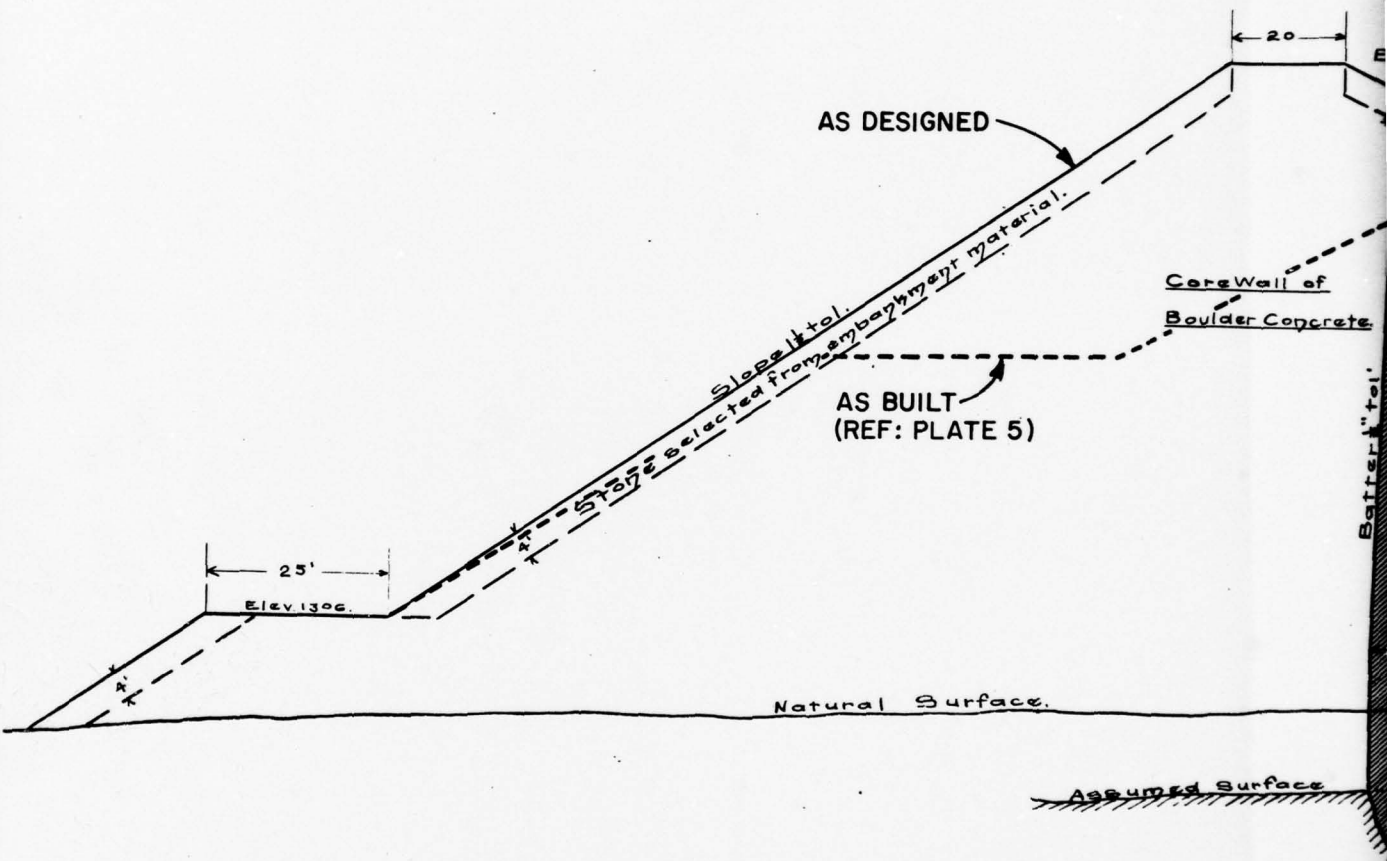
PLATE 3

- a. As designed, the dam was supposed to be a 90-foot-high embankment with its crest at Elevation 1383 (Plate 3). However, the dam was only completed to Elevation 1364.

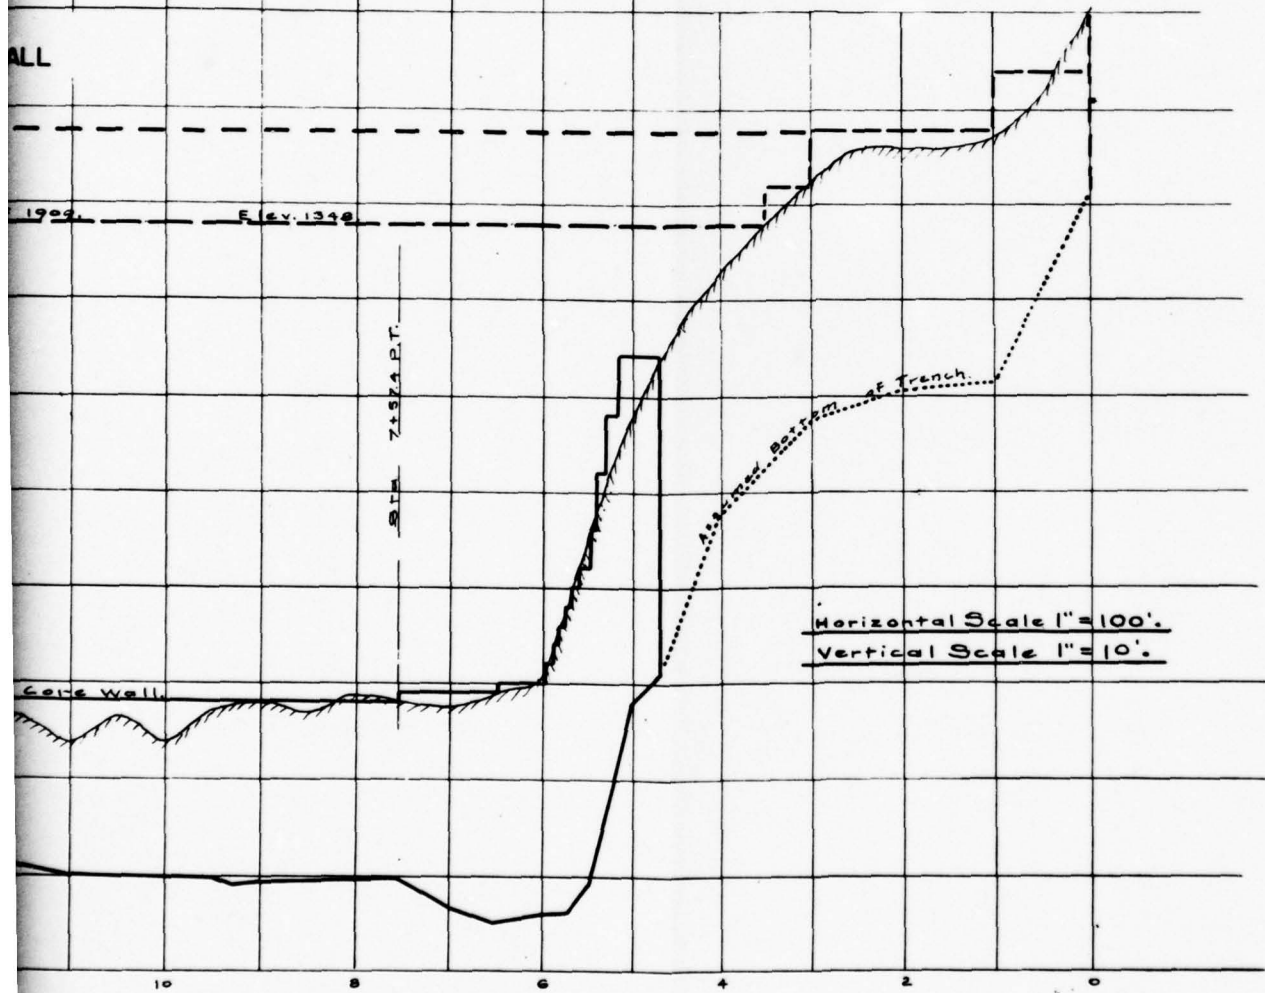
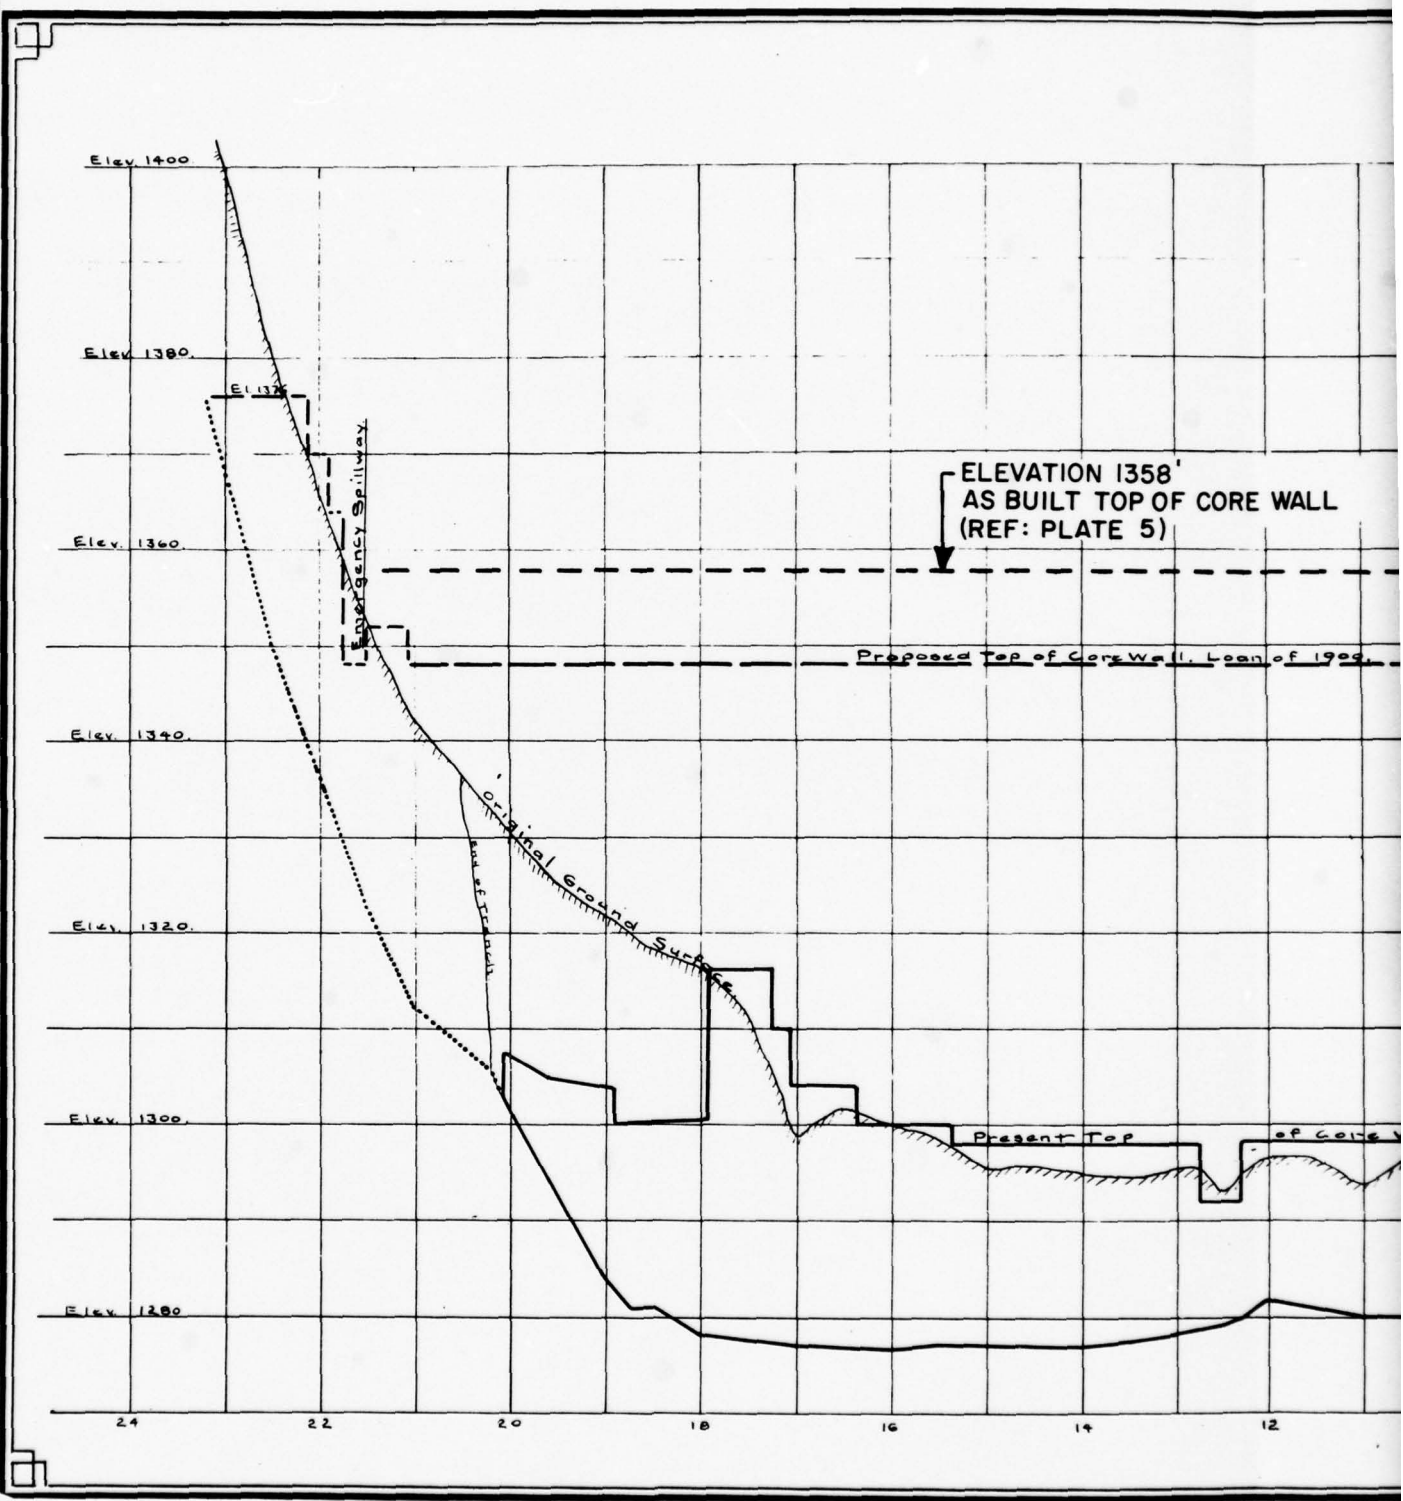
PLATE 4

- b. As designed, the dam is essentially a homogeneous embankment with a concrete cutoff wall extending from six feet below the present crest elevation to about 20 feet into the original ground level (Plate 4). As constructed the cutoff wall is about 20 feet downstream of the dam center line.

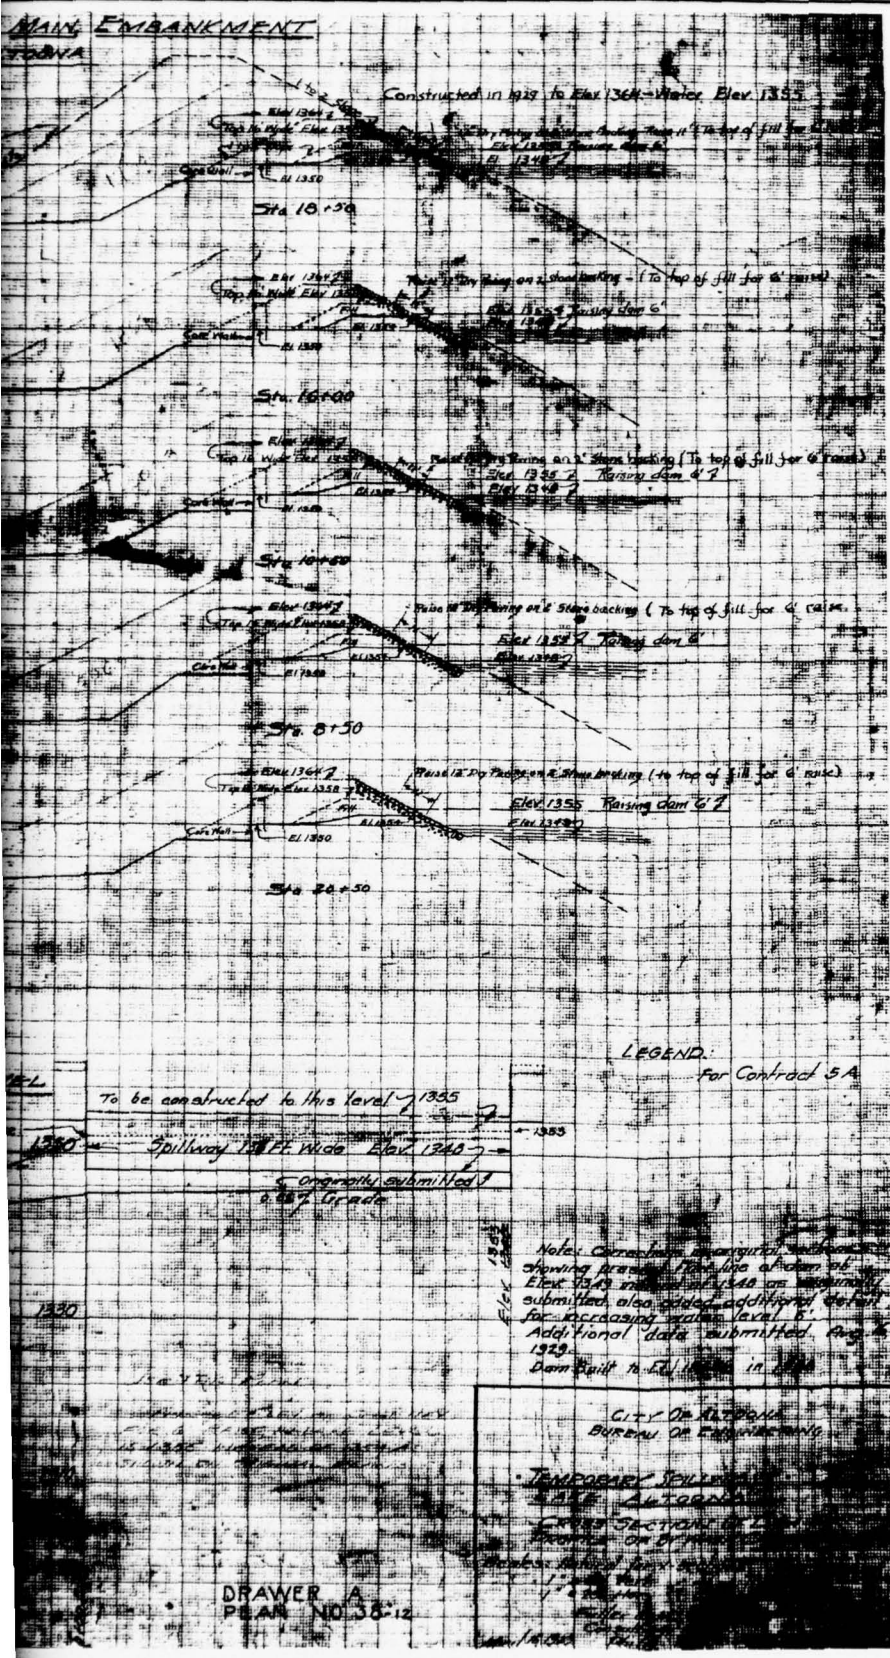
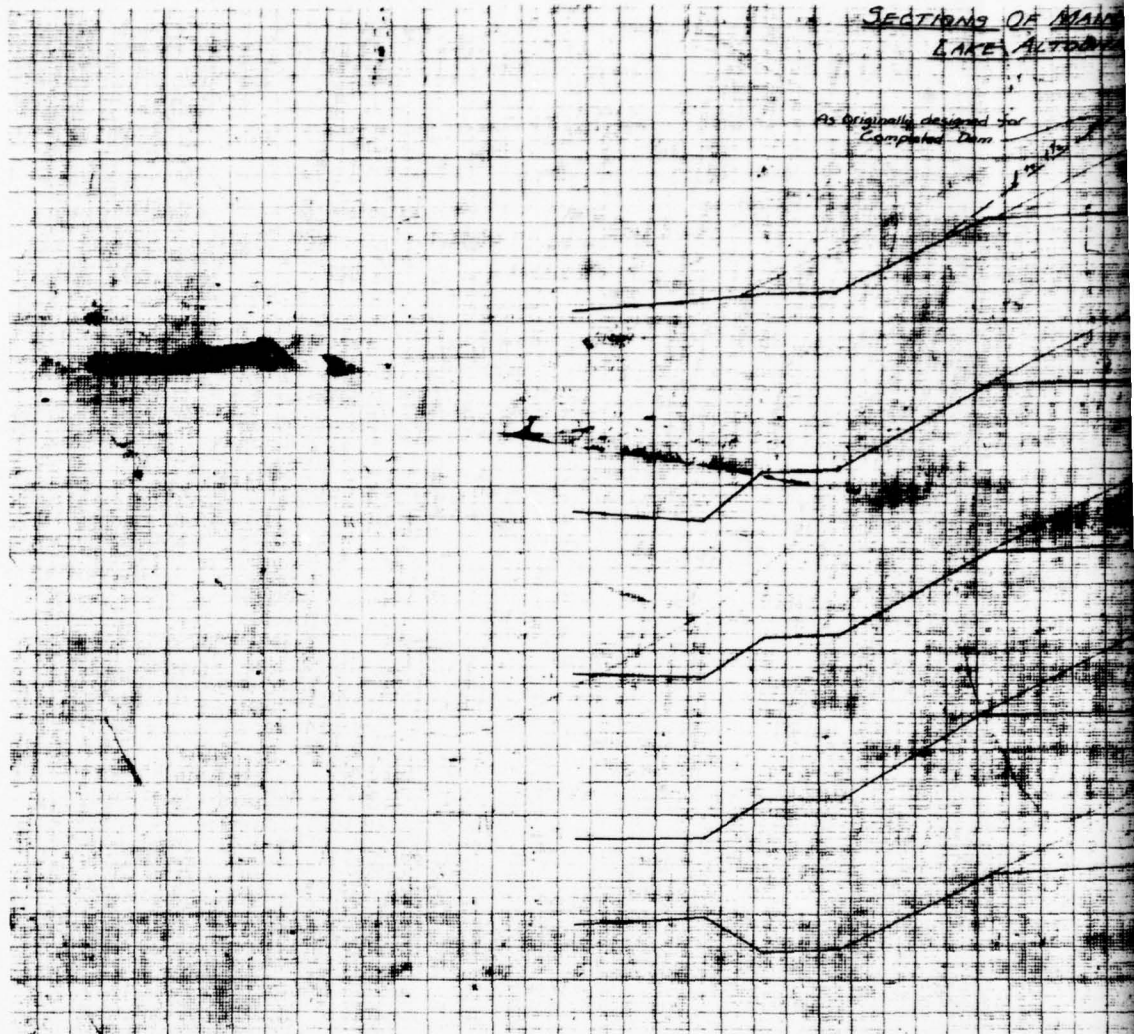
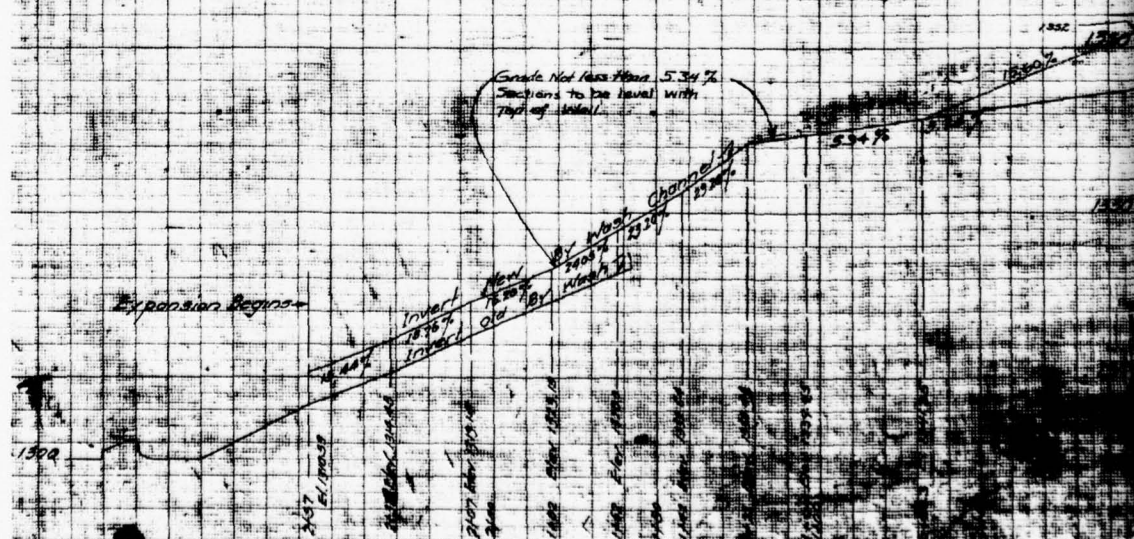
PLATE 5

- c. The embankment, as it exists, has two to one (horizontal to vertical) slopes on both the downstream and upstream slopes (Plate 5). The downstream slope of the dam is broken by two benches: a 40-foot-wide bench 33 feet below the dam, and a 25-foot-wide bench 58 feet below the dam crest.
