SILVER CREEK DAM

NDS ID NO. PA-00665
DER ID NO. 54-23

PHASE I INSPECTION REPORT

Prepared by
GANNETT FLEMING CORDDRY AND CARPENTER, INC.
Consulting Engineers
Harrisburg, Pennsylvania 17105

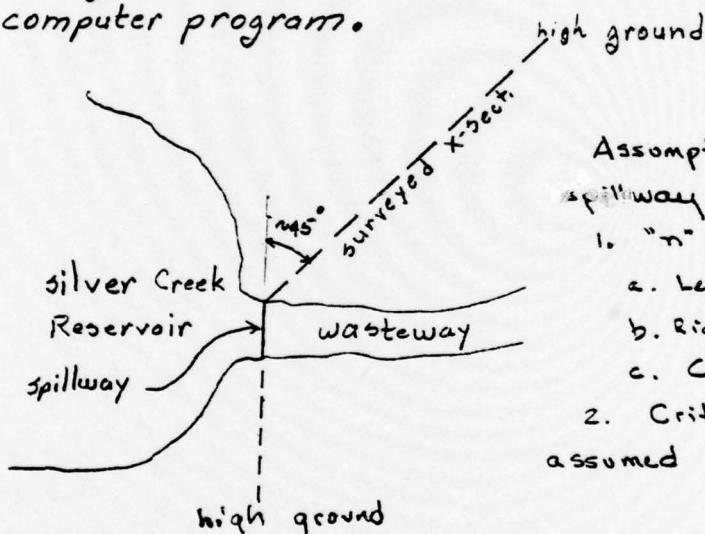
The emergency outflow from the dam will occur over the spillway and as overbank flow on the low-lying ground adjacent to the spillway. This emergency flow will go into the next watershed (Big Creek).

The depth of flow @ $Q = 1870$ cfs was analyzed using surveyed cross section data and the HEC-2 computer program.

- Assumptions for computing spillway capacity:
1. "n" values:
 - a. Left overbank: $n = 0.085$
 - b. Right overbank: $n = 1.20$
 - c. Channel: $n = 0.040$
 2. Critical depth assumed at weir

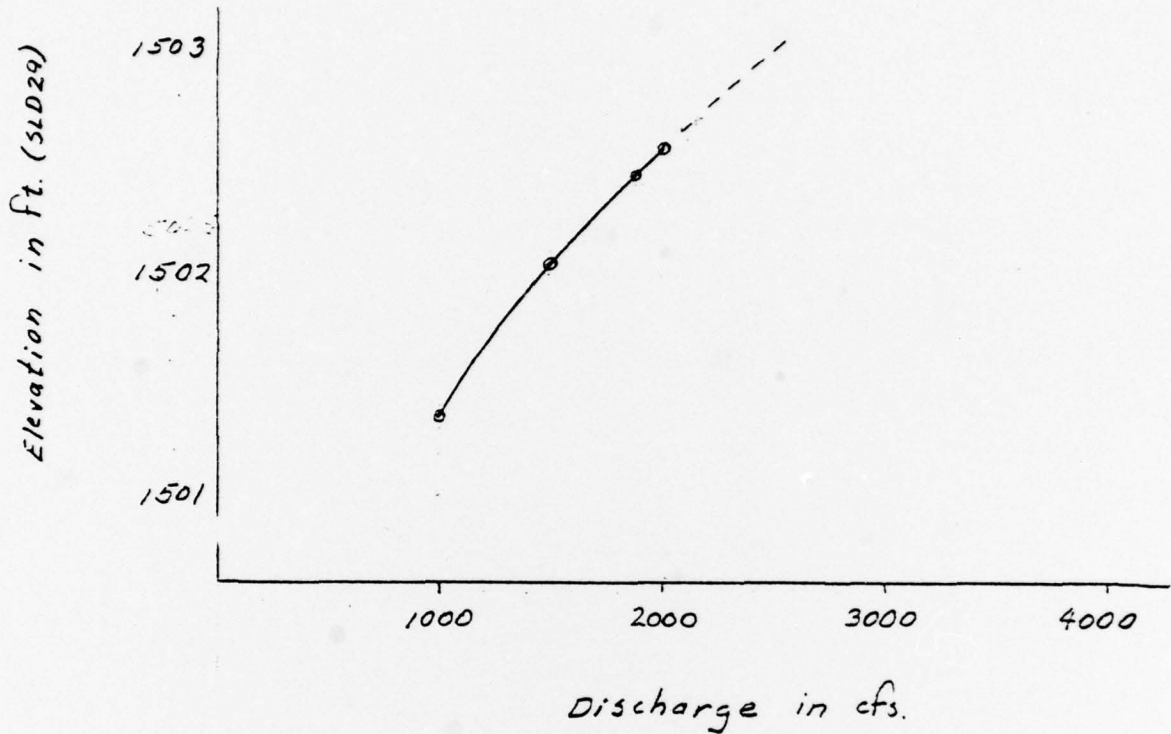
from extended rating curve (above) $Q_{max} = 2150$ cfs
@ Pool = 1502.7

$$\% = \frac{2150}{1870} \times 100 = 115\%$$
