**BEAVER RUN DAM  
NDI No. Pa. - 484**

**PHASE I INSPECTION REPORT  
NATIONAL DAM INSPECTION PROGRAM**

PHASE I INSPECTION REPORT  
NATIONAL DAM INSPECTION PROGRAM  
BEAVER RUN DAM  
ID NDI# PA-484, PENNDER# 65-114

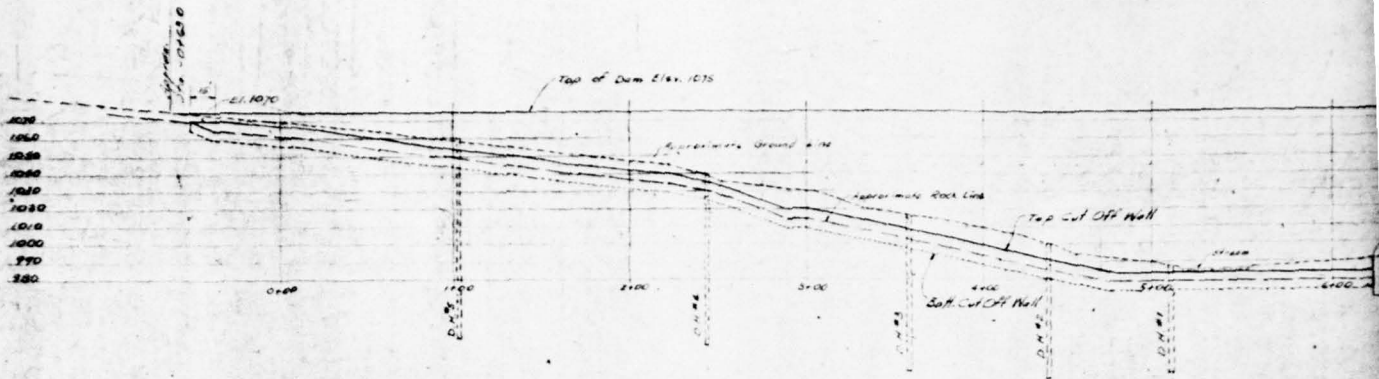
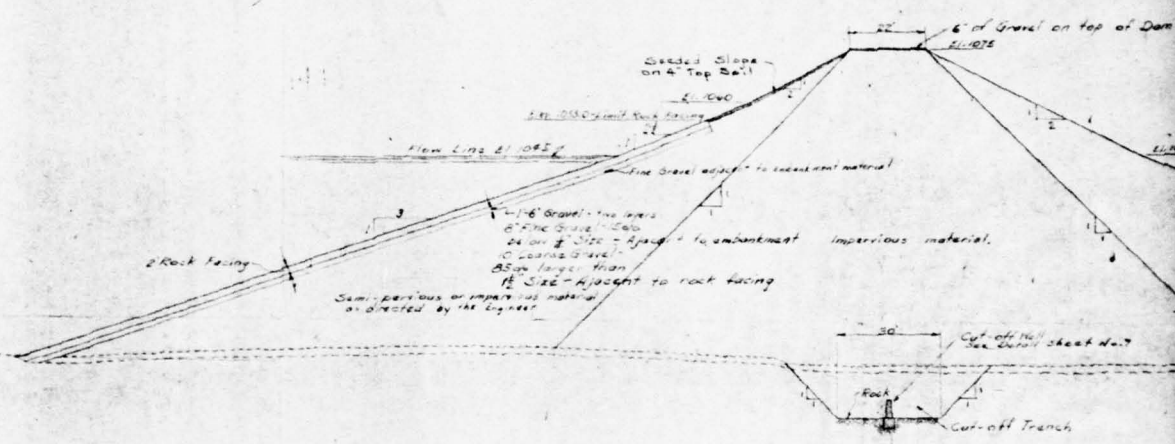
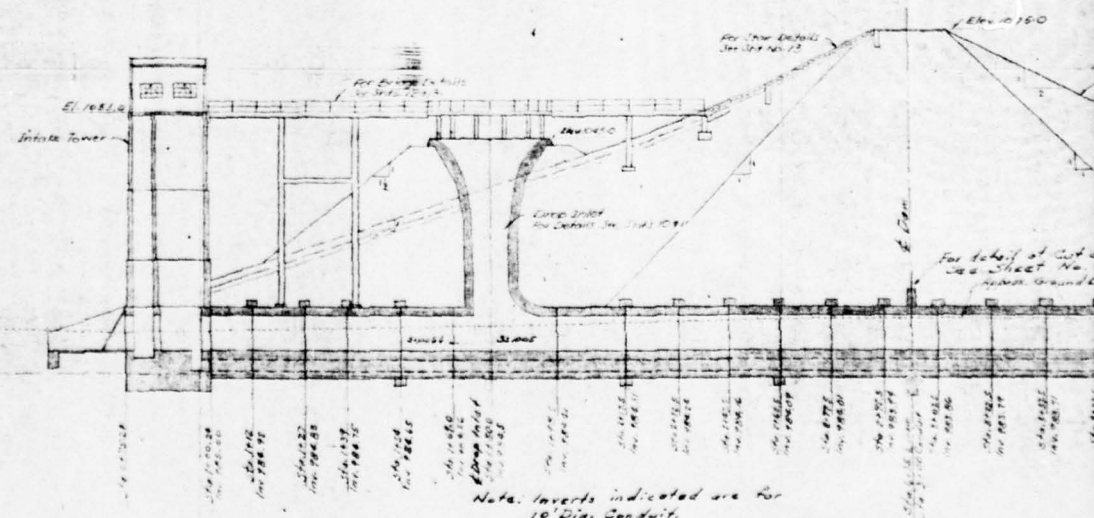
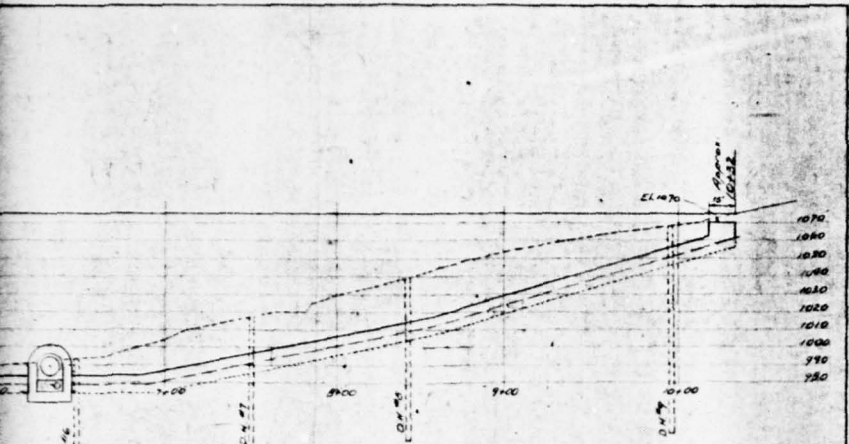
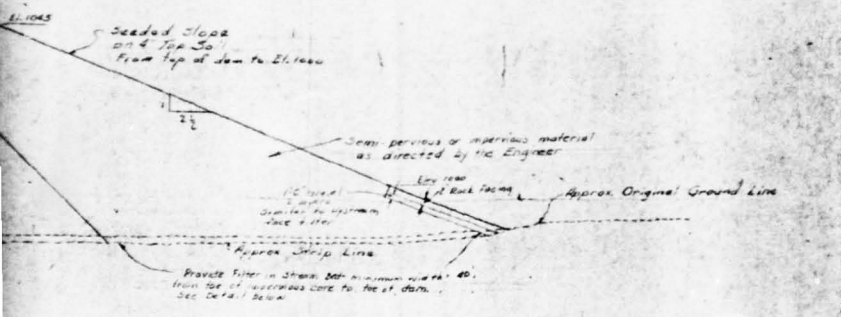
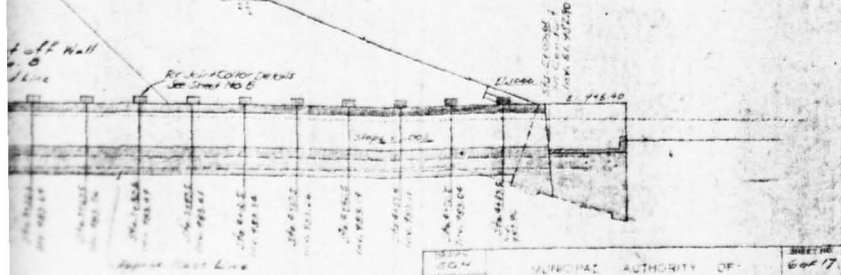
FIGURE 3 C-7258

The original design called for an earth embankment with a downstream rock zone (see Figure 3). Preliminary investigations failed to produce the quantity of material needed to construct the rockfill portion of the embankment and subsequently an earthen embankment was reportedly constructed (see Geology, Appendix E). The details of embankment construction are only inferred since as-built drawings are not available.

Zoning - (inferred from drawings and PennDER files) - Rolled earth with a riprap bedding on upstream face. According to the most recent pre-construction drawings, a 40-foot wide sand and gravel filter was installed in the old streambed (see Figure 3).

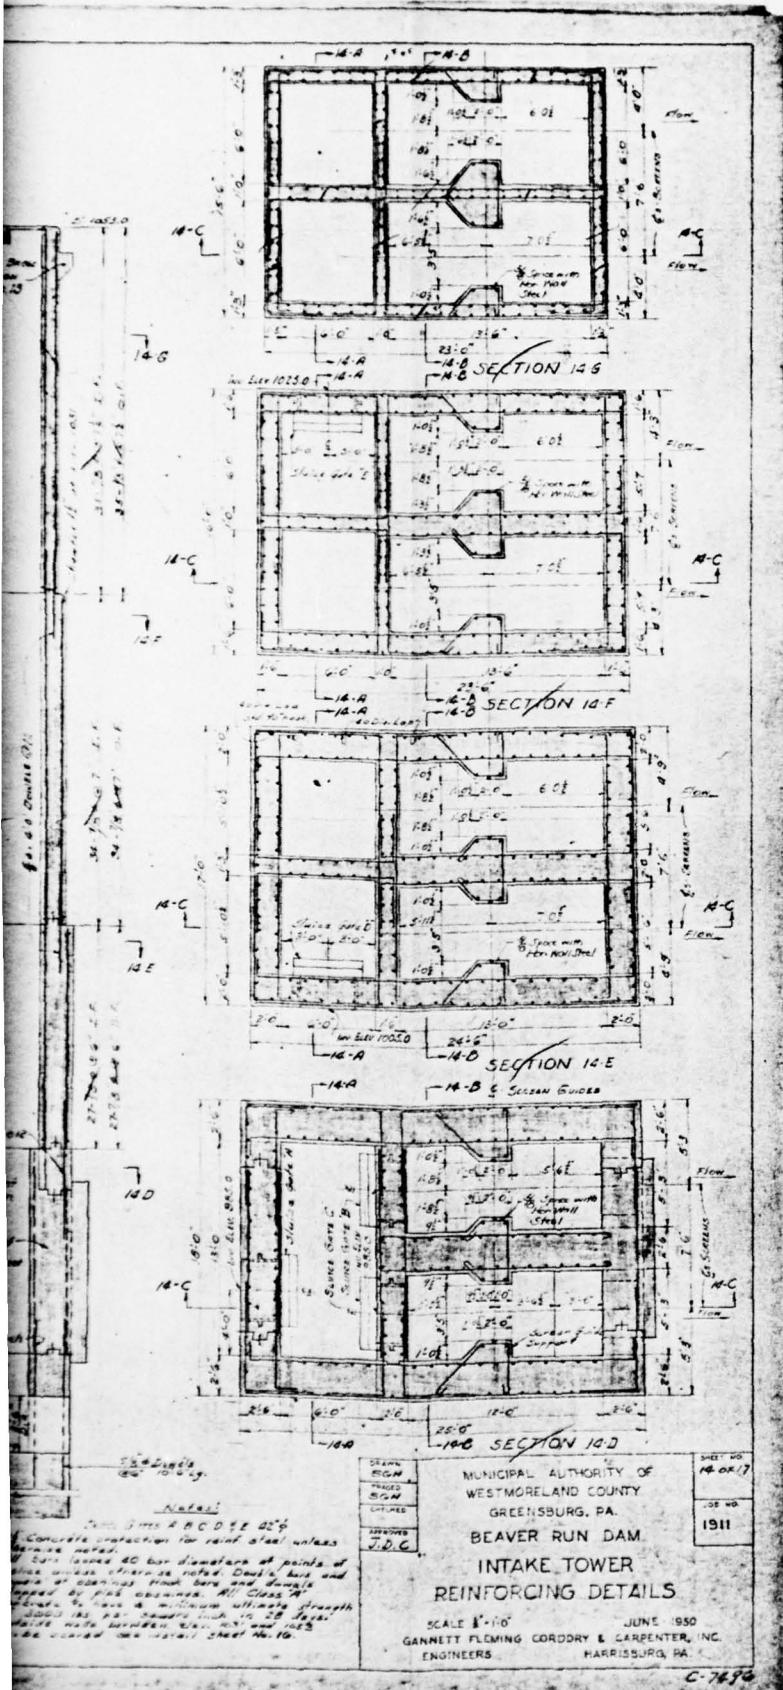
FIGURE 6

2. Gate House. The general condition of the gate house, access bridge, and valves appeared satisfactory. According to a representative of the Water Authority, the valves are in good working order and are periodically maintained. Three valves located within the gate house allow for the removal of water from different elevations within the reservoir. This water discharges into two 42-inch cast iron pipes which pass through the dam beneath the 10-foot diameter extension to the spillway (see Figure 6).
