**NDI No. Pa. - 231
HIGH POINT LAKE**

**PHASE I INSPECTION REPORT
NATIONAL DAM INSPECTION PROGRAM**

High Point Lake, NDI Number PA-231.
Ohio River Basin, Negro Glade Run, Somerset
County, Pennsylvania. Phase I Inspection
Report.

**PREPARED BY
GAI CONSULTANTS, INC.
570 BEATTY ROAD
MONROEVILLE, PENNSYLVANIA 15146**

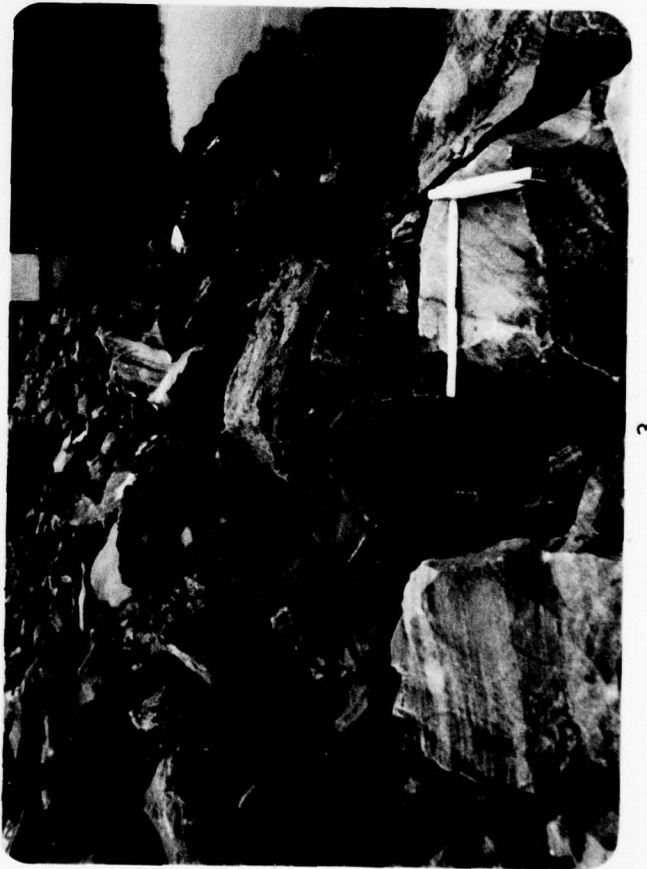
3

b. Embankment. The upstream slope of High Point Lake Dam is covered with a durable limestone riprap (see Photograph 3) which was dumped in place. The downstream slope and crest are grass covered. No indications of slope settlement were observed at the time of inspection.

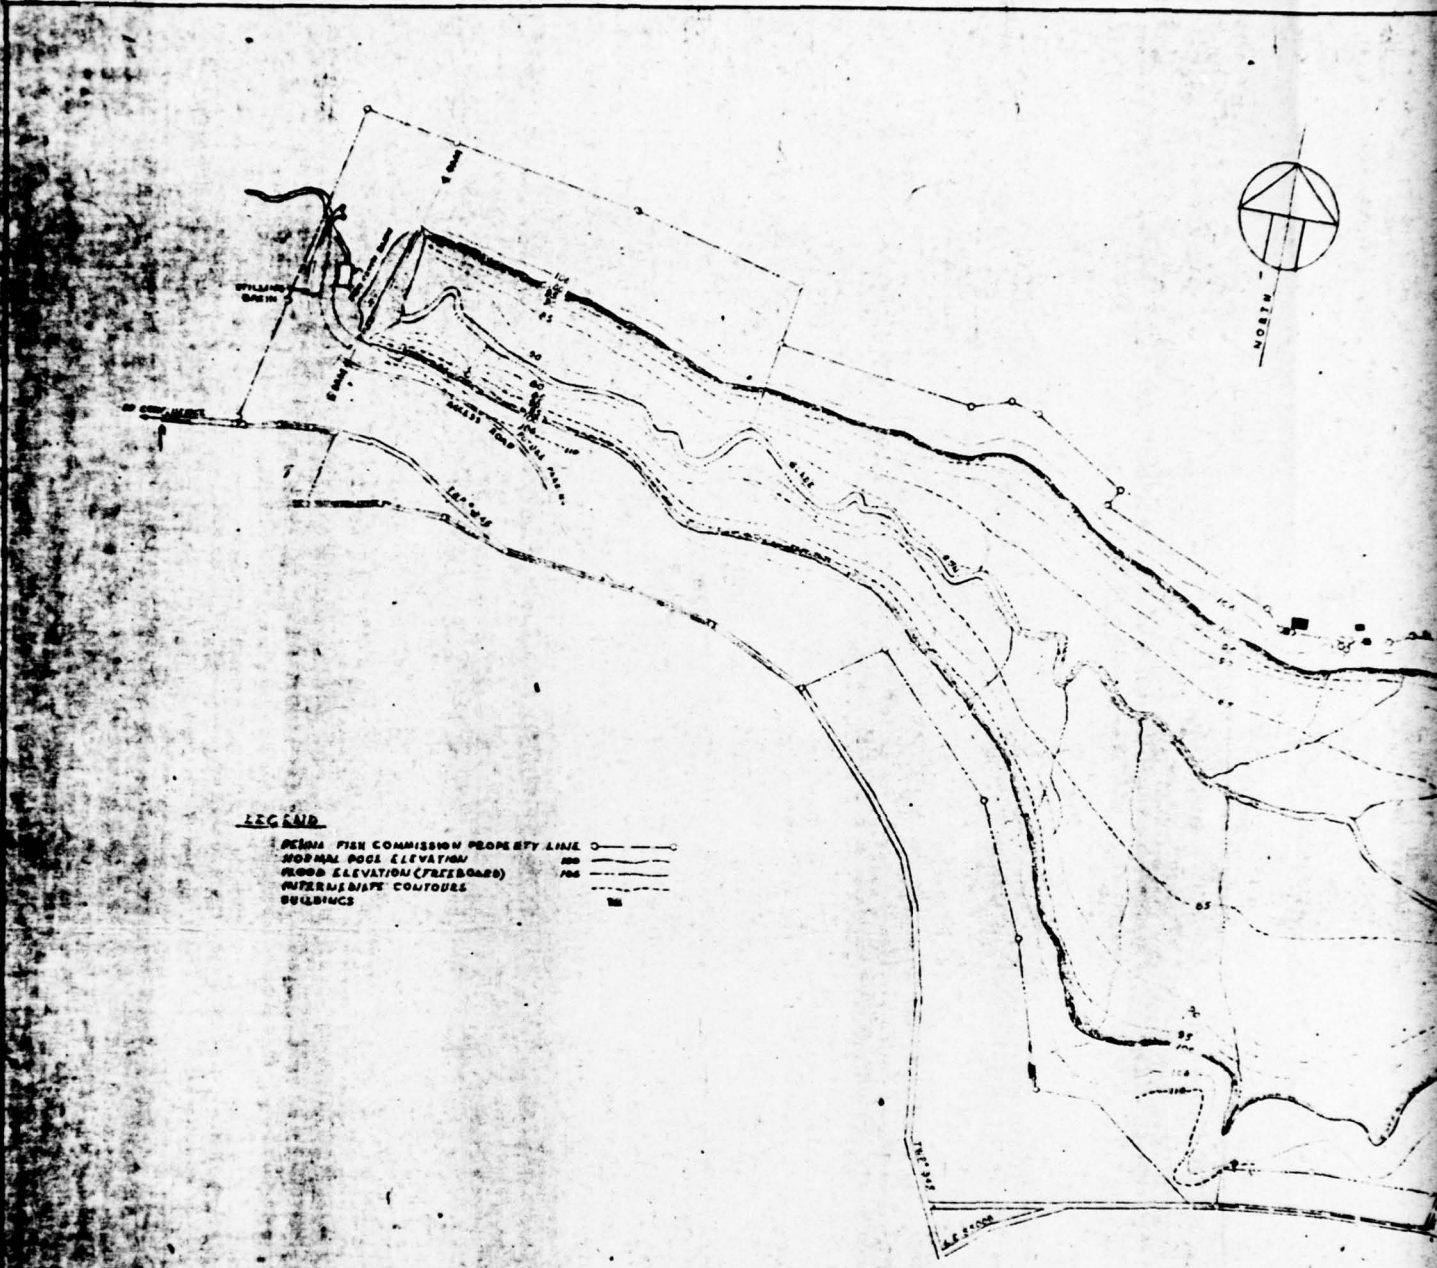
FIGURE 1

Some seepage was observed in the area just to the right of the right spillway sidewall. It is probable that the seepage is passing through or atop the original ground surface since there is little fill in the area (see Figure 1). In any case, the seepage is not considered serious at this time (seepage flow could not be measured) although small erosion gullies are forming.

a. Embankment. Based on visual observations, the embankment appeared to be in good condition. Some seepage (saturated zones-flows could not be measured) was noted to the right of the spillway sidewall in the area shown on Figure 1. Small erosion gullies had developed in the area in what appears to be natural ground. The situation, in its present state, is not considered serious.

Erosion gullies to the right of the spillway (see Figure 1). May be springs in original ground but apparently they are now being fed by the reservoir pool since the spillway excavation would have cut off any source on the left abutment.

- a. Fill in the erosion gullies that have developed to the right of the spillway sidewall with materials that will retard further erosion. The seepage should also be monitored to insure that the condition does not worsen.
- b. Develop a formal warning system to notify downstream residents should hazardous conditions develop.
- c. Develop a manual for the operation and maintenance of the outlet works at the facility.
