National Dam Inspection Program. Oneida
Mining Co. Dam (NDI PA-830), Ohio River
Basin, Unnamed Tributary to Brush Creek,
Indiana County, Pennsylvania. Phase I
Inspection Report.

PHASE I REPORT
NATIONAL DAM INSPECTION PROGRAM

Oneida Mining Company Dam

PHASE I INSPECTION REPORT
NATIONAL DAM INSPECTION PROGRAM
ONEIDA MINING COMPANY DAM
NDI# PA-830, PENNDER# 32-79

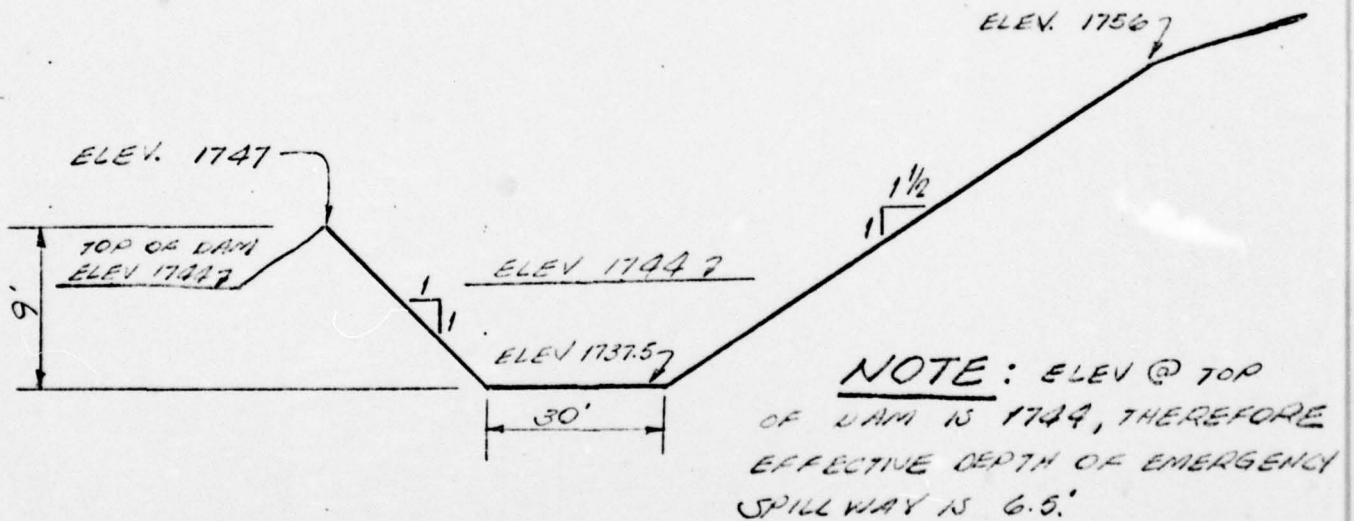
FIG. 1

TYPICAL CROSS-SECTION OF EMERGENCY SPILLWAY
 NOT TO SCALE

ALL ELEVATIONS, DETAILS, AND DIMENSIONS ARE TAKEN
 FROM REF 1, DWG 5 OF 11, AND HAVE BEEN FIELD
 VERIFIED.

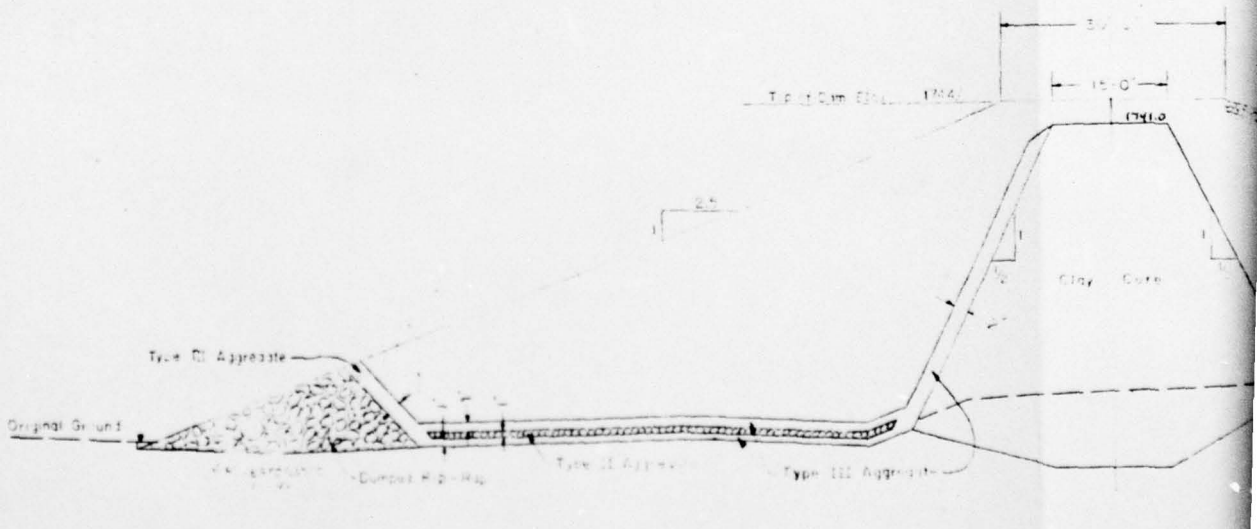
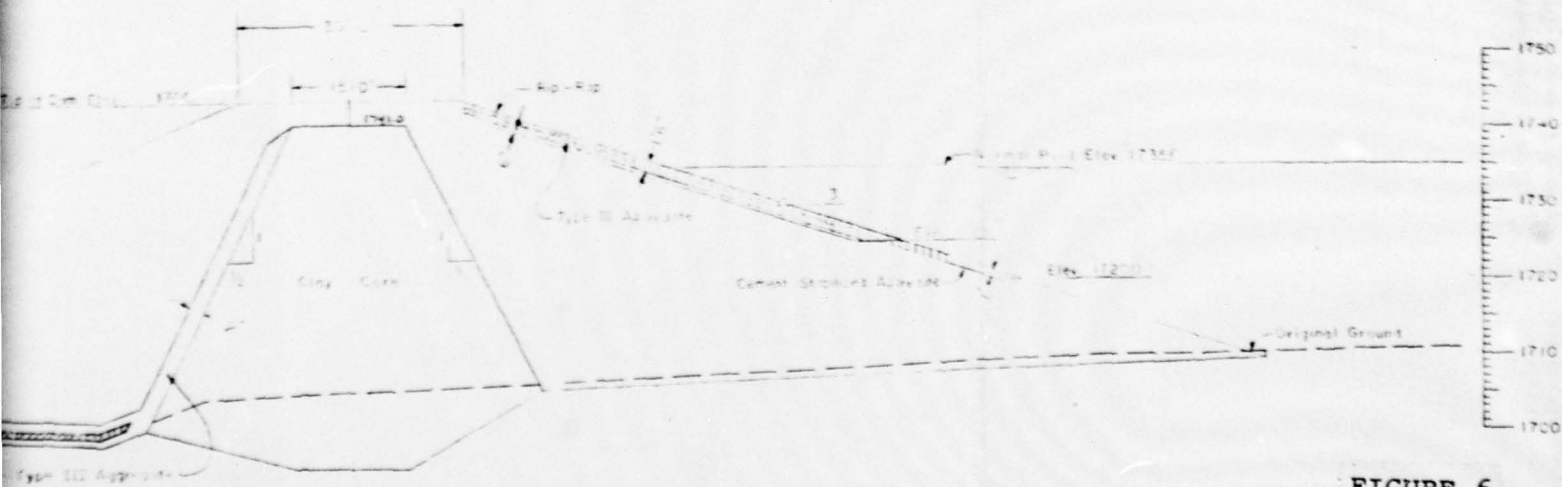
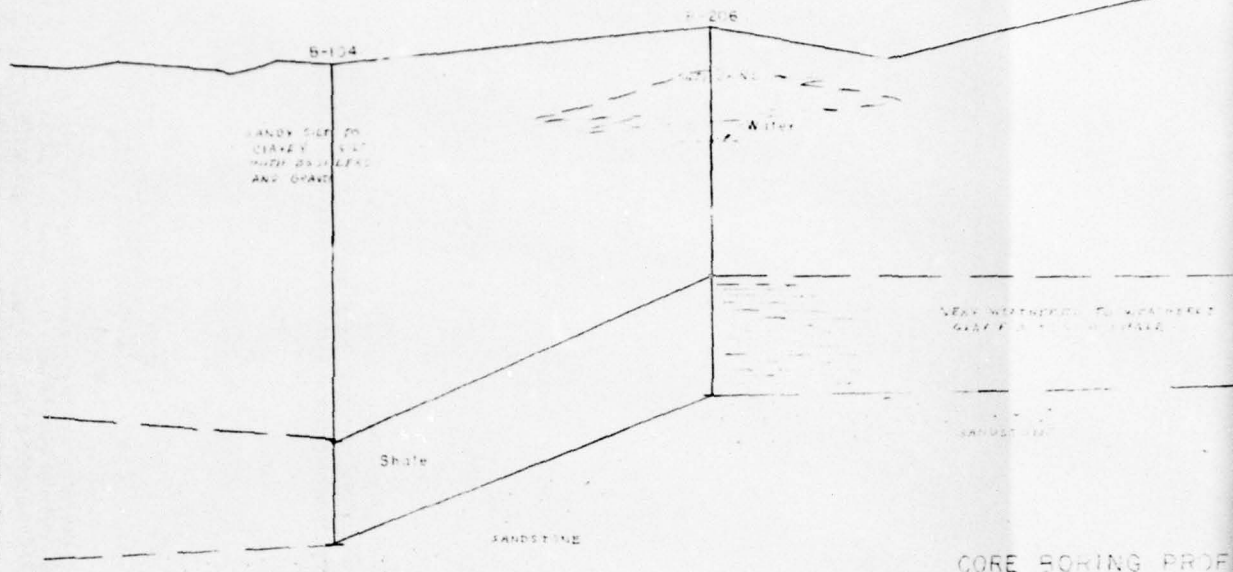
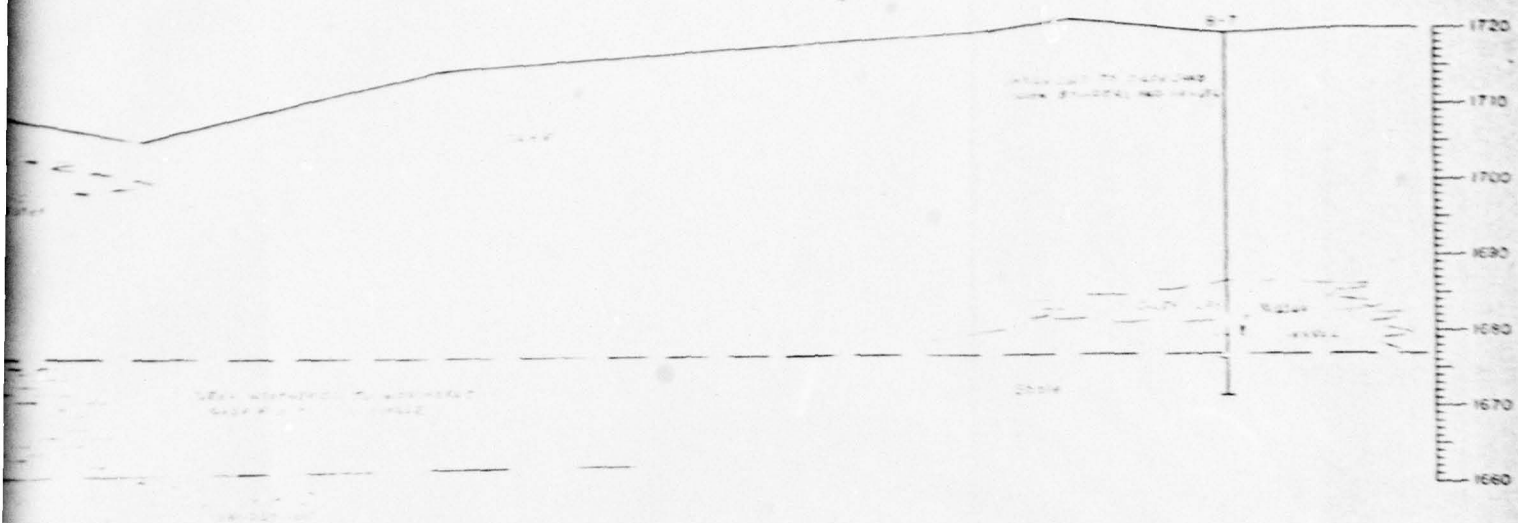
FIGURE 6

Zoning - The embankment contains an impervious core section consisting of clay materials. The outer zones of the embankment both upstream and downstream consist of random fill materials excavated from the core cutoff trench and the emergency spillway. The design includes a gravel and sand filter blanket under the downstream zone of random fill. The total thickness of the filter blanket is three feet. A 2-foot thickness of fine aggregate material serves as an inclined drain between the clay core and the downstream random zone of the embankment. A rock toe drain is provided at the downstream toe with provisions to collect the drainage from the filters. For wave and ice protection, there is resistant rock riprap (limestone) on the upstream face of the dam from elevation 1725.0 to the embankment crest (see Photograph 2). Below elevation 1725, there is a cement stabilized aggregate extending to elevation 1720. This latter feature was below current pool and, therefore, could not be observed (see Figure 6).

Impervious Core - Figure 6 indicates the central portion of the embankment contains a 10-foot deep cutoff trench containing a tapered clay core built up from the bottom of the cutoff trench to elevation 1741. The clay core has a top width of 15 feet and side slopes of 0.5H:1V.

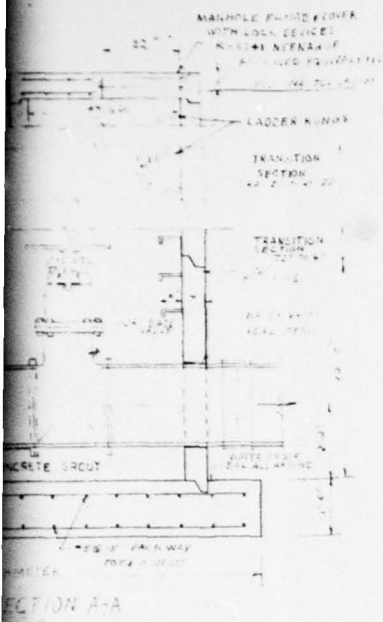
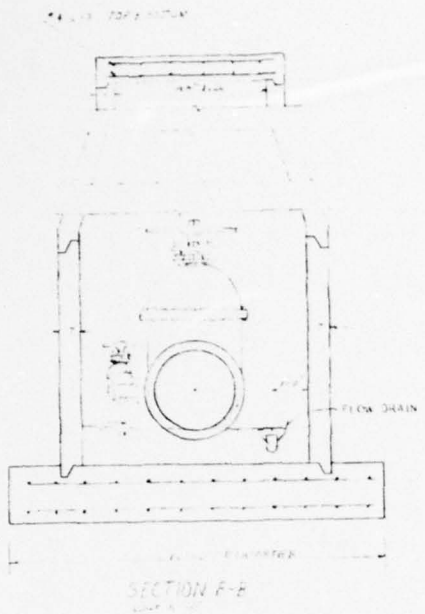
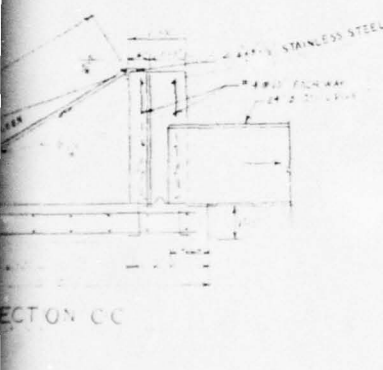
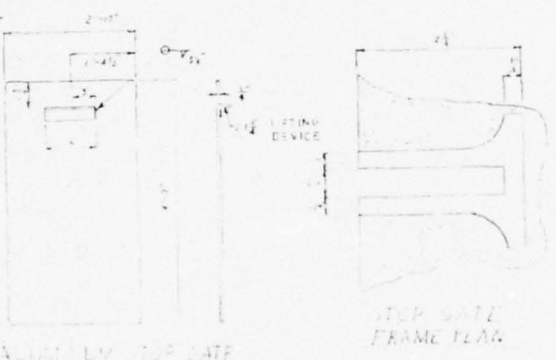
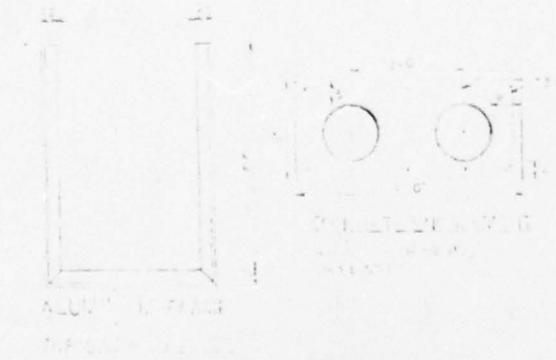
FIGURE 7

Type (submerged inlet) - A 24-inch diameter steel pipe encased in concrete with concrete cutoff collars spaced at 20-foot intervals is constructed beneath the embankment. The inlet end is equipped with a stainless steel bar trash rack (see Figure 7).

Regulating Facilities - Discharge is controlled via the 24-inch gate valve at the bottom of the gate valve control manhole. The 3-inch by-pass gate valve is used to maintain a minimum flow in the stream channel downstream of the embankment (see Figure 7).
